REPORT N° 70012805-001

ENVIRONMENTAL AND SOCIAL IMPACT ASSESSMENT GAP ANALYSIS REVIEW

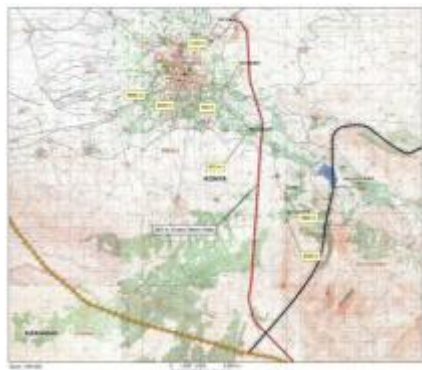
The proposed route for the 380kV OHL (partly renewed) from the Mersin CCGT to the Mersin 380kV substation was observed during the recent site visit using existing municipal roadways. It was not possible to follow the exact route. However, during this 12km section a number of commercial properties were observed.

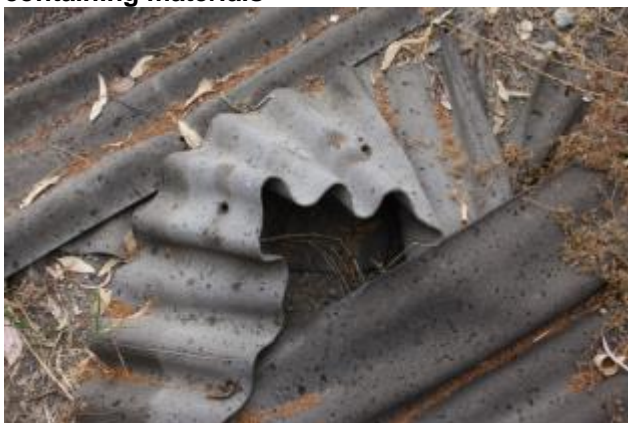
Photo 10: Mercin region OHL Route – Current 154 kV line route that will be replaced.

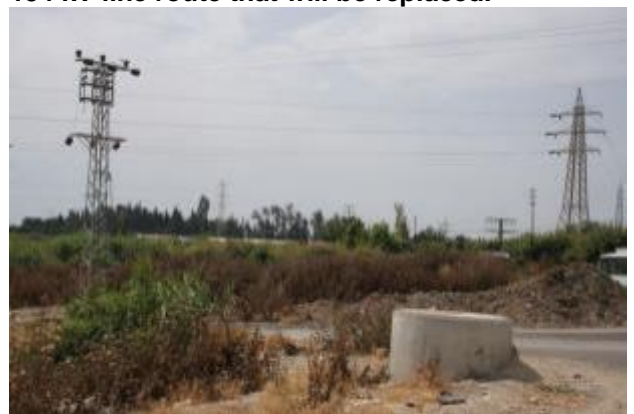
Photo 11: Mercin region OHL route – line likely to pass over or near commercial buildings in this area.

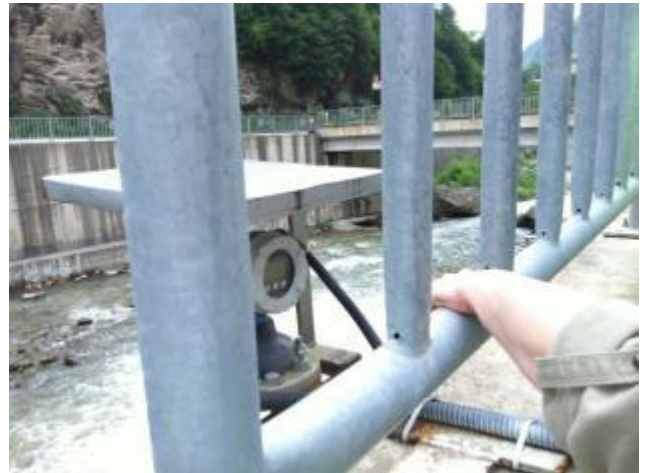
Photo 19: Yagmur HEPP - Oil storage compound (rear) with no kerb adjacent to SE drain direct to river (drainage grill removed resulting in fall hazard).

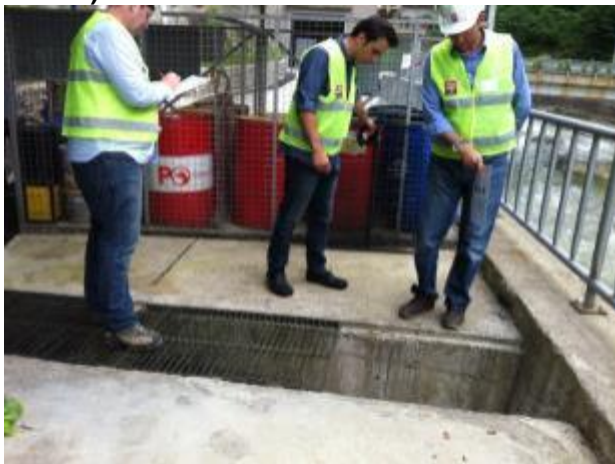
Photo 20: Yagmur HEPP Turbine hall at lower elevation.

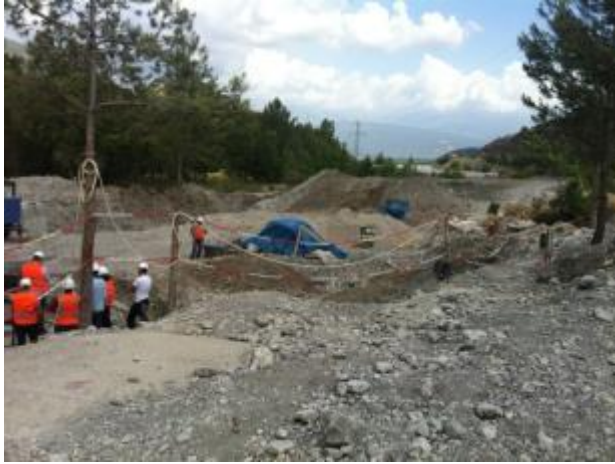
Photo 28: Sekiyaka II - Construction site (slip, trip and fall hazards).

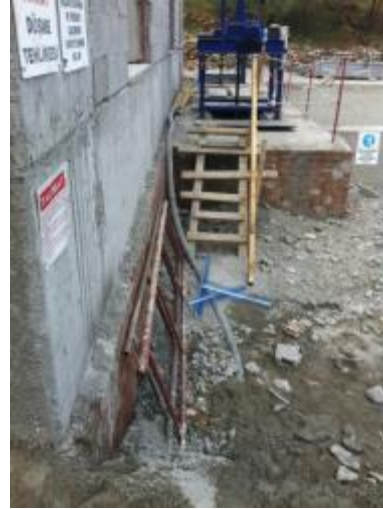
Photo 29: Sekiyaka II - Construction site (inside new HEPP).
