**ENVIRONMENTAL AND SOCIAL
PERFORMANCE
ANNUAL MONITORING REPORT (AMR)**

Mozal S.A.R.L.
MOZAMBIQUE

REPORTING PERIOD: 1 JULY 2001 – 30 JUNE 2002

PREPARED FOR: INTERNATIONAL FINANCE CORPORATION

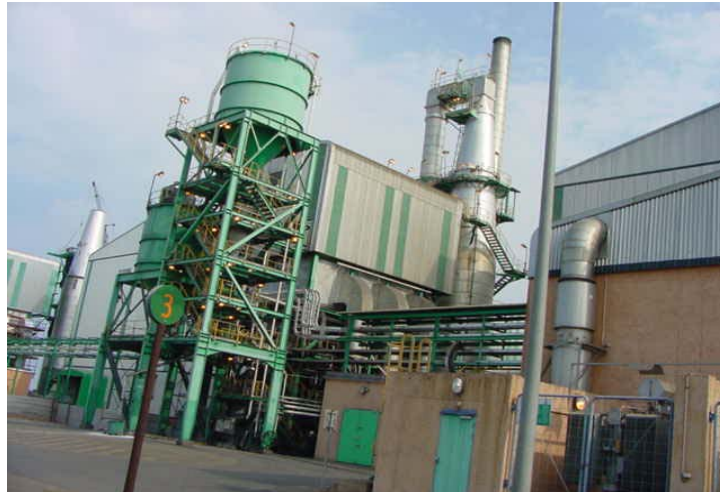
Figure 3: Photograph showing fume treatment centre at carbon plant with second unit under construction in background

The Gas Treatment Centre (GTC) and Fume Treatment Centre (FTC) are the principal mechanisms of air pollution control on the smelter. In both, fluoride is scrubbed from the gas stream by being brought into contact with the incoming raw alumina. The alumina is then captured in a series of bag filters, which also have the effect of removing particulate matter (particulate fluoride and alumina dust) from the exhaust stream.

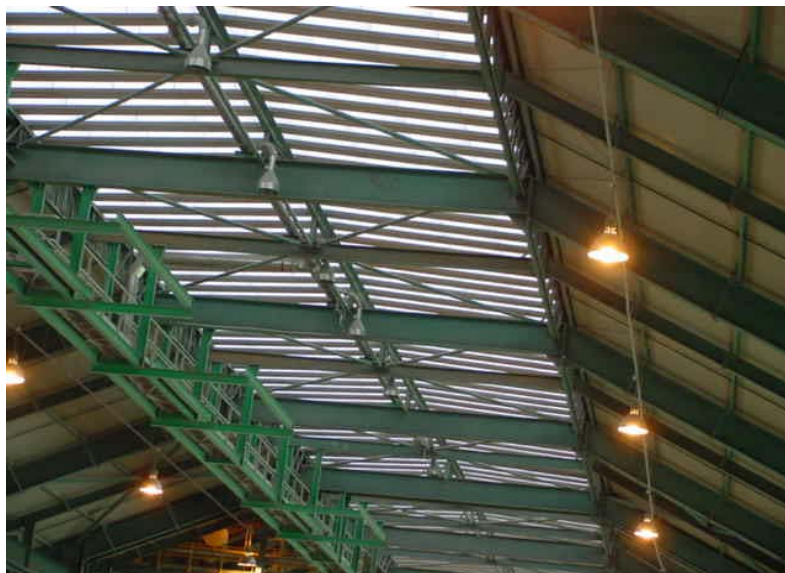
Figure 4: Photograph showing potroom roof vent monitoring system.

Within the potroom the hoods on the reduction cells periodically have to be removed for maintenance purposes. When this happens the fumes generated in the pot are vented into the potroom from where they are emitted into the atmosphere via roof vents in the potroom roof. The roof vent monitoring system is shown in Figure 4. The monitoring of these pollutant emissions is shown in Table 3.

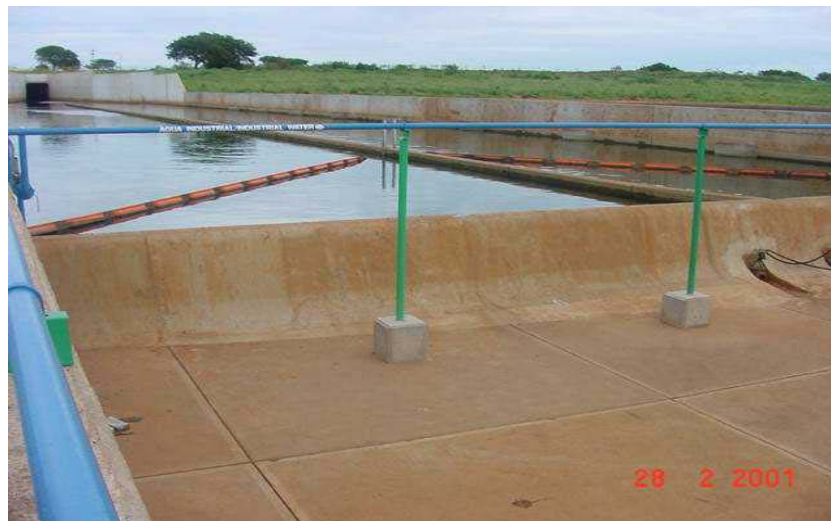
Figure 5: View of the impoundment dam inlet structure (stormwater enters the inlet from the far side). The inlet provides for sediment trapping and oil skimming. The complete impoundment dam can be seen in the cover photo of the entire smelter site.

There are two principle wastewater streams from the smelter, namely stormwater that falls on site, and cooling/blowdown water from the various cooling water circuits across the smelter. The cooling/blowdown water has an accumulation of salts (dissolved solids) as the cooling water is cycled and possibly some oil contamination, but no other contaminants. Local oil traps are installed and then the cooling/blowdown water is discharged to a central holding/balancing facility, also equipped with a back-up oil trap, from where it is directed to the Matola river estuary.

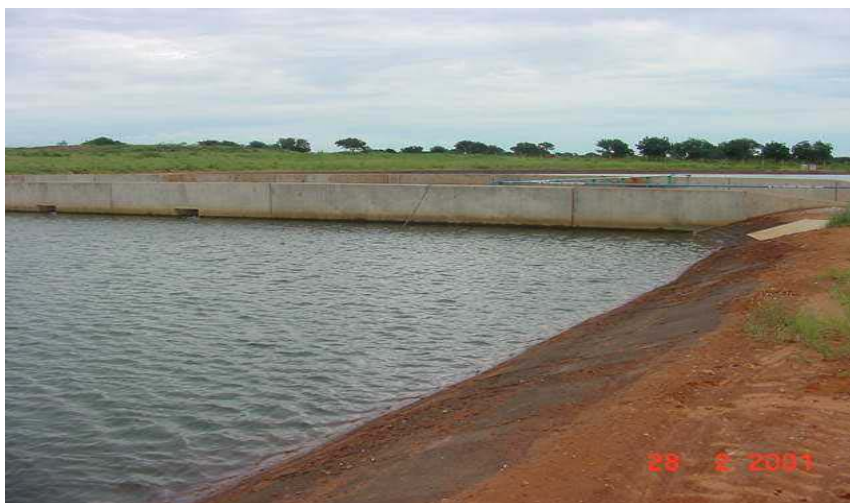
Figure 6: View of the south dam, one of two that provide for the impoundment of stormwater containing fluoride from the smelter site. The complete dam can be seen in the cover photo of the entire smelter site.

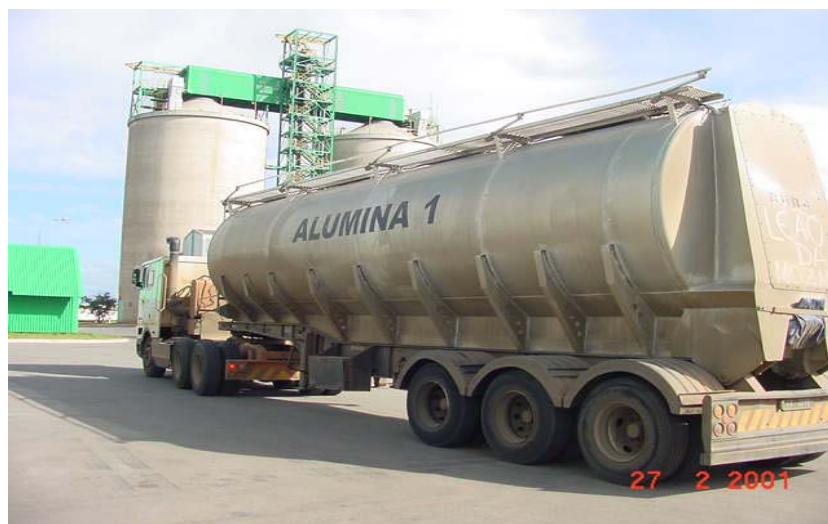
Figure 7: Photograph showing one of the alumina tankers that transports alumina from the harbour to the smelter.

Stabilisers have been fitted to all trailers to improve their stability and daily inspections of specific failure points on the trailers implemented to assess the rate of failure. Finite element analysis has been performed and engineering recommendations to alter the trailer design are currently being reviewed for possible implementation. Three trailers have been removed from service and substitute vehicles are being rented. All exhaust brakes have been disconnected to ensure that noise levels remain within acceptable limits and the project is continuing to explore suitable mitigation for ensuring that noise levels do not exceed required noise levels on the harbour access road.

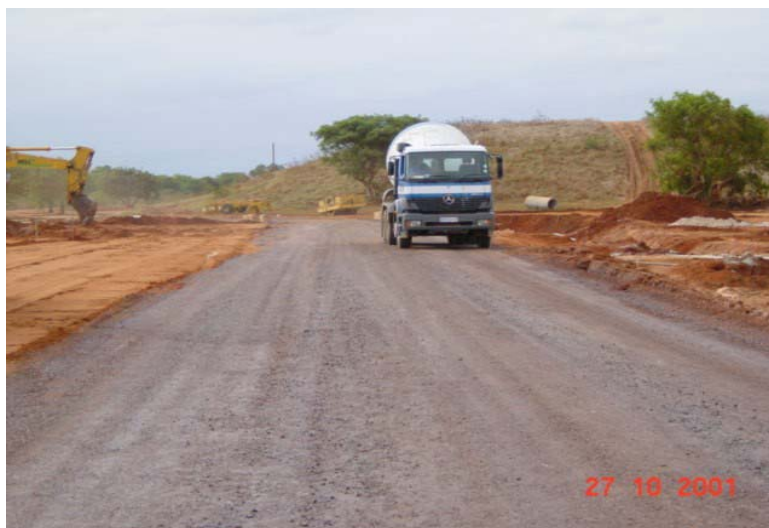
Figure 15: Photograph showing construction road treated with dust suppression palliatives.

To date dust has been well managed, resulting in no complaints being received from the construction site and no dust related incidents either in terms of possible contamination of the metal (through higher silica presence) or through concerns raised in the surrounding community.

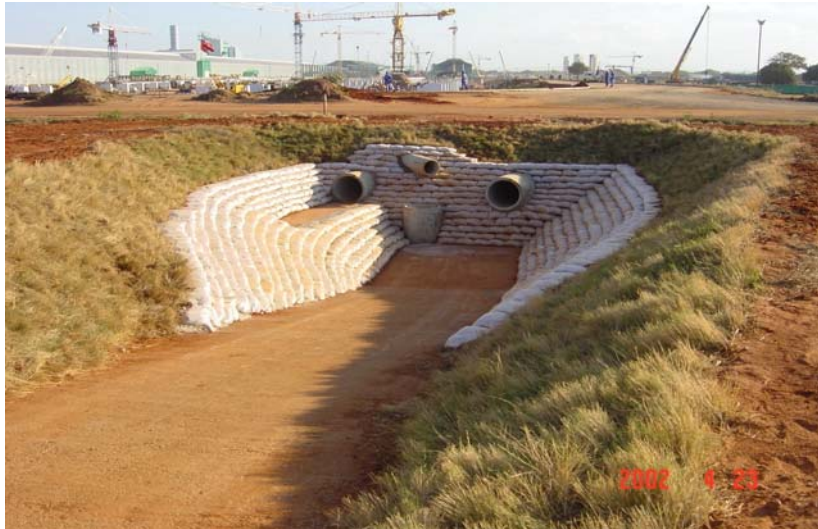
Figure 16: Photograph showing secondary sediment traps on construction site.

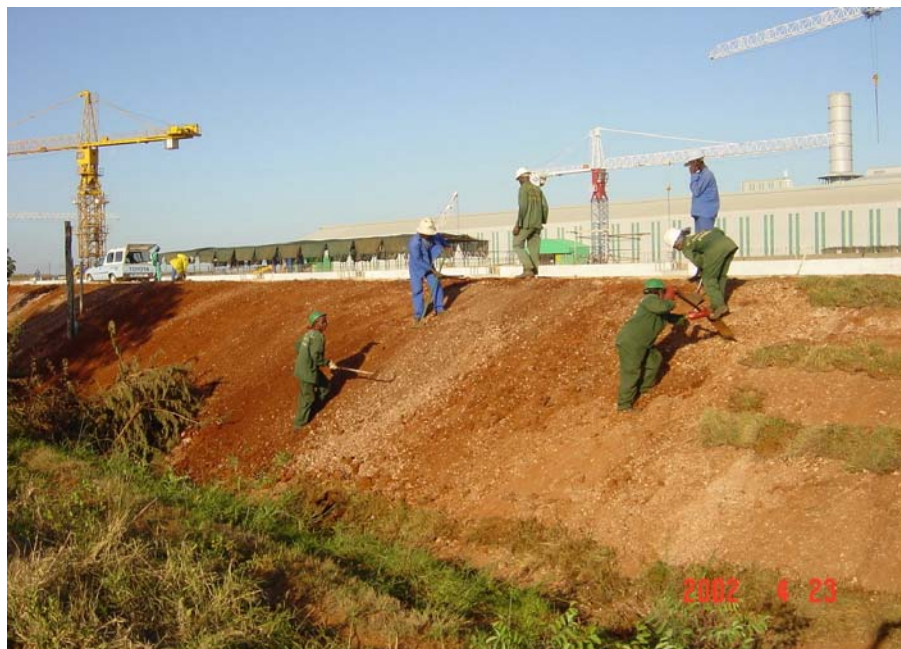
Figure 17: Photograph showing stabilisation of water channels and road embankments with grass

Areas vulnerable to erosion include the road embankments and these, together with the temporary stormwater channels, have been grassed to reduce the risk of erosion (Fig. 17). In addition, the points at which stormwater enters the temporary stormwater channels contain stone gabions to prevent the inlet areas from being scoured and to provide some rudimentary filtering of the incoming stormwater. Excavations pose a risk of high sediment loading and as a result the C-EMP guideline dictates that spoil from excavations must be placed on flat ground away from terraces or embankments.

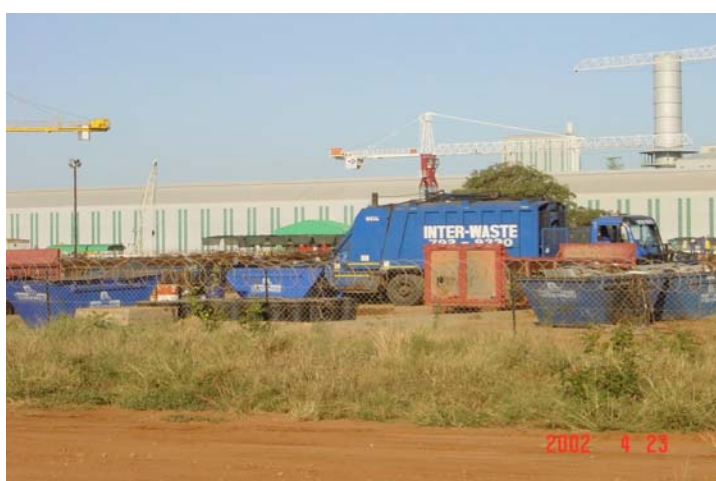
Figure 18: Photograph showing the waste transition station established during the Aluminium Expansion Project to provide for the segregation and safe disposal of waste generated during the project.

In terms of waste disposal, domestic waste (including plastic and cardboard wrapping, waste food and food containers, paper and so forth) is compacted and disposed of at the Matola landfill site. Waste timber is sorted into useable timber, which is taken to the Selesians College where it is used in furniture making, or as firewood (Fig. 19). The waste management contractor distributes the firewood to local communities. Some of the waste timber (especially the cable drums) has been treated with copper chrome arsenate (CCA). This timber is not distributed and is crushed and mixed with concrete for disposal on the building rubble site to prevent it being scavenged by the local community¹. Scrap metal is sorted into aluminium, copper and steel from where it is sold to scrap metal merchants.

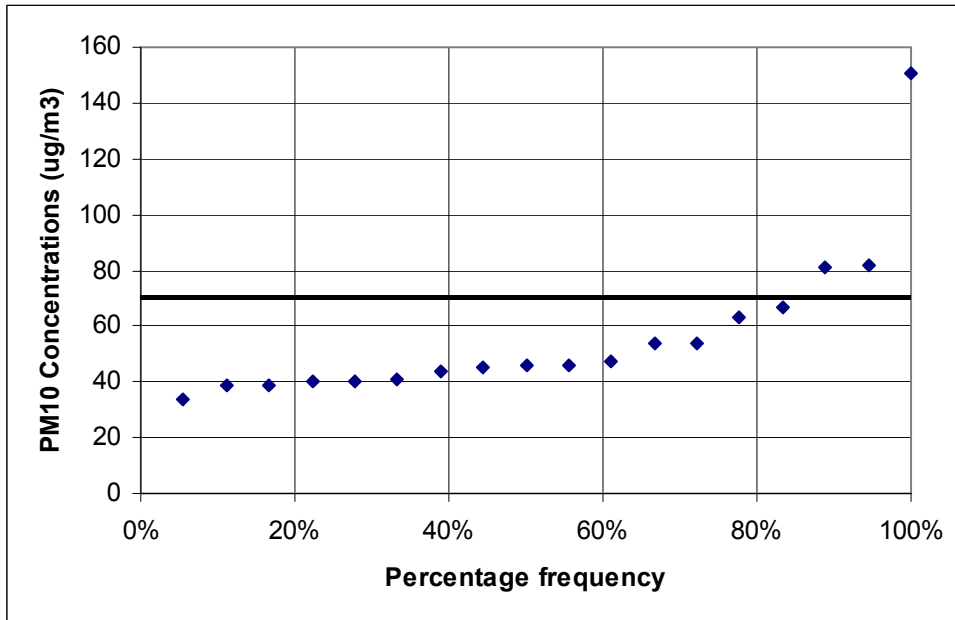
Figure 29: Frequency distribution of 24-hour PM_{10} measurements during a two-week ambient air quality survey in the vicinity of the smelter. The dark horizontal line represents the World Bank standard of $70 \mu\text{g}/\text{m}^3$.

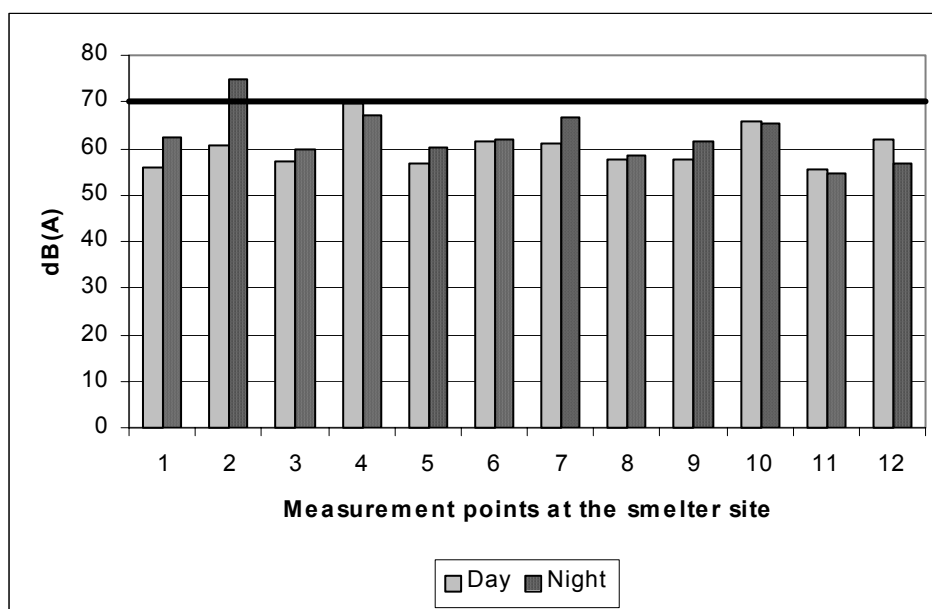
Figure 30: Night-time and day-time measurements of L_{eq} on the smelter perimeter. The applicable World Bank standard is 70 dB(A). Monitoring points are shown in Appendix 7.

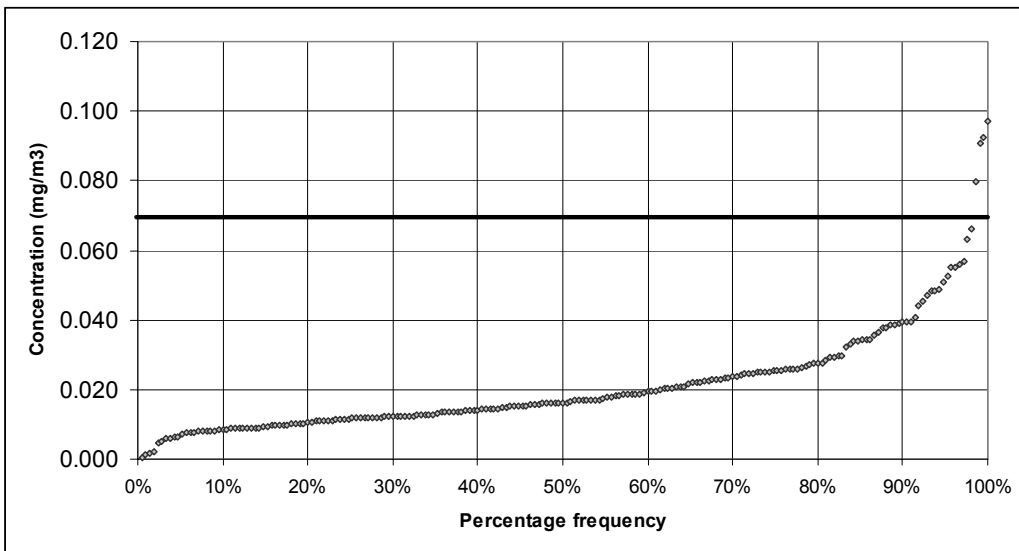
Figure 38: Probability plot of mean measured dust concentrations using the continuous dust monitor. Target value is illustrated by a dark horizontal line.

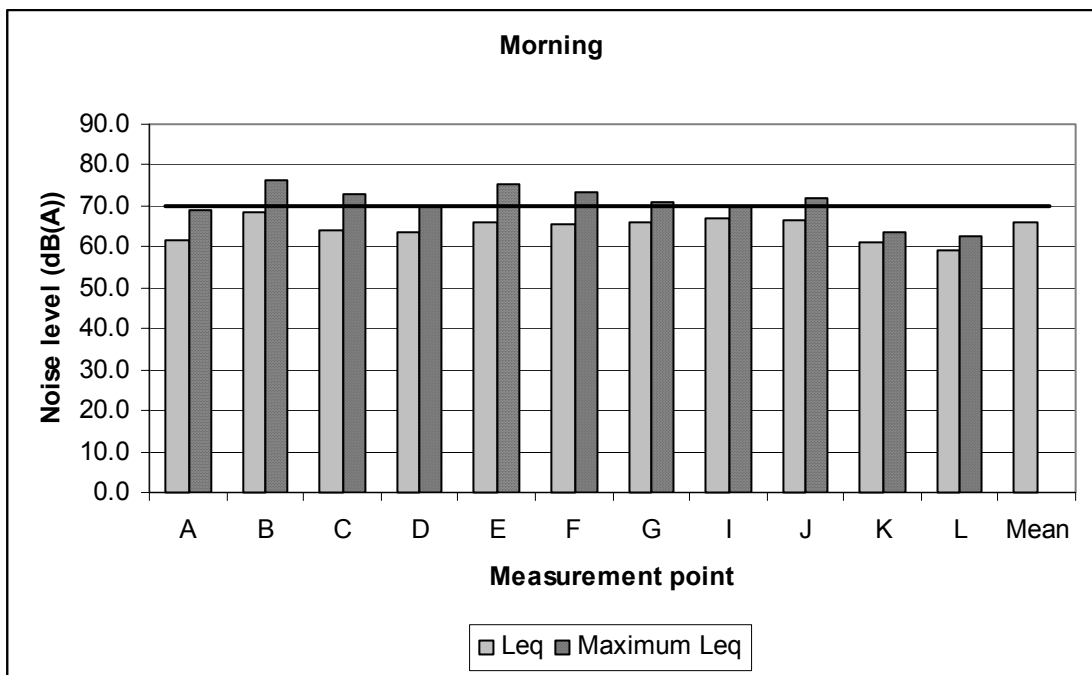
Figure 40b: Composite of all morning noise measurement campaigns conducted during the reporting period showing mean (Leq) and maximum (maximum Leq) noise levels measured for selected points across the construction site.

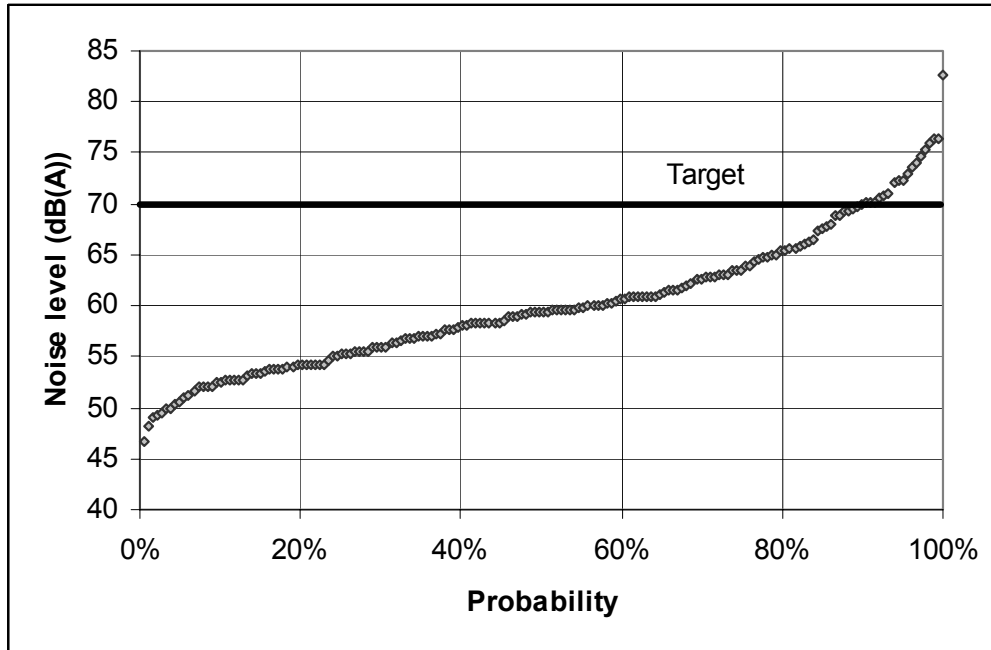
Figure 41: Probability plot of noise measurements taken on the construction site perimeter. The exceedances of the World Bank requirement of 70 dB(A) occurred during February 2002 and have not occurred since.

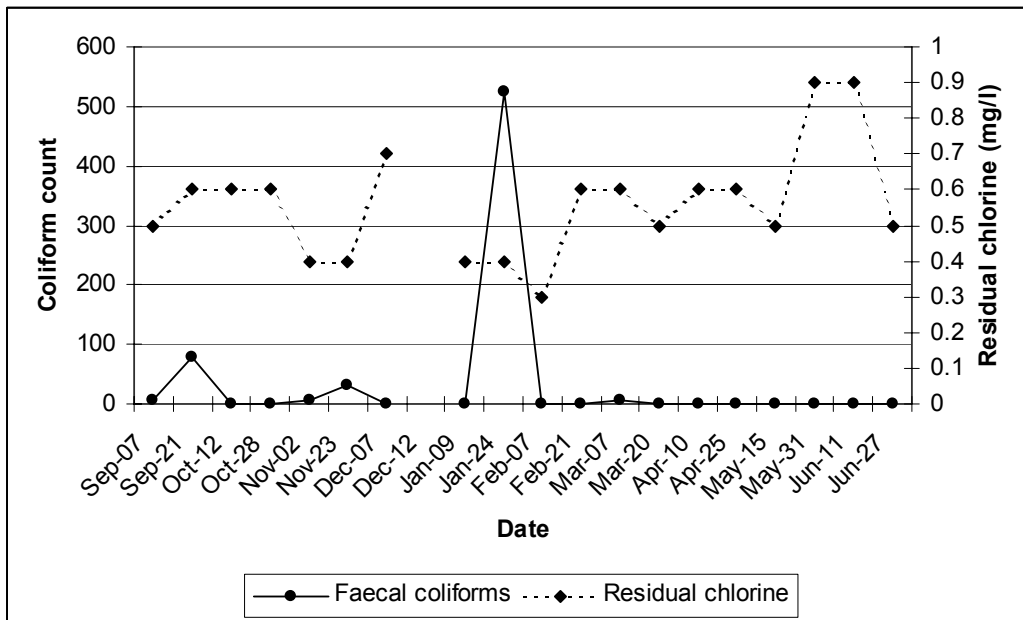
Figure 43: Relationship between faecal coliform counts and residual chlorine. Note the high coliform count during January when the chlorine dosing system malfunctioned and had to be repaired.

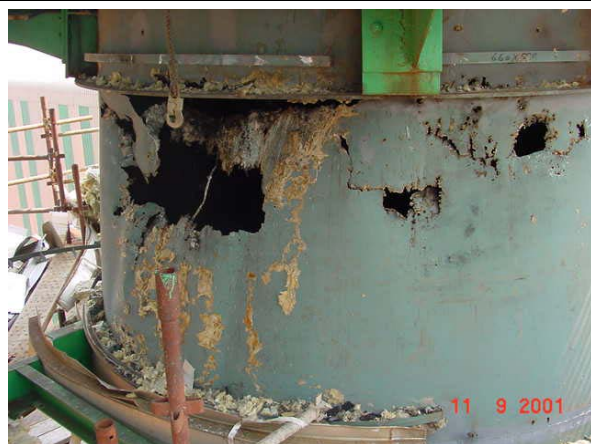
Figure 1: Corrosion on the damaged section affected the walkway structure as well as the shell.

In September 2001, corrosion was noted on the cooling tower of the Fume Treatment Centre of the Bake Furnace. As a result the cooling tower had to be repaired and during that time the FTC was run on by-pass during which time there was no scrubbing of fluoride emissions. A full incident report is provided in Appendix 3. Given that the incident was deemed a level 2 incident¹ – using the BHP Billiton, consequence severity ranking – the incident was not reported beyond MozaI.

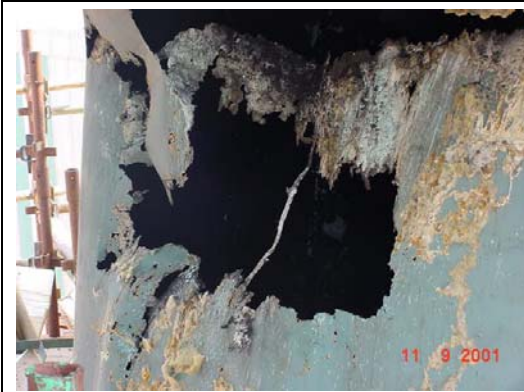
Figure 2: The corroded area of the Cooling Tower.

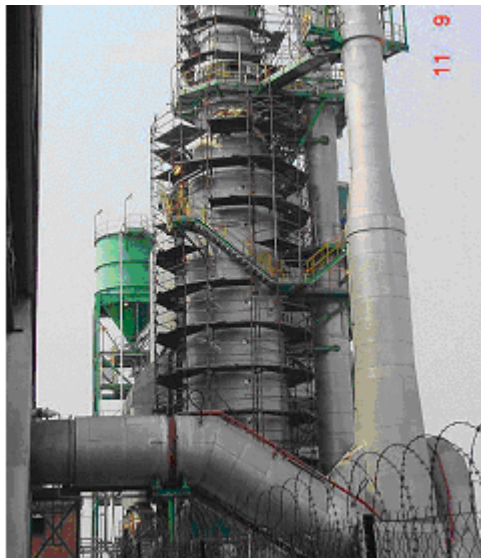
Figure 3: Scaffolding structure erected to support the Cooling Tower once the corroded area was discovered.

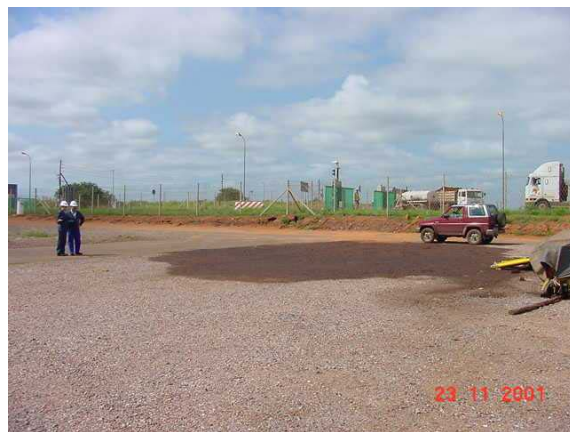
Figure 1: The oil-contaminated area.

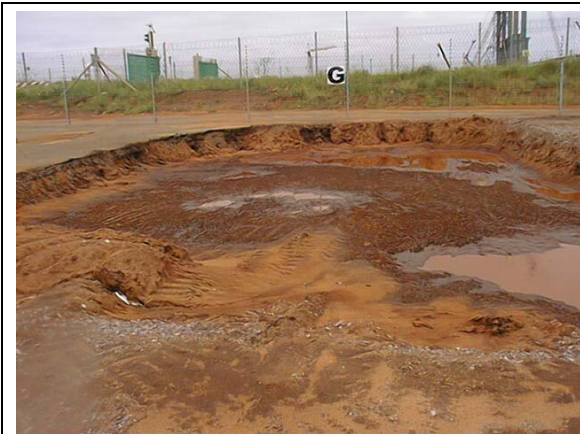
Figure 2: The site under rehabilitation.
