# **ECOLOGICAL FIELD SURVEY FOR THE PERU LNG NATURAL GAS PIPELINE PROJECT**

**PERU LNG S.R.L.**

**May, 2007**

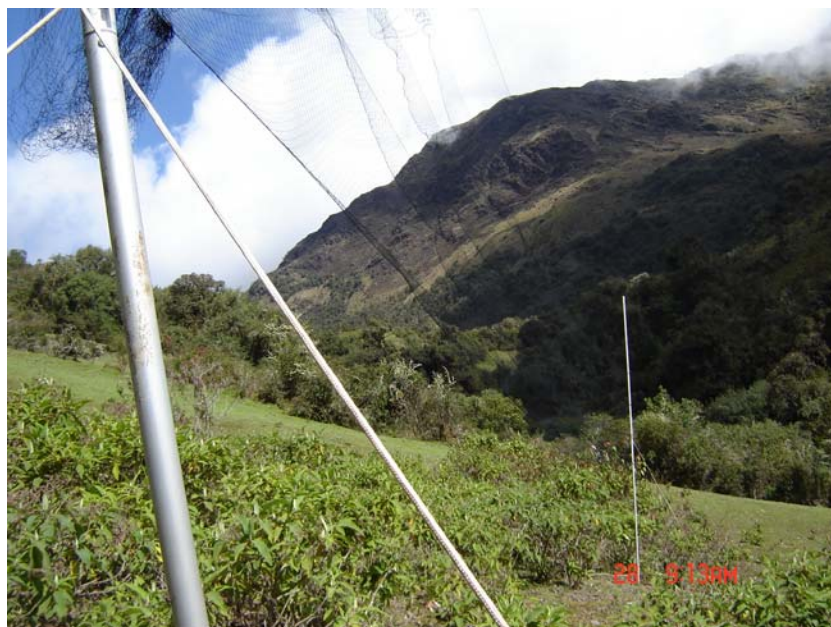
**Figure 2.** Mist net set in Montane Forest, 10 m far from the river that goes to SP3.
