**ENVIRONMENTAL & SOCIAL IMPACT
ASSESSMENT**

PROGRESS REPORT

For: SLALA RUBBER COMPANY.

Prepared By: EARTHTIME INC.

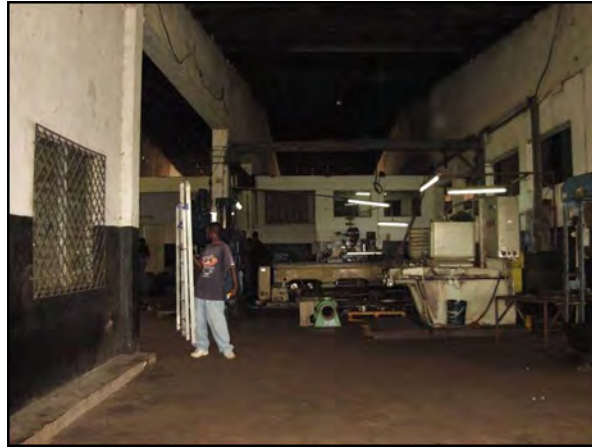
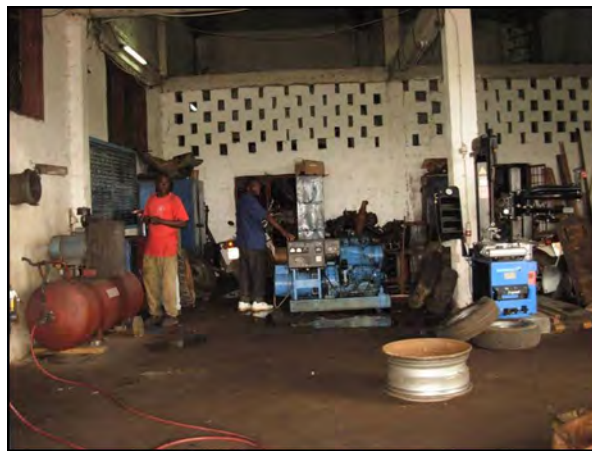
Figure 4-1: Views SRC factory's workshop.

A vehicle repair and maintenance workshop (Figure 4-1) and the power plant are located within SRC factory's compound. The workshop is used to facilitate repair and maintenance of factory's machinery and vehicles. Table 4-10 lists vehicles used by the SRC. The power plant is located within the factory's compound (Figure 4-2), houses three generators (Table 4-11). **Error! Reference source not found.** lists types and quantities of petroleum used at the facility.

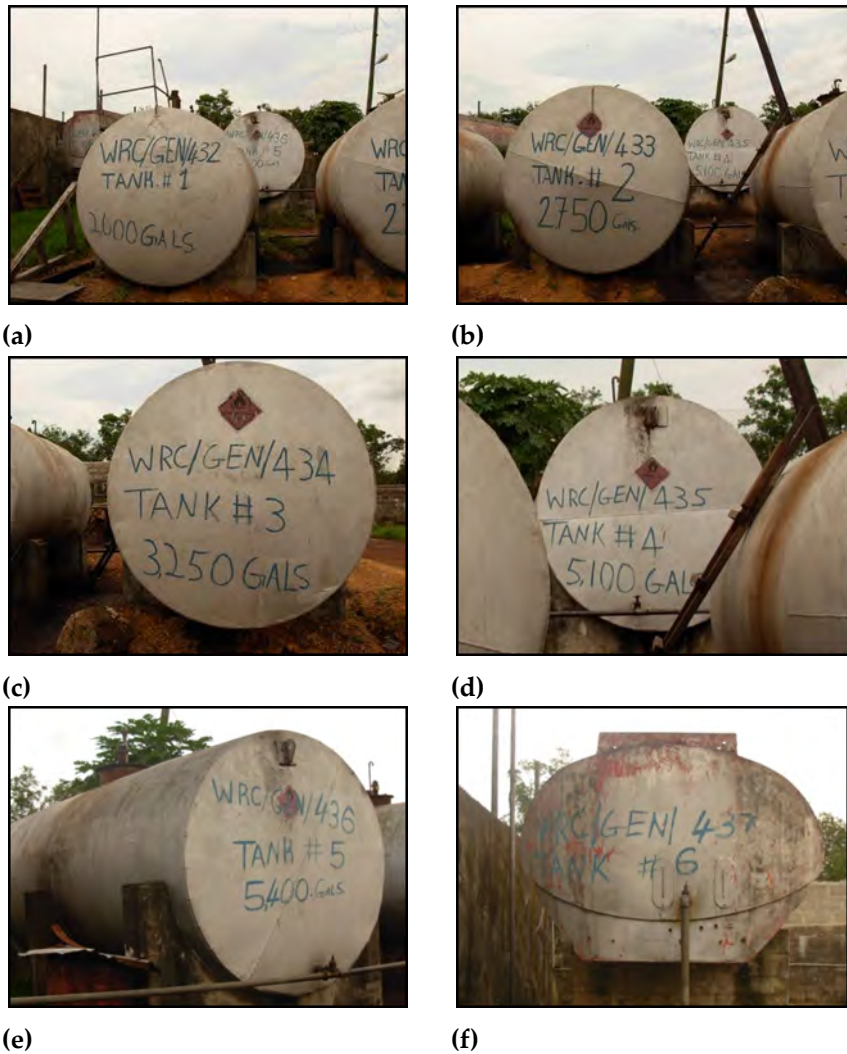
Figure 4-3: Fuel storage tanks. (a) tank # 1 with capacity 2600 gals; (b) tank # with capacity of 2750; (c) tank # 3 with storage capacity of 3250 gals; (d) tank # 4 with storage capacity of 5100 gals; (e) tank # 5 with storage capacity of 5400 gals; (f) tank # 6 currently not used.

Storage facilities at SRC include diesel fuel storage tanks factory vary from building to another and compose essential components of the production process. The facilities comprise a number of fuel tanks with various volumes mounted above ground (Figure 4-3). Fuel from these tanks is directed to a distribution system for use by vehicles, generators and the process dryer. The generators and dryer have day tanks for short term storage and control of fuel (Figure 4-4).

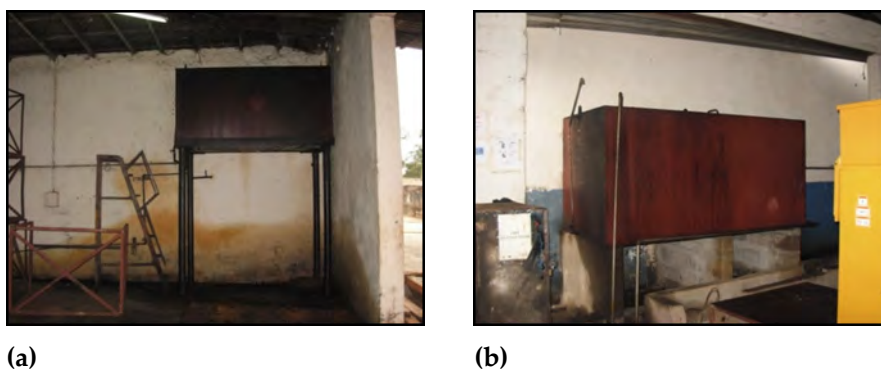
Figure 4-4: Short term storage tanks. (a) Located with the processing plant for the dryer and (b) located within the power plant for the generators.

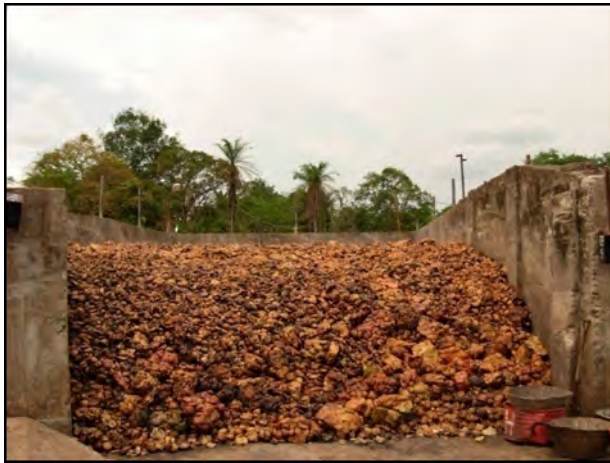
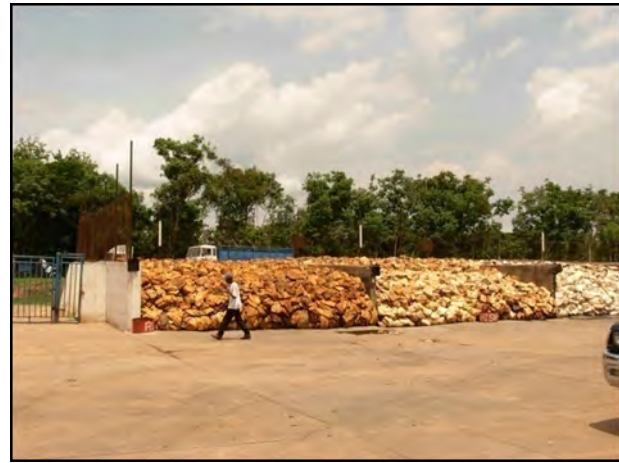
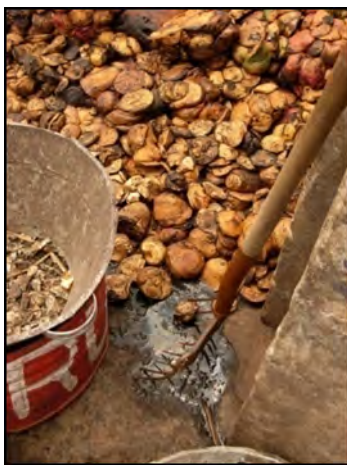
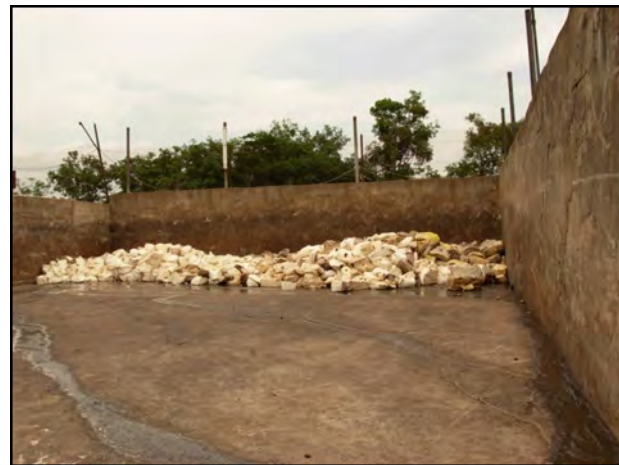
Figure 4-6: (a) & (b) bunkers filled with raw rubber before being processed; (c) raw rubber in bunker with syrup leachate; (d) bunker partially empty.

Among the main storage facilities on the factory's compound are the bunkers that are used for storing raw rubber awaiting processing. There are sixteen of these bunkers that are made of concrete walls and concrete floors and have a total storage capacity of 4,000 tons of raw rubber (Figure 4-6).

If these conditions are not met, the rubber is rejected. Meanwhile, accepted rubber is weighted and stored in the rubber bunkers (Figure 4-6). The base and walls of these bunkers are made of concrete. The staffs of the weighbridge identify each storage location and maintain records of amount and type of rubber and dates of opening and closing. Each location (bunker) has a signboard to carry information to correlate with the records related to bunker number, contents (C/L or Slab), weight (wet tons), opening date and closing date.

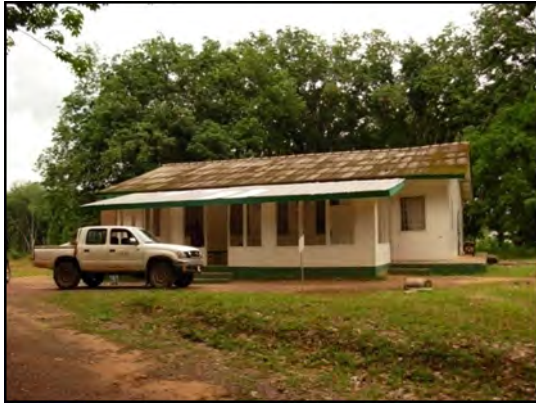
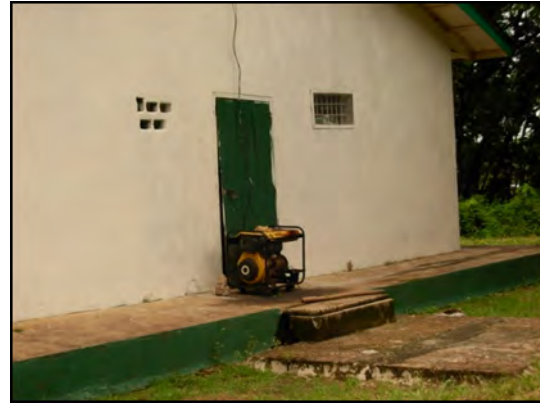
Figure 4-7: (a) Exterior view of plantation's clinic; (b) The only source of electricity for the clinic a gasoline generator.

The current source of energy for the clinic is a 7.5 kVA petrol engine generator which runs for approximately 1,000 hours per annum (**Error! Reference source not found.**). A plan to upgrade the plantation's clinic into a hospital is being considered by SRC's management. Proposed modifications are shown in **Error! Reference source not found.** and **Appendix. This will further be discussed in the Social Impact Assessment Section.**

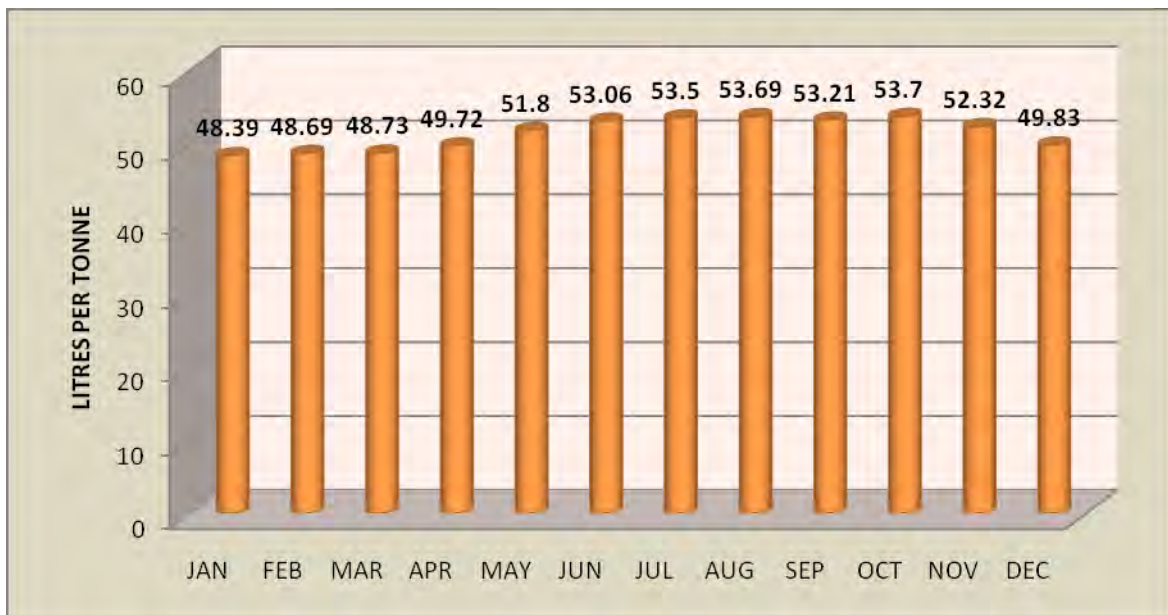
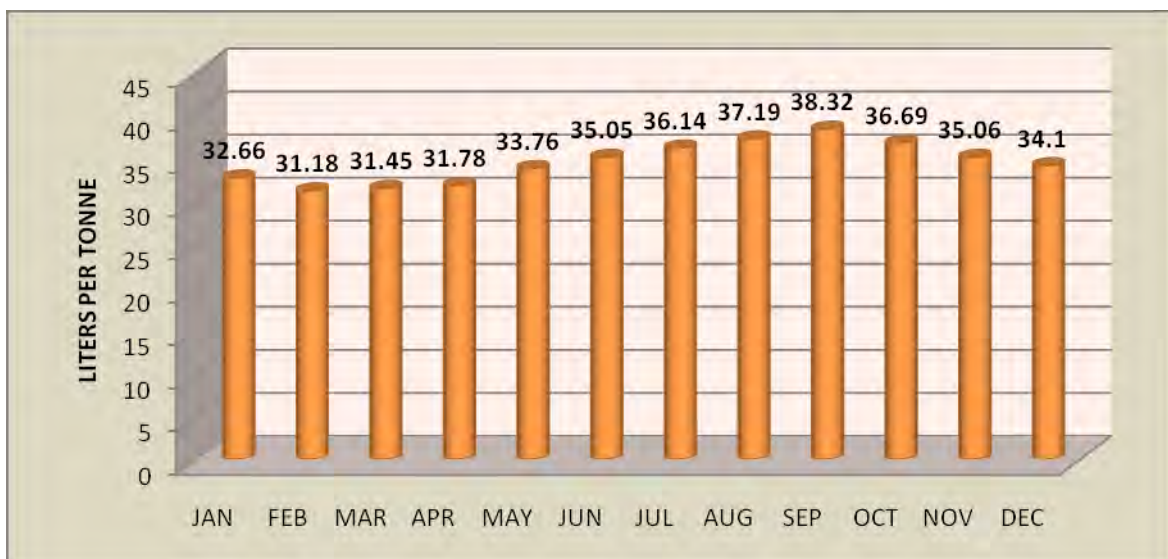
Fuel consumption for all uses is approximately 45,000 liters of diesel fuel per week (11,887.74 gallons/week). The rubber processing, the dryer and the generators consume approximately 31,000 liters or diesel fuel per week (8189.334 gallons/week). The other 14,000 liters (369.84 gallons) are used by vehicles used for rubber purchasing, operation of plantation, movement of factory materials, administration and finished goods transport. Fuel consumption varies with the variation of seasons (Figure 4-9 & Figure 4-10).

Figure 4-9: (a) Average fuel consumption of generators, 2001-2008. (b) Average fuel consumption of dryer, 2001-2008. Source: SRC, 2008.

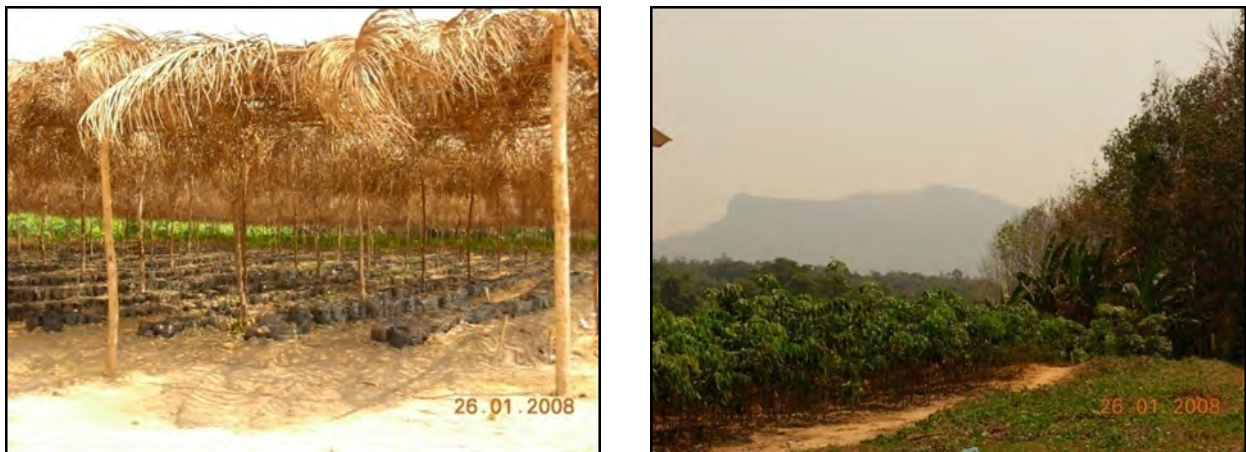
Figure 5-1: Nurseries at SRC's plantation.

The three part trees are grown for a short time in a pot and later planted out in a nursery before finally being transplanted into the plantation (Figure 5-1).

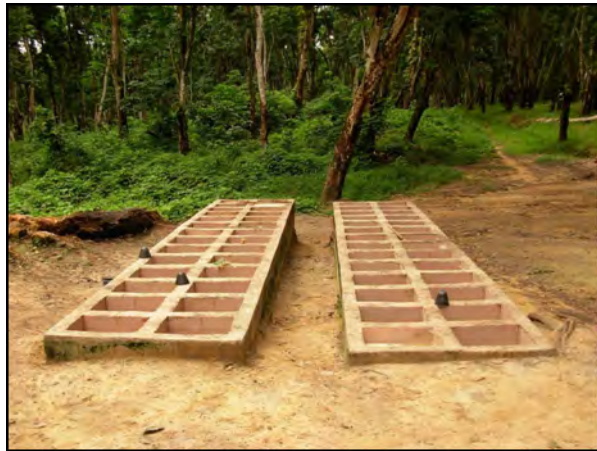
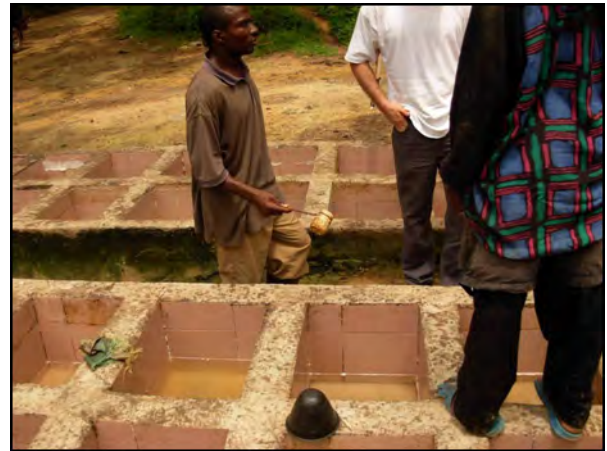
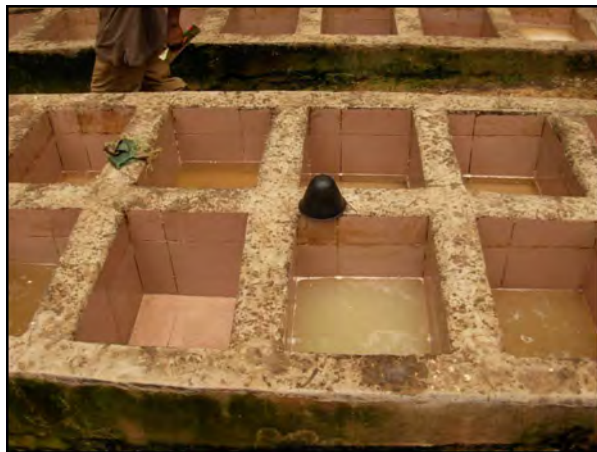
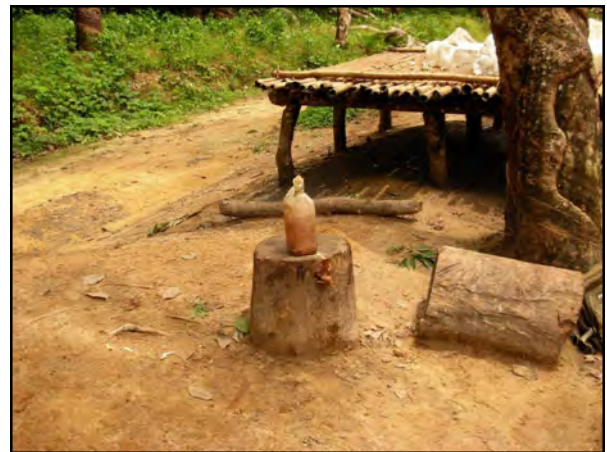
Figure 5-2: (a-c) Cement boxes in which latex is placed for coagulation after adding formic acid; note the small cup in the worker's hand in figure c which is used to add the formic acid to the rubber. (d) Formic acid bottle.

On the collection station, the latex is places in cement boxes (Figure 5-2) in volumes of 10 cm³. The latex is coagulated by the addition of few ml of 5% Formic acid. The effect is similar to curdling milk. It takes few hours to get the latex properly coagulated after which the latex turns into soft blocks known as coagulum. The coagulum is removed, cut into sizes and placed out on wooden platforms to dry (Figure 5-3) before being weighted (Figure 5-4) and transported to the factory for processing.

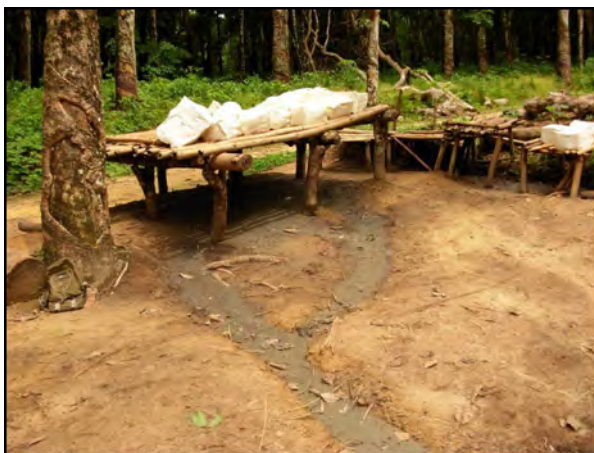
Figure 5-3: (a-b) Coagulated latex placed on wooden platform. Note the leachate in figure a. These tables are made bamboo that are replaced at least once a year while platform supports are tree sections that are replaced as needed.

The tables on which the coagulated latex is placed are made of bamboo that are replaced at least once per year while the platform supports are tree section that are replaced as needed (Figure 5-3). All material is natural, locally available and renewable.

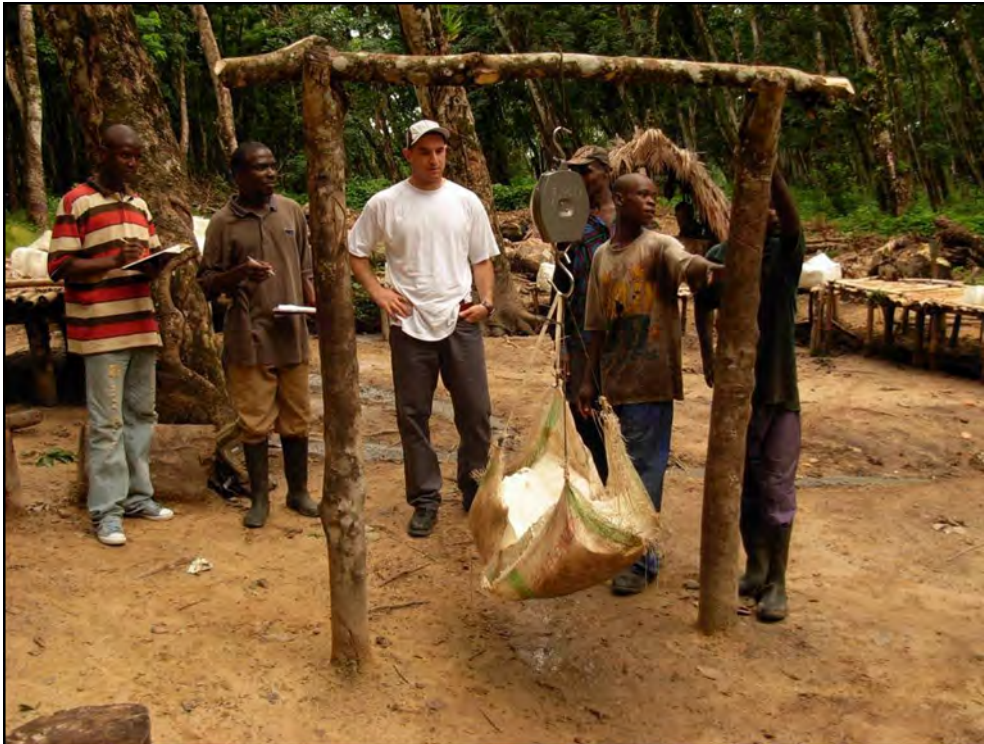
Figure 5-4: Weighing the coagulum before being sent to the factory.

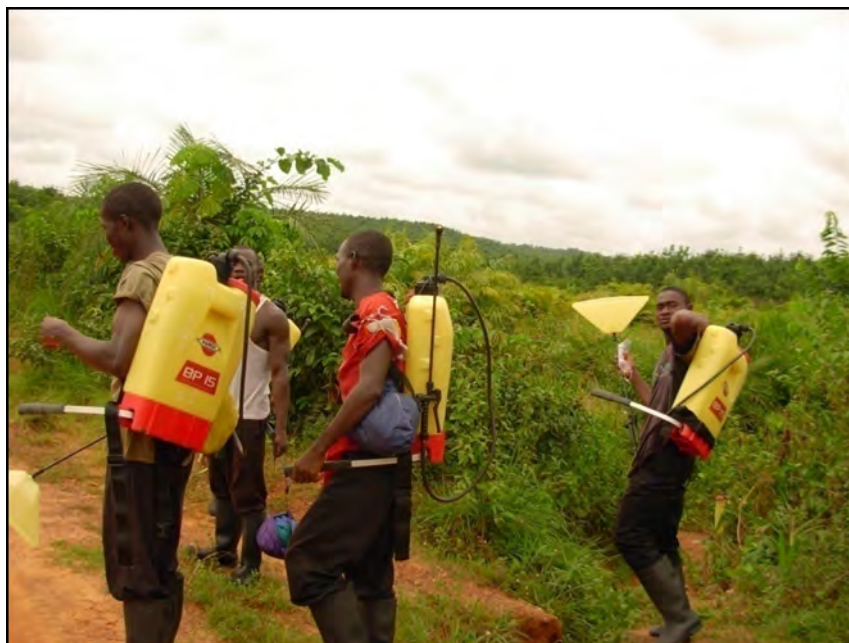
Figure 5-5: Workers equipped with spraying tools. Note the lack of use of safety tools and outfits.

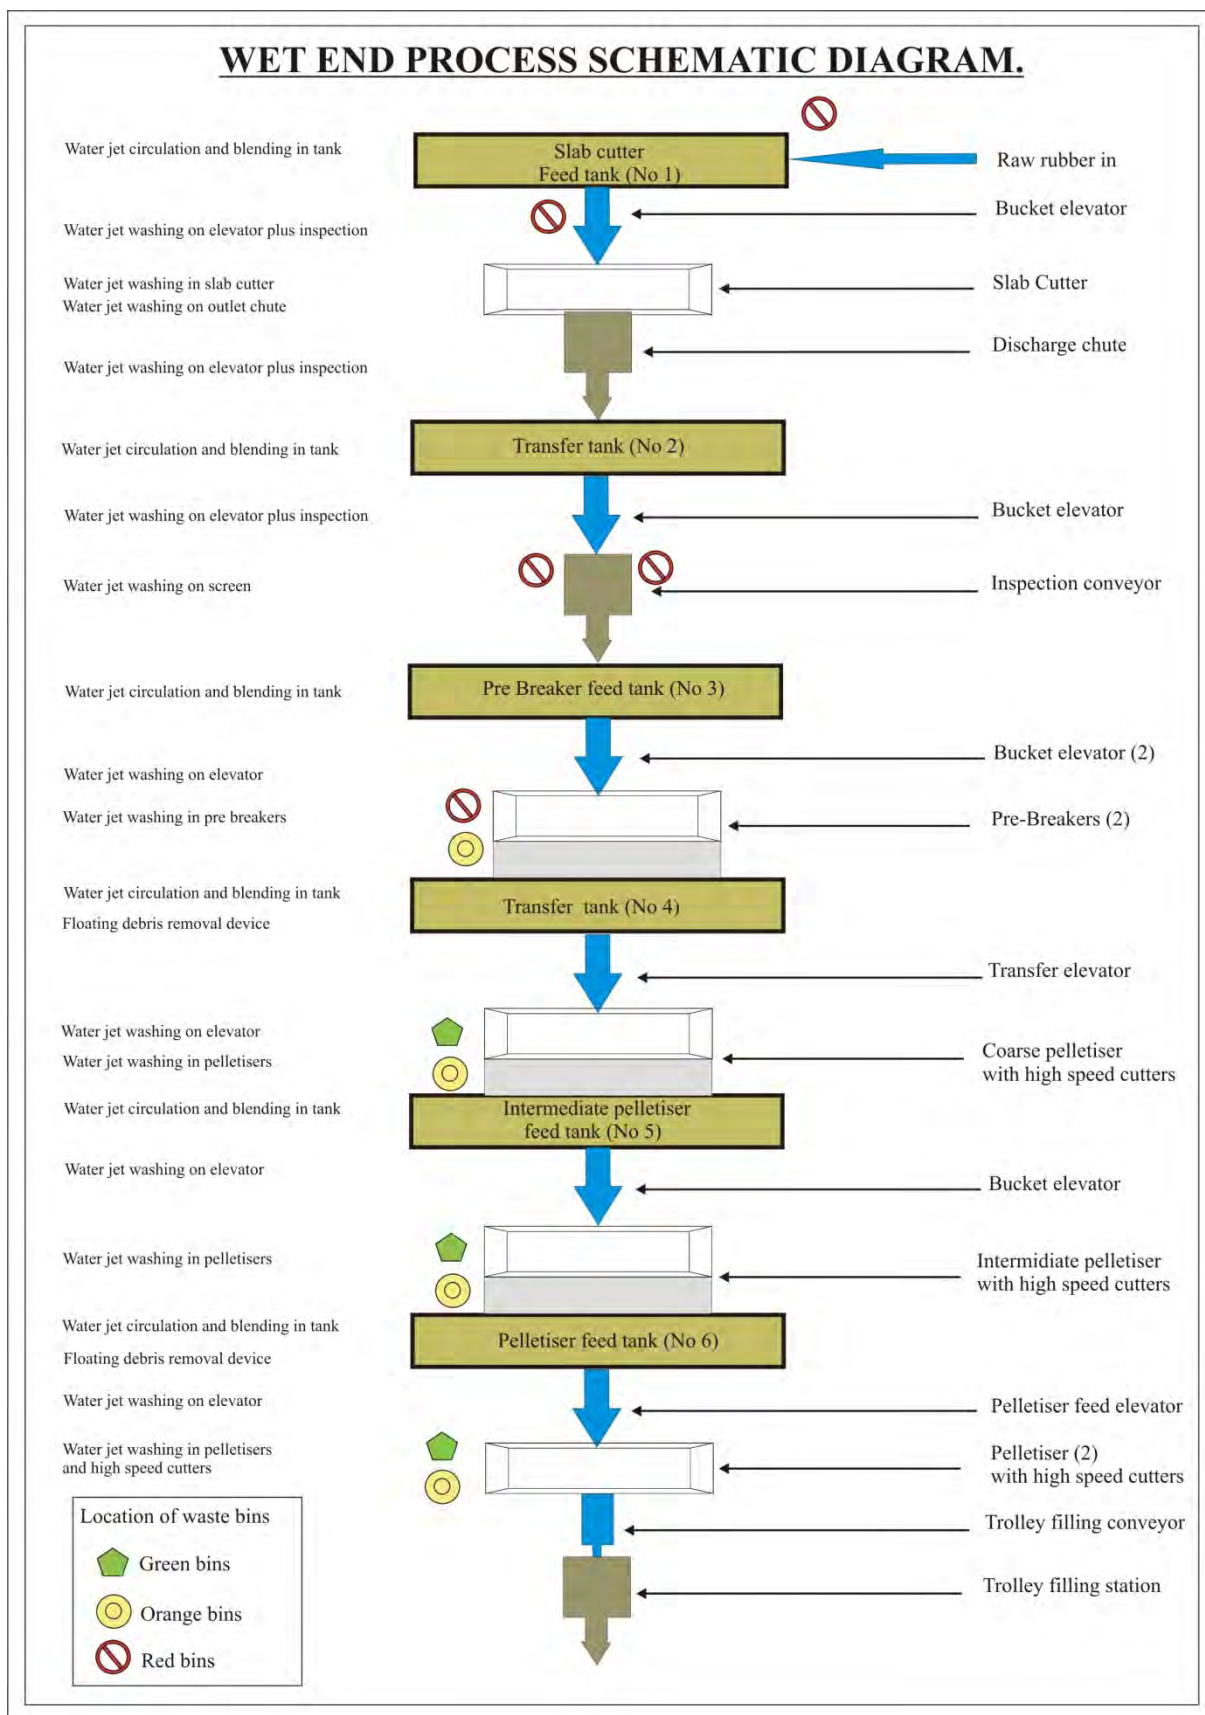
Figure 5-6: Wet end process schematic diagram. (Source: SRC, 2008)

The primary raw material processed at the factory is natural rubber, originally a liquid (coagulated latex) from rubber trees (*Hevea Brasiliensis*). Natural rubber as raw material is a plastic material which hardly can be used for any production without being processed and transformed into an elastic material. The latex is composed of 30-40% pure rubber, 3-5% non-rubber and the rest is water. Secondary raw materials include caustic soda (NaOH) and hydrated lime [Ca(OH)₂]. The coagulated latex goes through a process that transforms it from liquid to solid (Figure 5-6 & Figure 5-7). In this process, different chemicals are added and mechanically mixed into the rubber and a heating process (vulcanising) will finally transfer the compound into an elastic material. The production process consists of cleaning the rubber from impurities, blending coagulum, granulation, milling, drying, packaging and quality assurance.

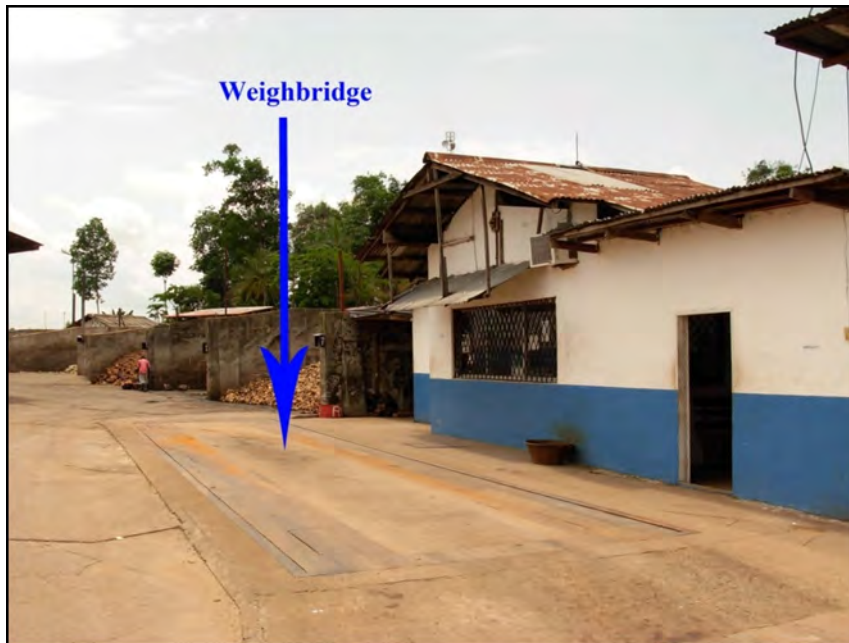
Figure 5-8: SRC's weighbridge located at the factory's site.

Coagulum received at SRC factory is weighed at the weighbridge (Figure 5-8) and inspected before unloading into the storage bunkers and any defective rubber is rejected. The rubber is mainly inspected to ensure the following:

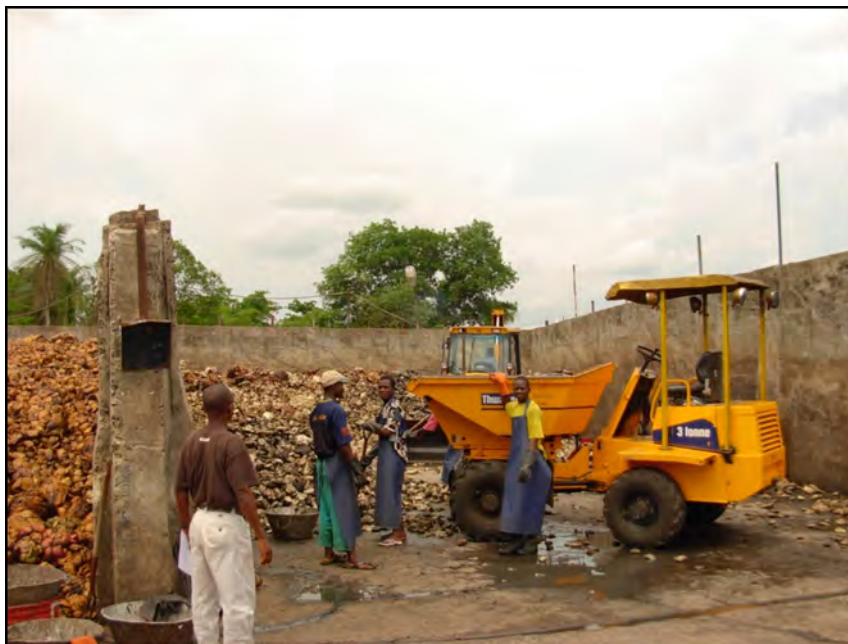
Figure 5-9: Collection of coagulum. Note that basic occupational safety equipment such as masks are not used by the workers.

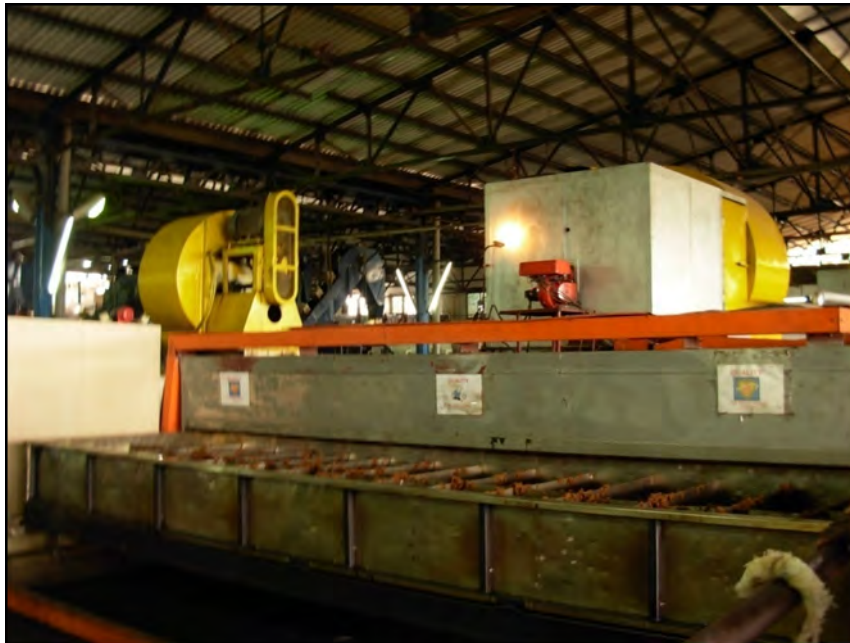
Figure 5-10: Dried rubber biscuit emerging from the dryer.

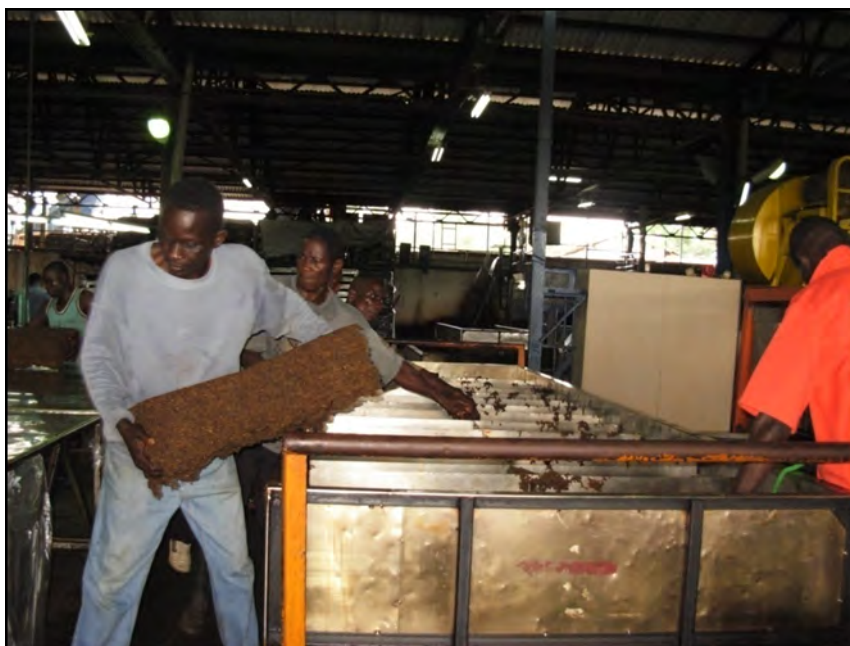
Figure 5-11: Dried rubber biscuits being unloaded from the dryer's trolley. Note the lack of use of safety equipment by workers.

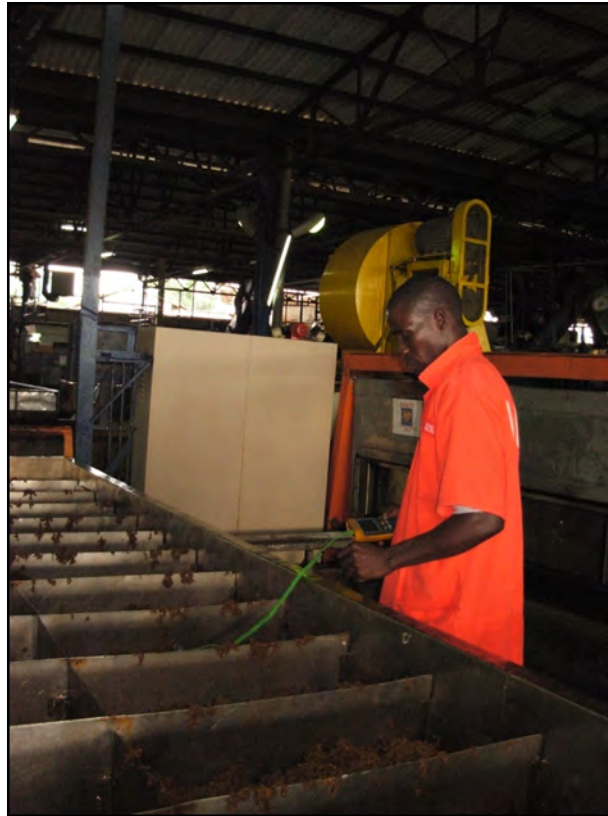
Figure 5-12: Internal temperature of biscuits being measured.

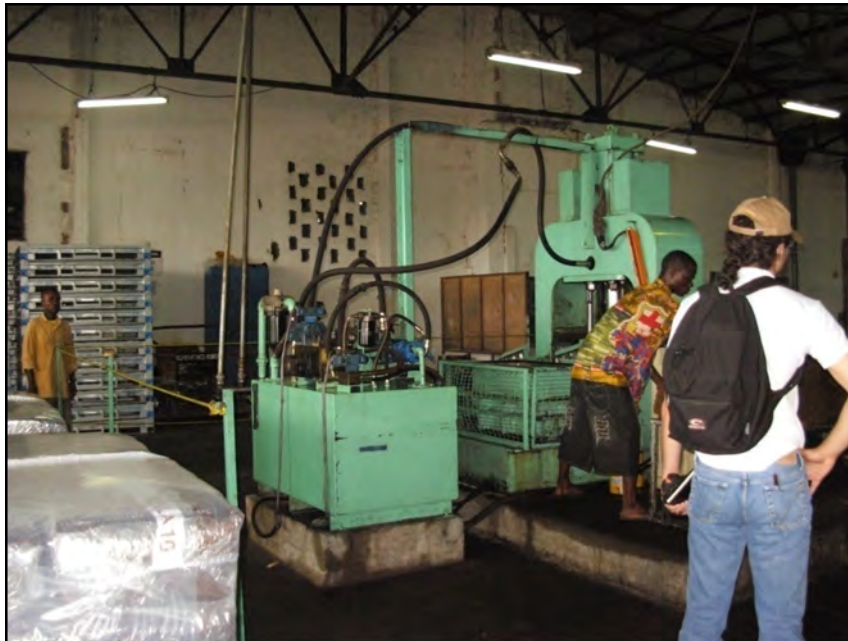
Figure 5-13: Pressing machines at SRC's factory.

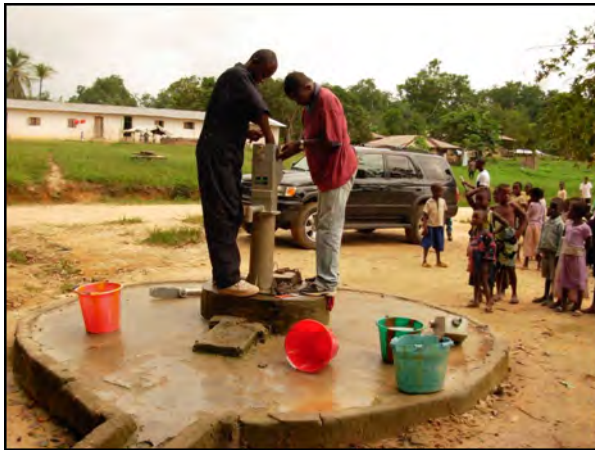
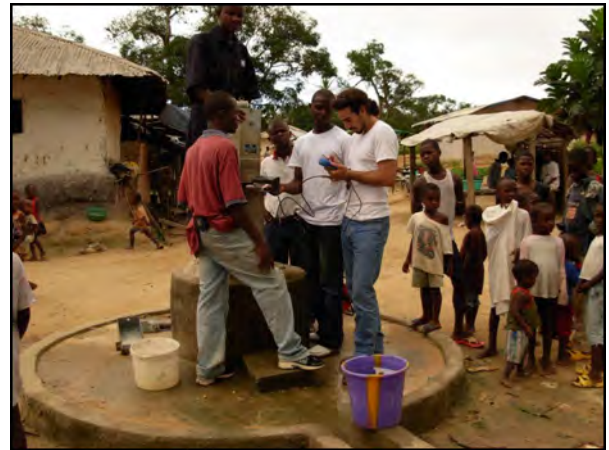
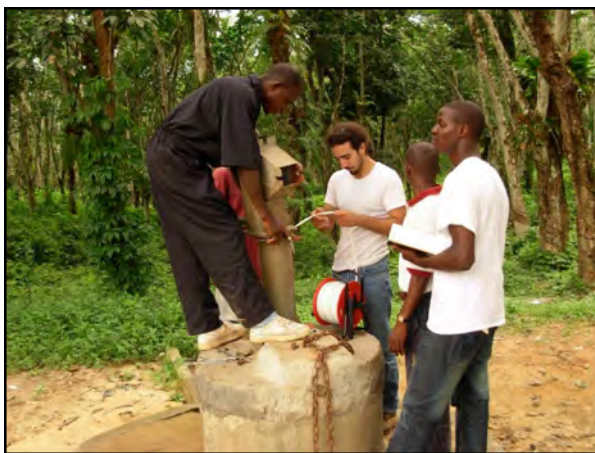
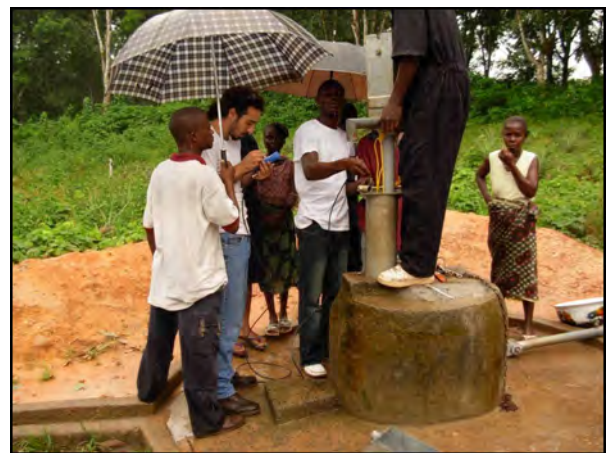
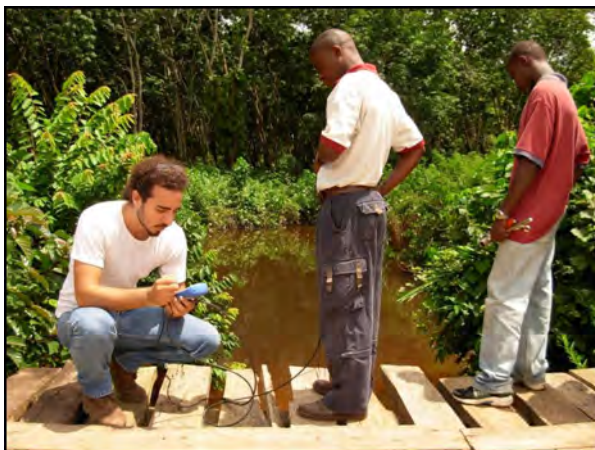
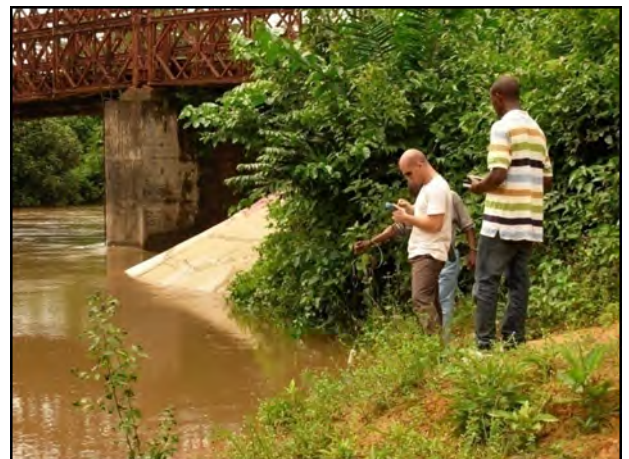
Figure 6-2: *In-situ* analysis activities at the plantation's wells and other water bodies. (e) *in-situ* analyses at the Kporlaryah stream within the plantation; (f) *in-situ* analyses at the Bolo River on the outskirts of the plantation.

Water was analyzed in six wells with at least one well in each camp in the plantation (Table 3-4 & Table 6-7). Water in the Bolo River located at the outskirts of the plantation was analyzed as well as water in the Kporlaryah that is crossing in the plantation. Figure 3-11 shows the different locations at which the in-situ analyses took place within the plantation. The process was conducted on both the 8th and the 10th of July, 2008 (Figure 6-2).

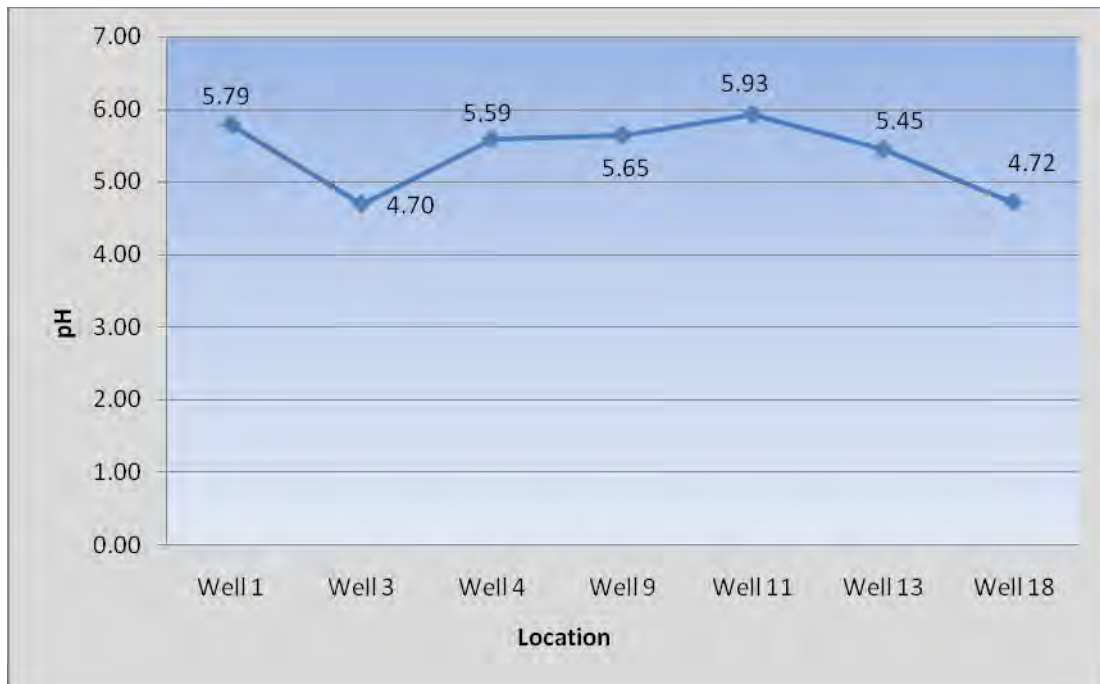
Generally, pH values in all wells tested on the plantation are below drinking water standards (6.5 – 8) and tend to be acidic as the highest value is 5.93 for Well 11 (Figure 6-3). Wells 3 and 8 show critical pH values of 4.70 and 4.72 (Figure 6-4), respectively. Although pH usually has no direct effect on consumers, it is one of the most operational water quality parameters (WHO, 2006).

Figure 6-3: Variation of pH at the tested wells within the plantation.

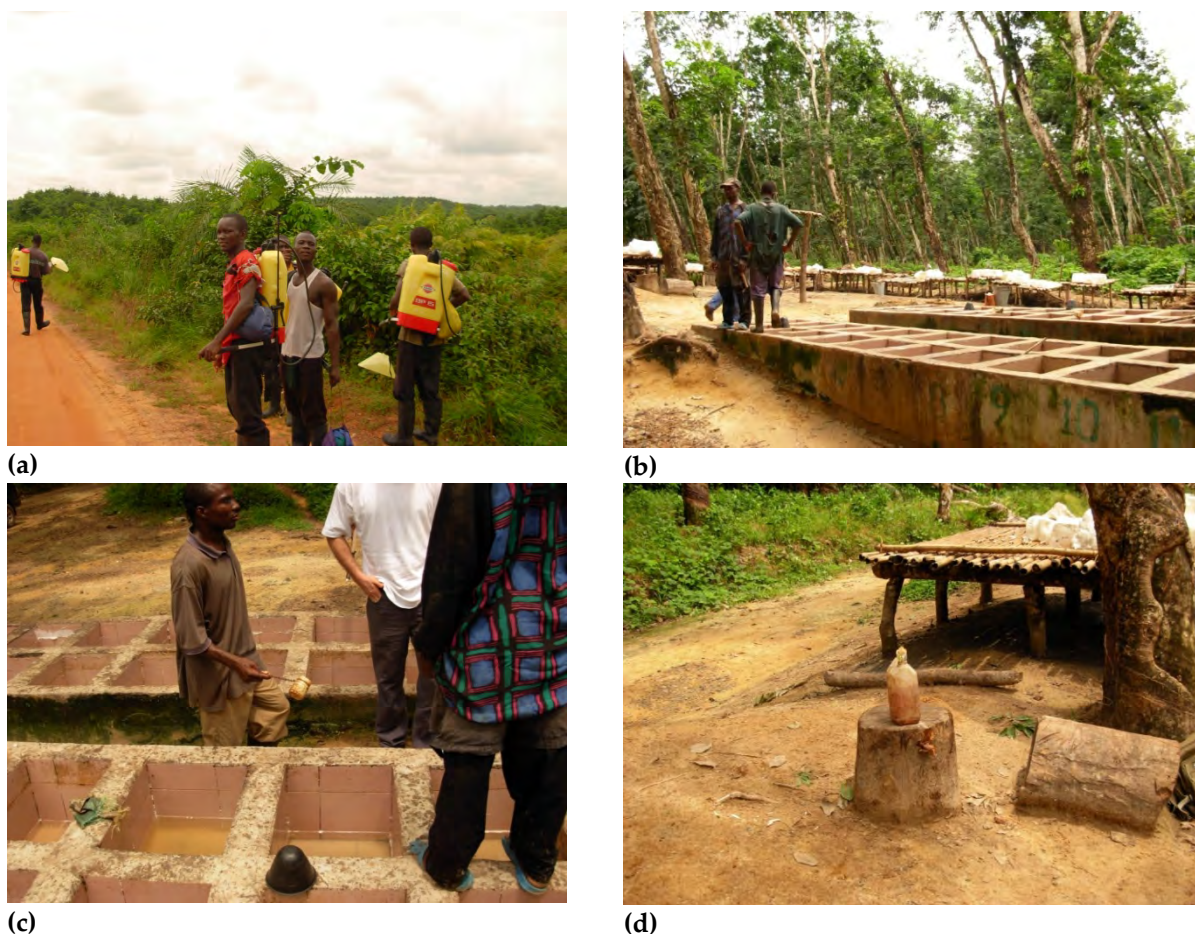
biocides' application, leading to an increased occupational risk (Figure 6-8).

Figure 6-8: (a-c) Workers on plantation poorly equipped with personal protective equipment; (d) a container of formic acid placed near a coagulation location with no labeling or appropriate storage.

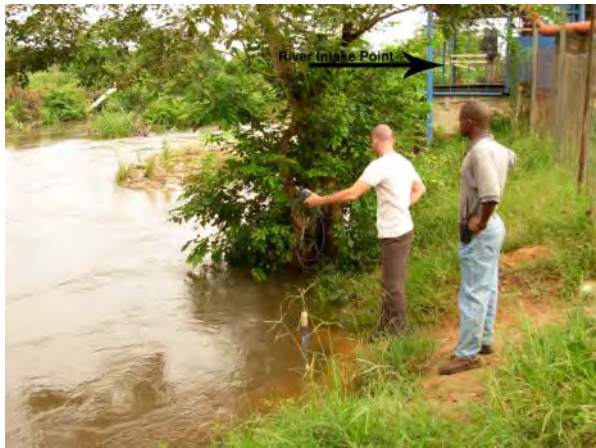
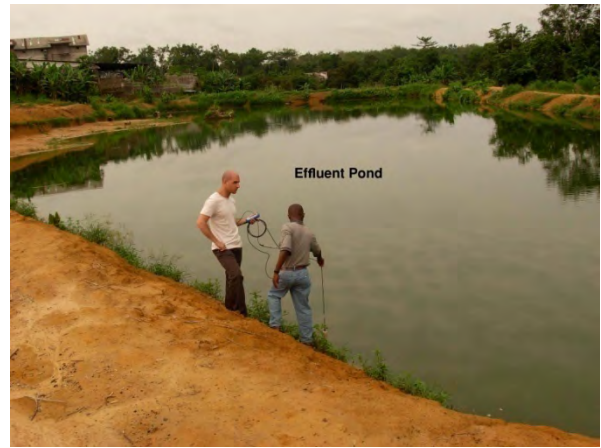
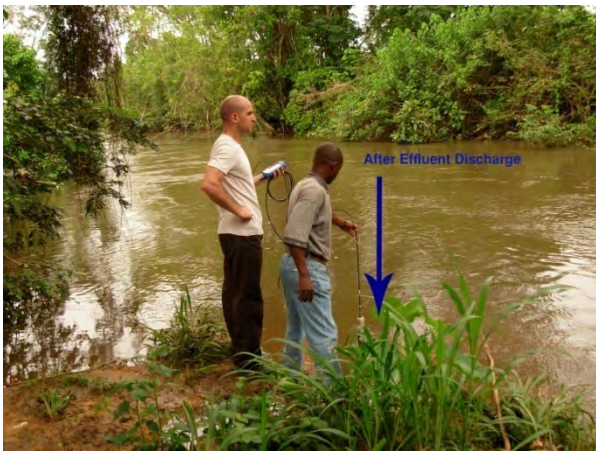
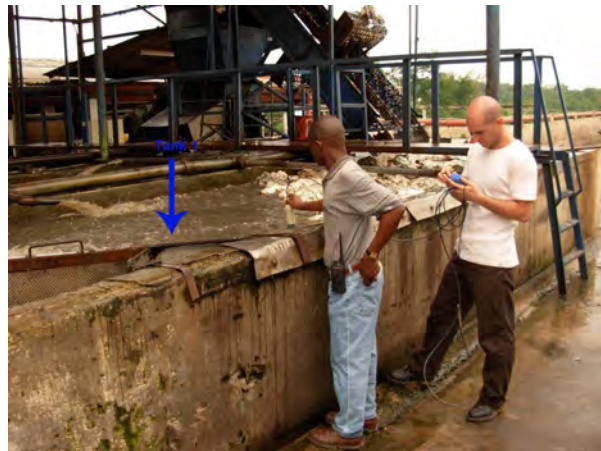
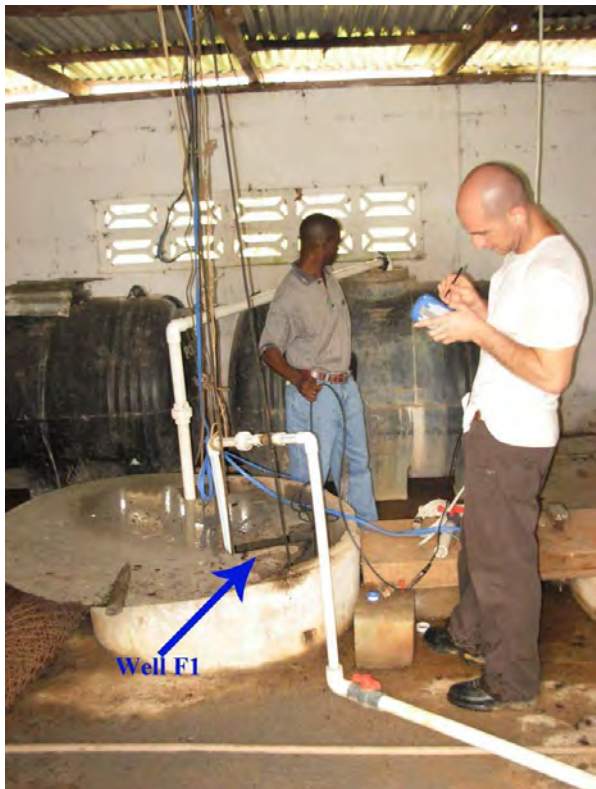
Figure 6-12: In-situ analysis activities at the factory's site.

Water was analyzed in one well within the factory (Table 3-4), the nearby Yia Creek, the effluent pond and in Tank 1 (Table 6-7). Figure 6-15 shows the different locations at which the in-situ analyses took place within the factory. The process was conducted on the 8th of July, 2008 (Figure 6-12).

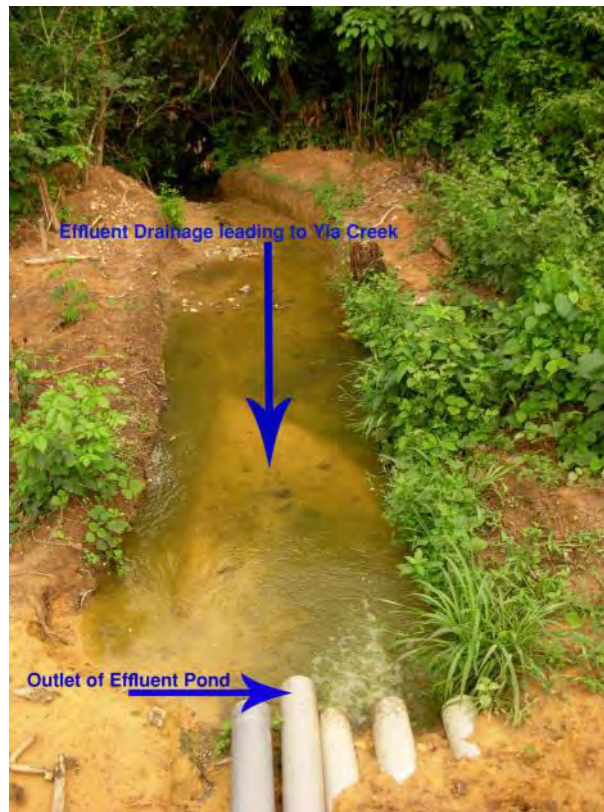
It should be noted that monitoring water quality for such an operation existing on a bank of river/creek should be performed at different intervals of time; i.e. seasonal monitoring, in order to detect pollution variation. This was not applied during the preparation of this report. Thus, the obtained results only represent the water quality at the sampling days and do not reflect general water quality of the creek. However, some analyses strictly represent the effluent discharge of the factory as they were conducted within the effluent pond (Figure 6-13 & Table 6-7). Water from the effluent pond is discharged through drainage into the Yea Creek (Figure 6-13).

Figure 6-13: (a) Effluent pond at SRC's factory; (b) outlet from effluent pond; (c) effluent drainage leading to the Yea Creek.

Obviously, effluents from the WRC facilities require further treatment to reduce the water quality degradation and aquatic ecosystems disturbance. Suggestions for wastewater treatment strategies that can be adopted by the WRC management will be discussed later in this report.

Samples for effluent discharge should be collected from outlet of effluent pond as well as the effluent pond itself (**Figure 6-13**). The sampling frequency as indicated in Table 9-3 should be on a weekly basis; however, this frequency can be on a monthly basis if a water treatment plant is installed to treat the effluent discharge. Process discharge should not be diluted prior to treatment with the objective of meeting the discharge or water quality standards. Moreover, the sampling method should be conducted by entities permitted or certified for this purpose. Sampling and analysis Quality Assurance/Quality Control (QA/QC) plans should be prepared and implemented. QA/QC documentation should be included in monitoring plan.

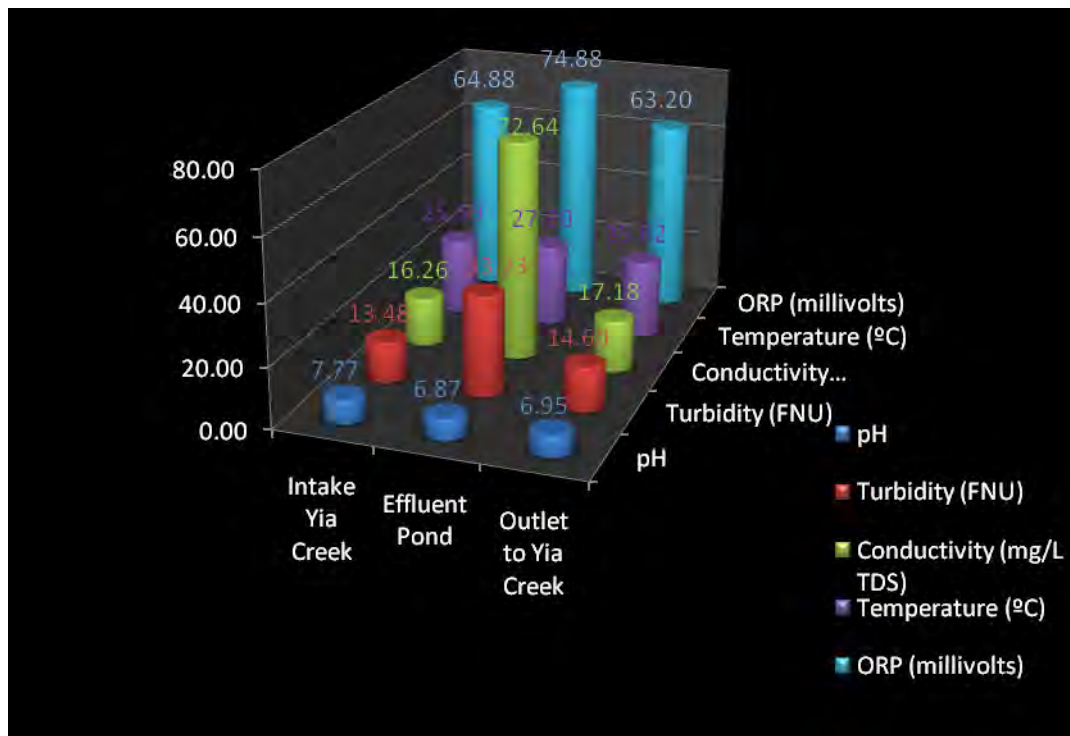
difference in values obtained for the different parameters for the Intake Point, the effluent pond and after the outlet to the Yia Creek from the effluent pond.

Figure 6-14: Comparison of water quality between the intake point (Yea Creek), effluent pond and Outlet point (Yea Creek).
