**ENVIRONMENTAL & SOCIAL IMPACT
ASSESSMENT**

PROGRESS REPORT

For: SLALA RUBBER COMPANY.

Prepared By: EARTHTIME INC.

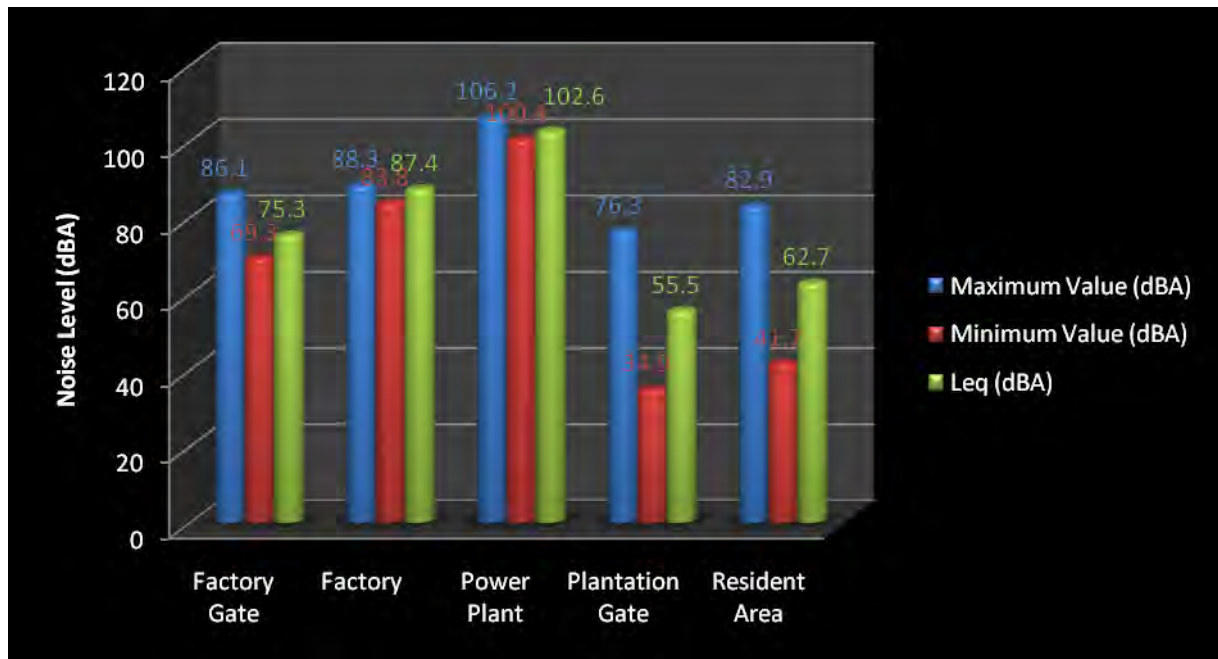
Figure 6-15: Noise level at various locations at SRC.

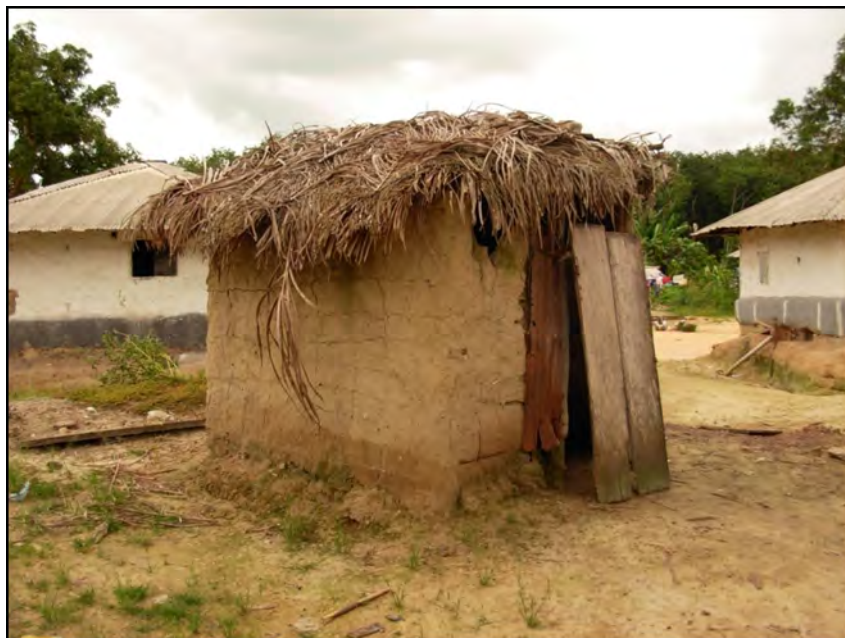
Figure 7-8: Toilet facility within Camp 1.

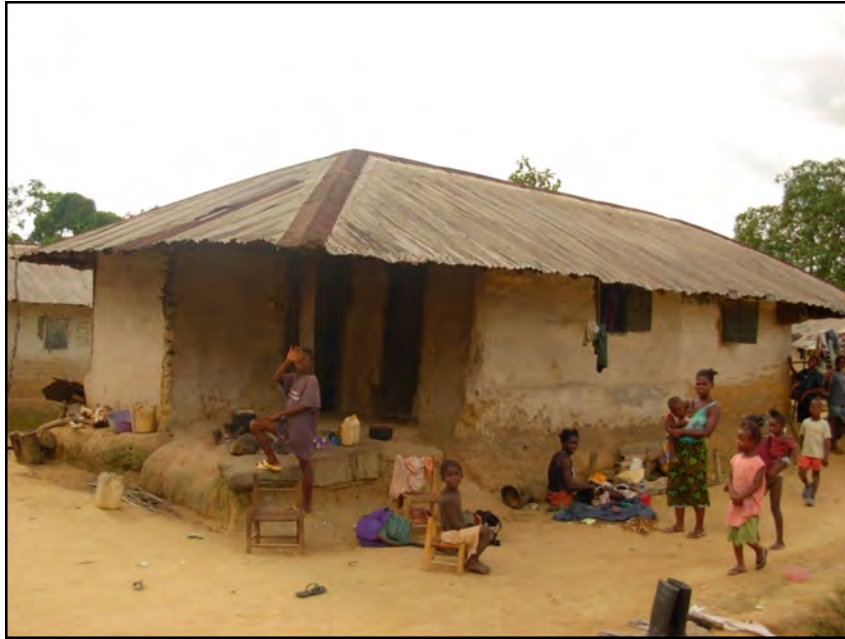
Housing conditions in camp 2 are below standards. There are 56 households that are fully occupied and overcrowded. Most houses are composed of two bedrooms with no basic facilities such as kitchen and toilets. Each house is occupied by at least two families and each room is occupied by the worker (generally tappers) and his/her family. Each family is between 6-8 individuals. In general, each of the two-bedroom house shelters between twelve (12) to sixteen (16) people. The houses are owned by SRC and the residents do not pay rental fees.

Figure 7-12: A two-bedroom house in camp 2.

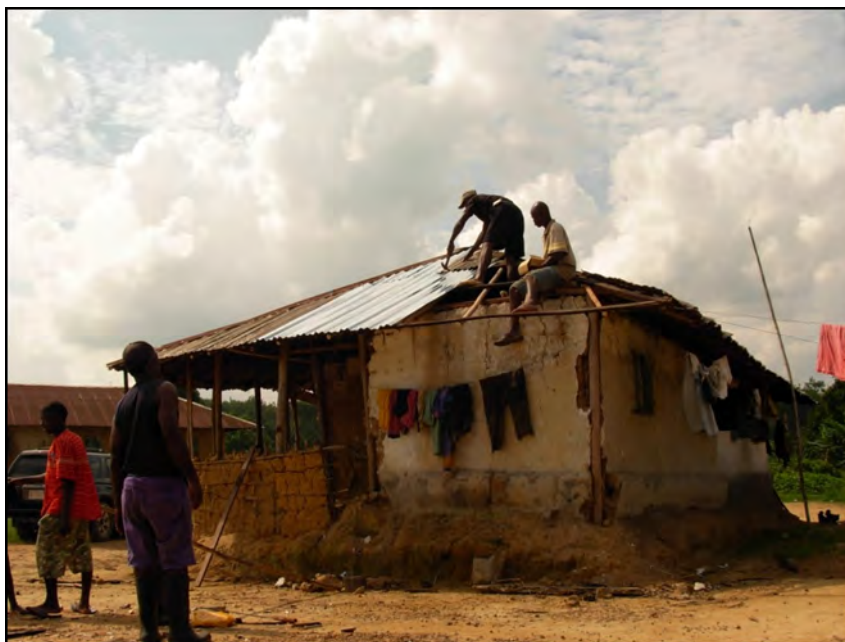
Figure 7-13: Basic renovation for one of the houses in Camp 2.

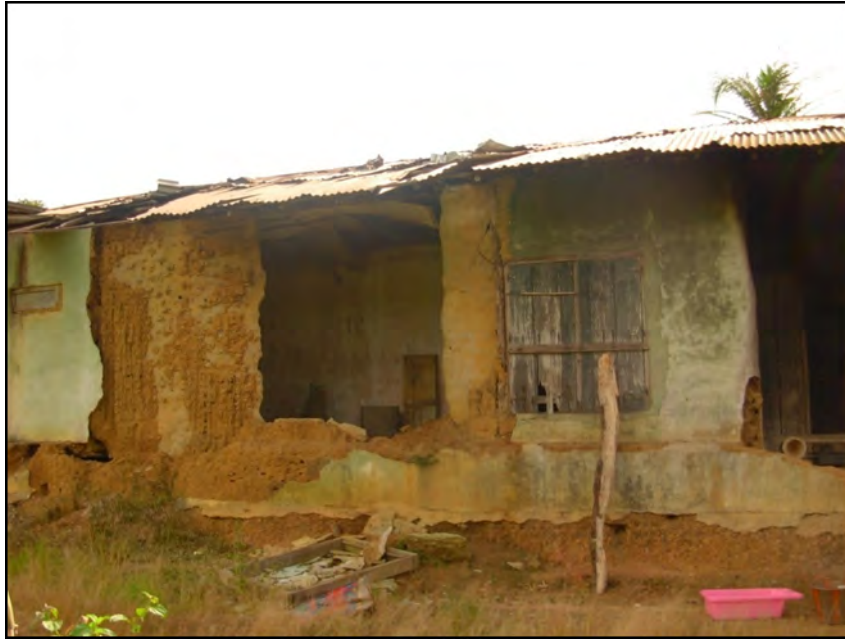
Figure 7-14: One of the houses with broken wall within camp 2.

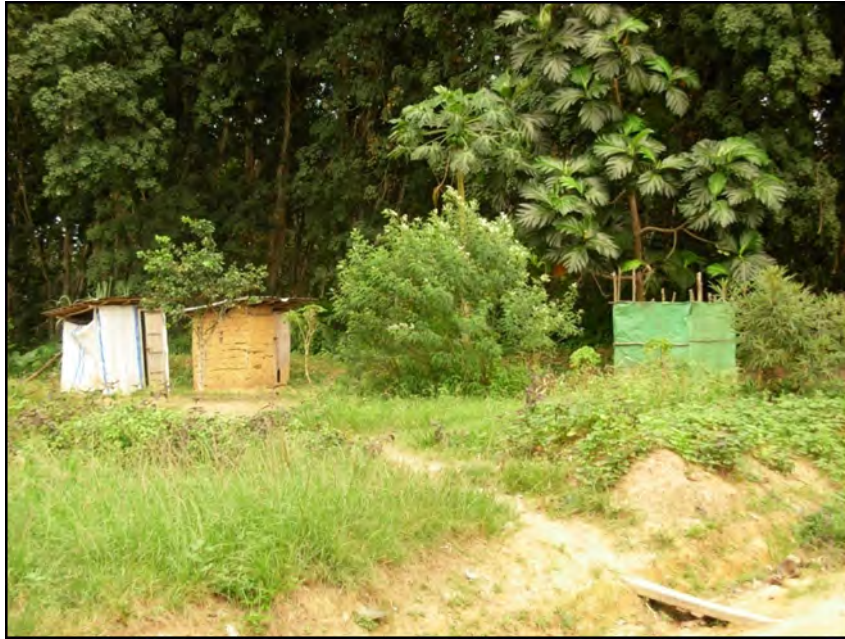
In addition to the lack of basic facilities such as kitchen and toilets, the residents have no access to electricity and pipe borne water; kerosene lanterns and candles are generally used to generate light, and fuelwood and charcoal are the principal energy source for cooking. Some of the residents annexed additional rooms mainly as kitchens at their own expense. Most of the houses are built of mud and sticks. The roofs are often damaged and the sticks are damaged by termites. Some houses have collapsed walls (Figure 7-14). Houses are also affected by erosion due to heavy rainfall. Toilet and bathing facilities are built separately either near or at far from the houses while others are relatively far. Toileting and bathing facilities exist separately in the camp. The residents of the camp share few inadequate toilets and bathrooms that are located at a distance from the houses (Figure 7-15).

Figure 7-15: Toilet and bathing facilities within Camp 2.

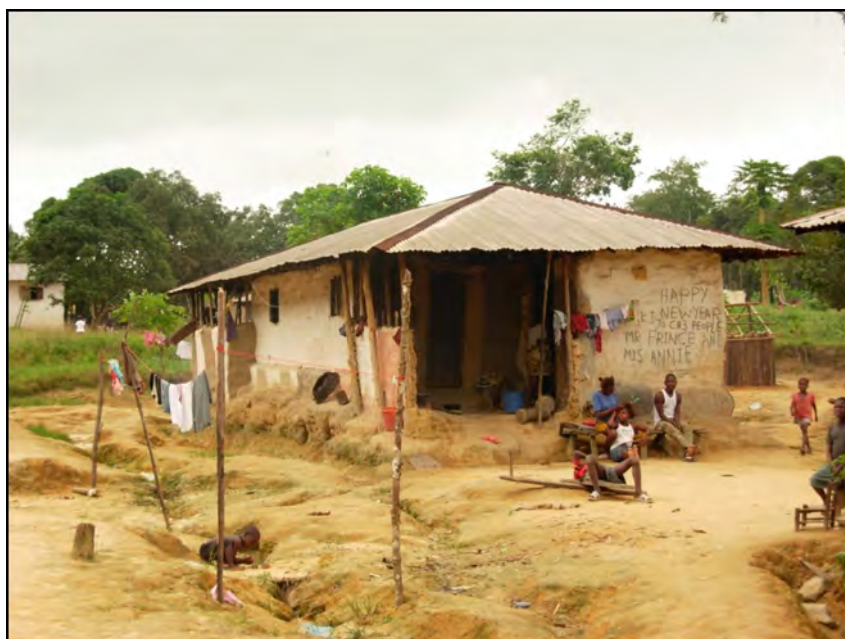
Housing condition in the camp is below standard (Figure 7-17). There are 59 households that are fully occupied and overcrowded. Most houses are composed of two bedrooms with no basic facilities such as kitchen and toilets. Each house is occupied by at least two families and each room is occupied by the worker (generally tappers) and his/her family. Each family is between 8-10 individuals. In general, each of the two-bedroom house shelters between sixteen (16) to twenty (20) people. The houses are owned by SRC and the residents do not pay rental fees.

Figure 7-17: Sample view of household condition in Camp 3.

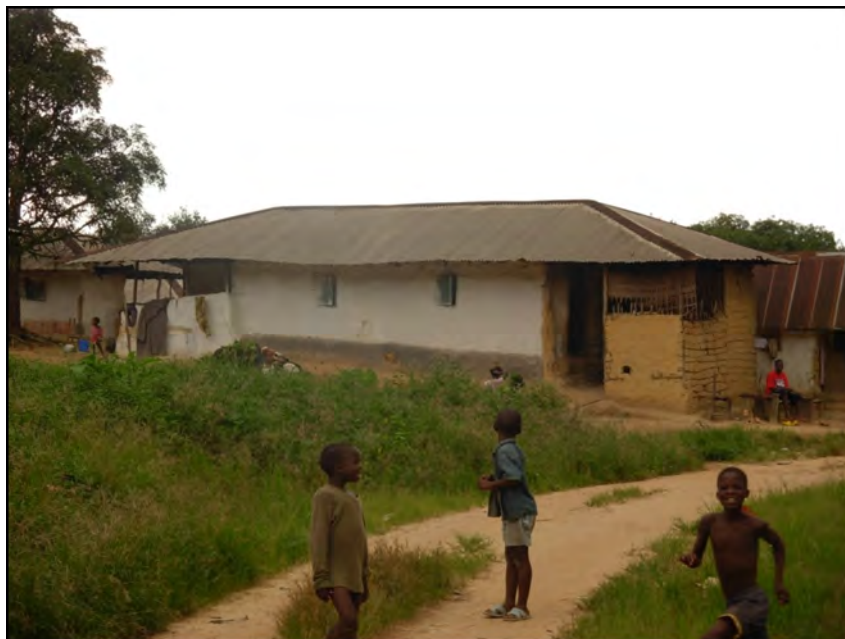
Figure 7-18: Note the added section to the house that is made of mud and sticks. This section serves as a kitchen for the household residents.

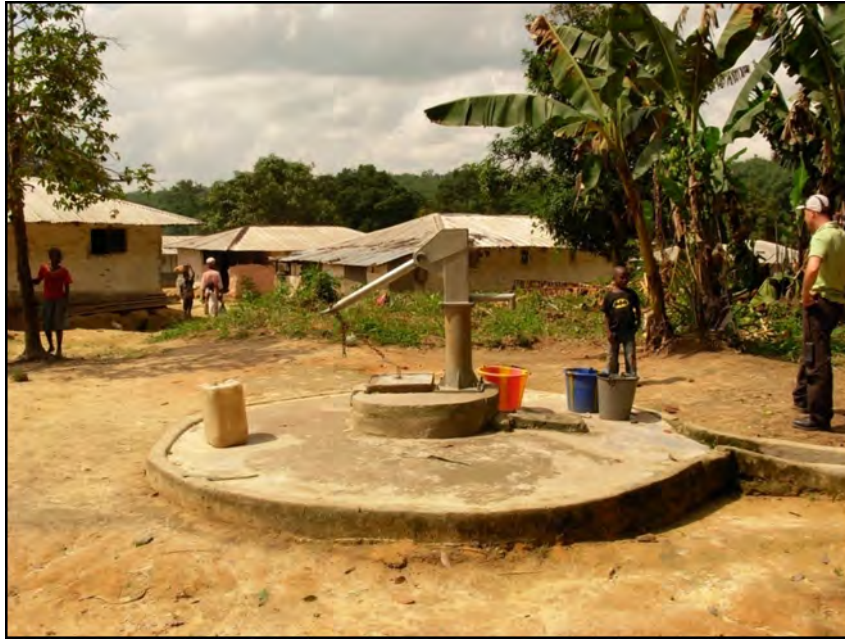
There are three (3) wells within Camp 3 (Table 4-17), equipped with manual hand pumps and protected by cement covers (Figure 7-19). These wells are the source of domestic and drinking water. Water source for animals is from a nearby creek. Sources of water for irrigation are the wells and a nearby creek.

Figure 7-19: A well in Camp 3 with cement cover.

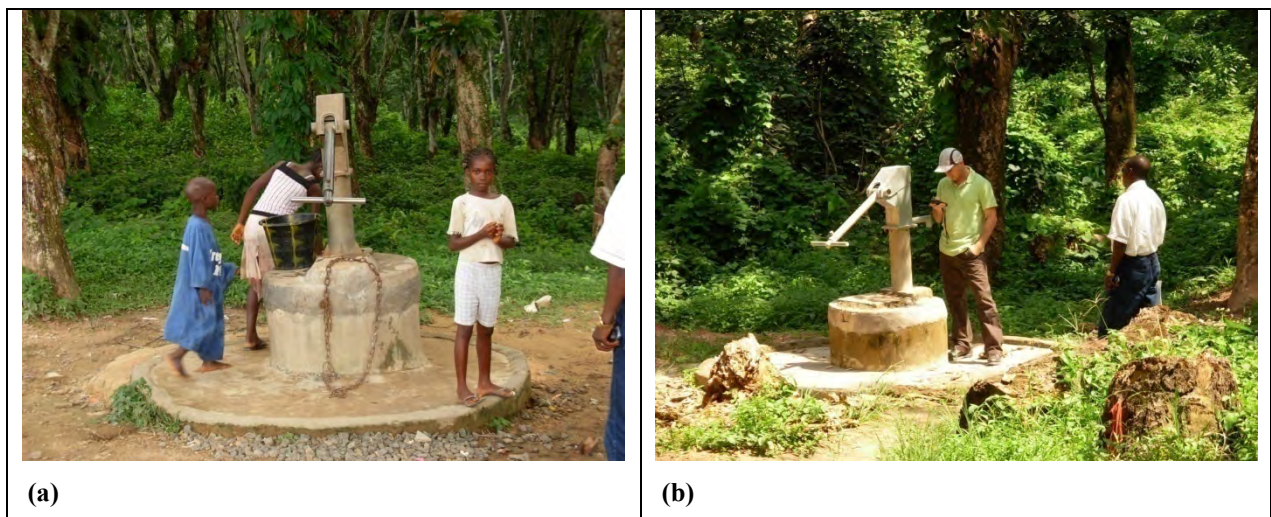
There are two (2) wells within Camp 4 (Table 4-17), equipped with manual hand pumps and protected by cement covers (Figure 7-19). These wells are the source of domestic and drinking water. Water source for animals is from a nearby creek. Sources of water for irrigation are the wells and a nearby creek.

Figure 7-22: (a) Well 11 located close to the school; (b) Well #12 located within the camp.

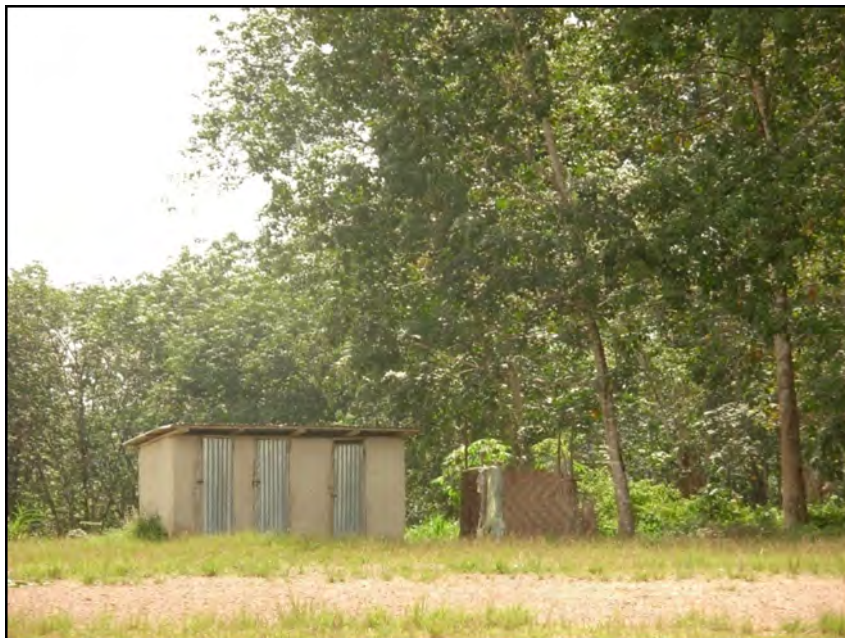
In addition to the lack of basic facilities such as kitchen and toilets, the residents have no access to electricity and pipe borne water; kerosene lanterns and candles are generally used to generate light, and fuelwood and charcoal are the principal energy source for cooking. Toilet and bathing facilities are built separately either near or at far from the houses while others are relatively far (Figure 7-25). Toileting and bathing facilities exist separately in the camp. The residents of the camp share few inadequate toilets and bathrooms that are located at a distance from the houses (Figure 7-15).

Figure 7-25: Toilet and bathing facilities within Camp 5.

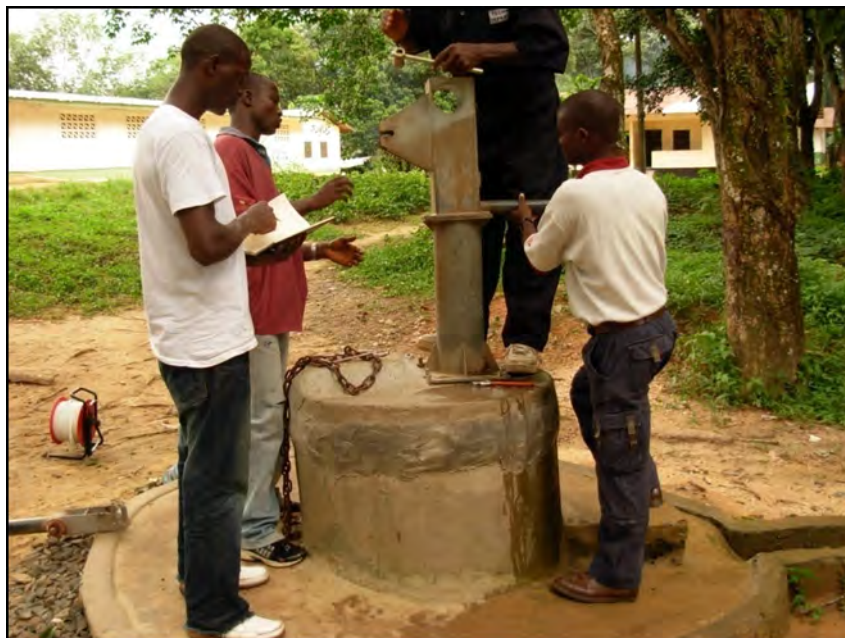
There are six (6) wells within Camp 5 (Table 4-17), equipped with manual hand pumps and protected by cement covers (Figure 7-26). These wells are the source of domestic and drinking water. Water source for animals is from a nearby creek. Sources of water for irrigation are the wells and a nearby creek.

Figure 7-26: Well with cement cover in Camp 5.

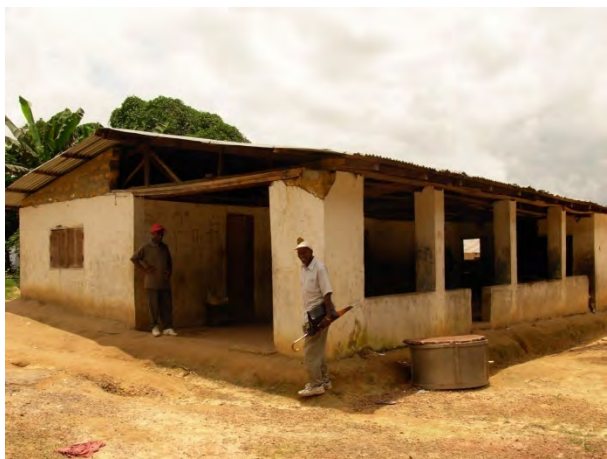
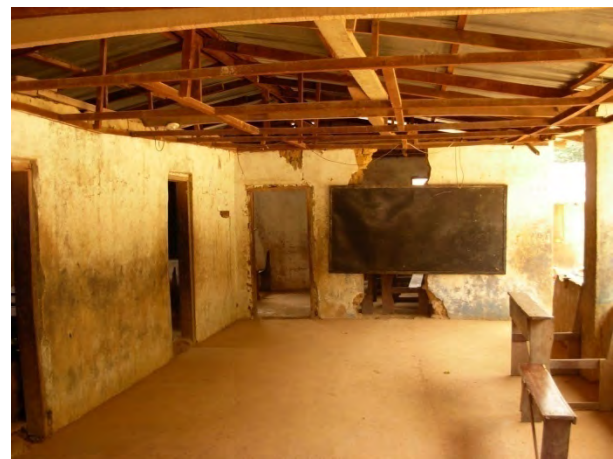
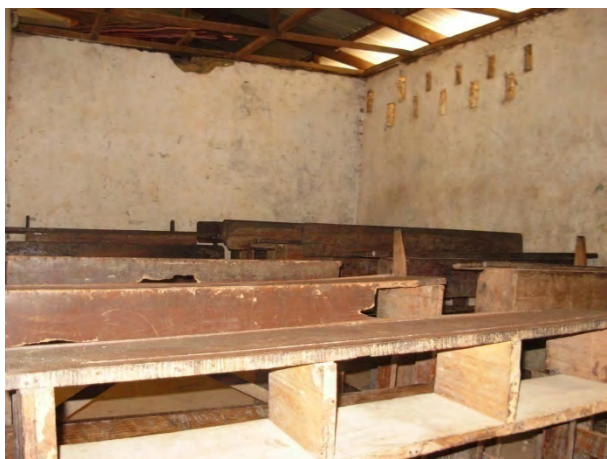
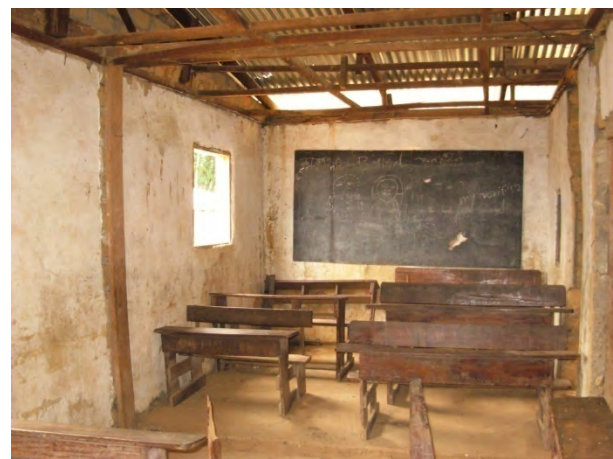
According to the assessment matrix (to be included in appendix) of existing educational infrastructure, buildings lack proper furniture, playgrounds, air-conditioning, science laboratory equipment, and lighting (Figure 7-36). Schools are exposed to noise and some classes are leaking during winter season. During the field survey, a room in one of the school's annex located in Camp 3 was used for the storage of chemicals and fertilizers (Figure 7-37).

Figure 7-36: (a-b) different views of school's condition in Camp 3.

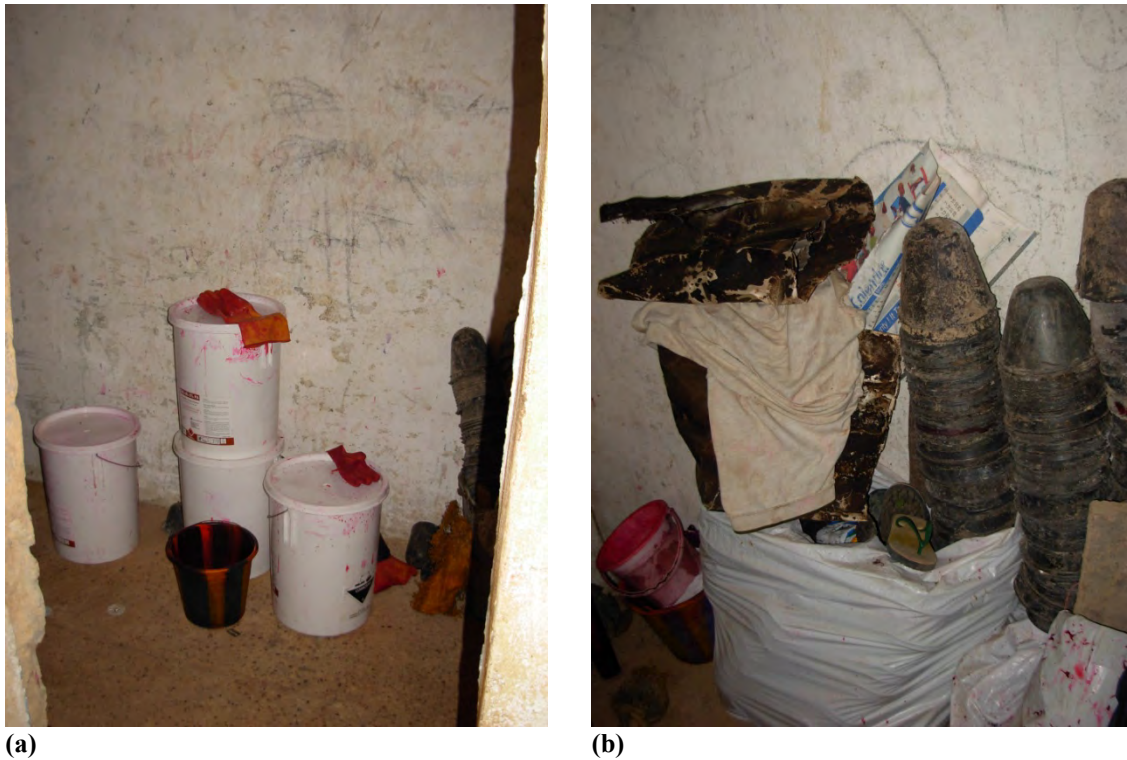
Figure 7-37: (a-b) chemicals and tools stored in one of the rooms within the school of Camp 3.

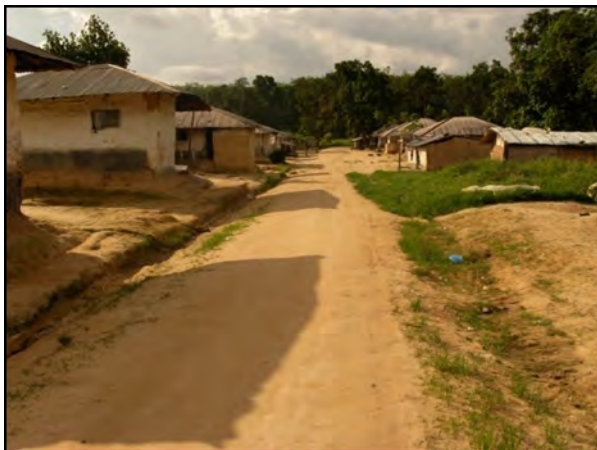
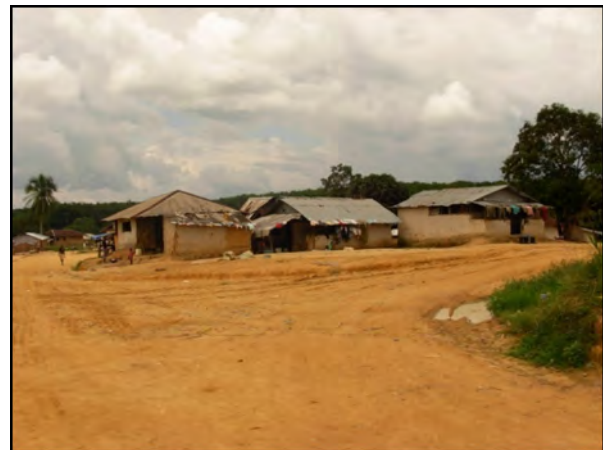
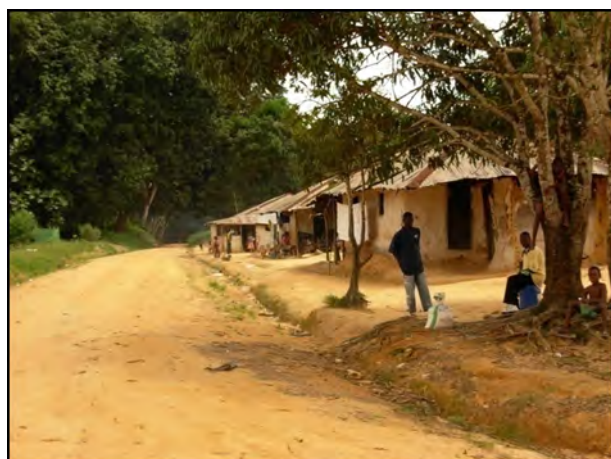
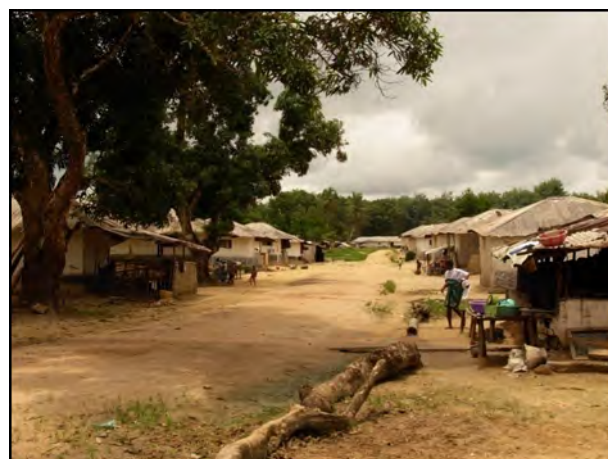
All roads within the plantation site are unpaved. 55% of the surveyed residents consider roads condition as poor and 14% evaluate them as good (Figure 7-39).

Figure 7-39: Road conditions in the camps.
