ENVIRONMENT AND SOCIAL DUE DILIGENCE OF AN OPERATING ROAD ASSET BETWEEN END OF KOTAKATTA BYPASS TO KURNOOL ON NH-7

Andhra Pradesh, India

Environment and Social Due Diligence of an Operating Road Asset between end of Kotakotta Bypass to Kurnool

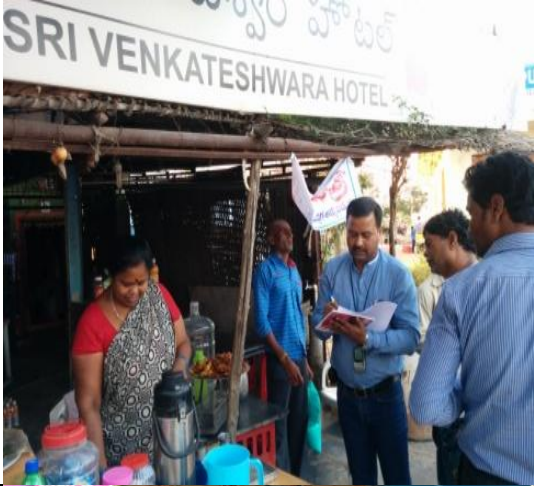
| S.No. | Area | Type of Area | Village Name | Encroachment | Since when | Why is encroachment here | Picture Documentation |
|---|---|---|---|---|---|---|--|
| 1 | Road Side with in ROW (RHS) | Road side Tea Stall | Kondanadapuram | Tea Stall | 20 Years | Opportunistic | |

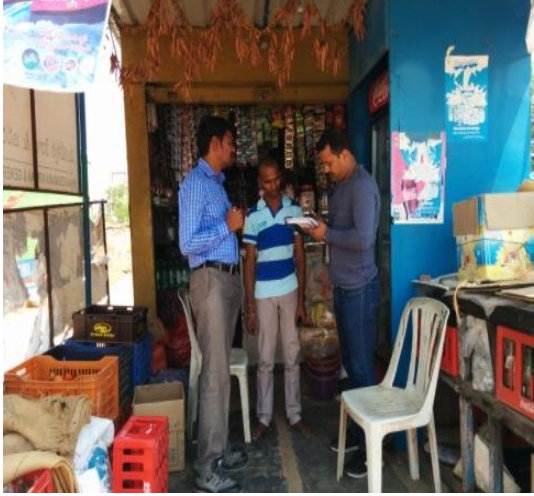
| S.No. | Area | Type of Area | Village Name | Encroachment | Since when | Why is encroachment here | Picture Documentation |
|---|---|---|---|---|---|---|--|
| 2 | Road Side with in ROW (LHS) | Road side Shop | Kondanadapuram | Shop | 6 Years | Opportunistic | |

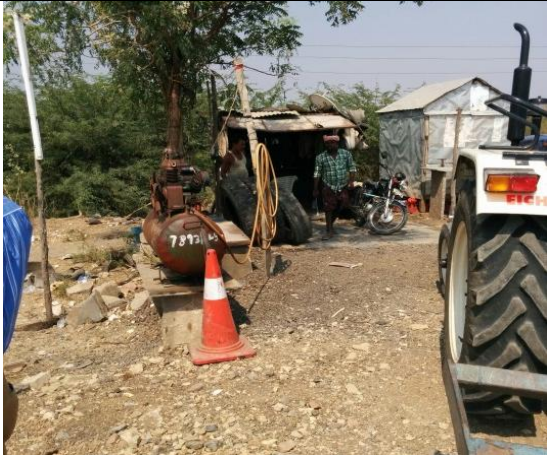
| S.No. | Area | Type of Area | Village Name | Encroachment | Since when | Why is encroachment here | Picture Documentation |
|---|---|---|---|---|---|---|--|
| 3 | Road Side with in ROW (RHS) | Road side Shop | Kondanadapuram | Temporary tyre repairing tin shop | 4 Years | Opportunistic | |

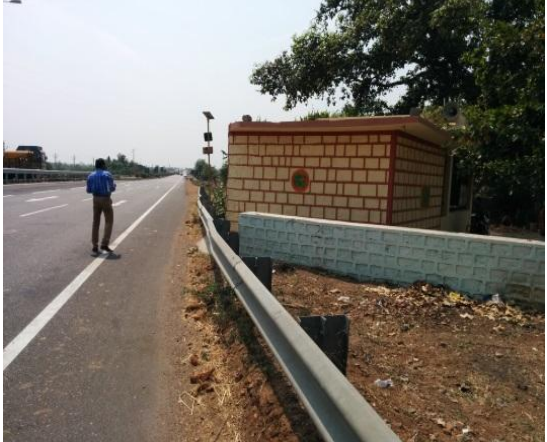
| S.No. | Area | Type of Area | Village Name | Encroachment | Since when | Why is encroachment here | Picture Documentation |
|---|---|---|---|---|---|---|--|
| 4 | Road Side with in ROW (RHS) | Road side Temple | Kondanadapuram | Temple | 300 Years | Legal process | |

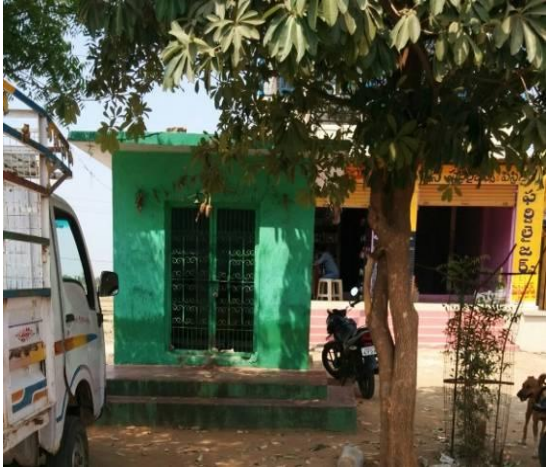
| S.No. | Area | Type of Area | Village Name | Encroachment | Since when | Why is encroachment here | Picture Documentation |
|---|---|---|---|---|---|---|--|
| 5 | Road Side with in ROW (RHS) | Road side Temple | Kondanadapuram | Temple | 80 Years | Legal Process | |

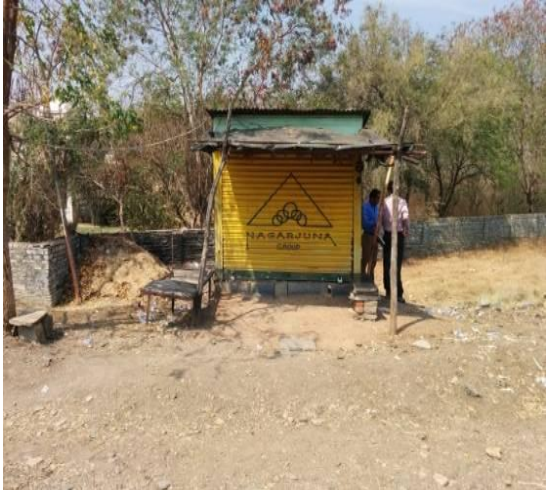
| S.No. | Area | Type of Area | Village Name | Encroachment | Since when | Why is encroachment here | Picture Documentation |
|---|---|---|---|---|---|---|--|
| 6 | Road Side with in ROW (RHS) | Road side Shop | Ittkaylapadu | Temporary General Kirana shop | 5 Years | Opportunistic (Shop Closed) | |

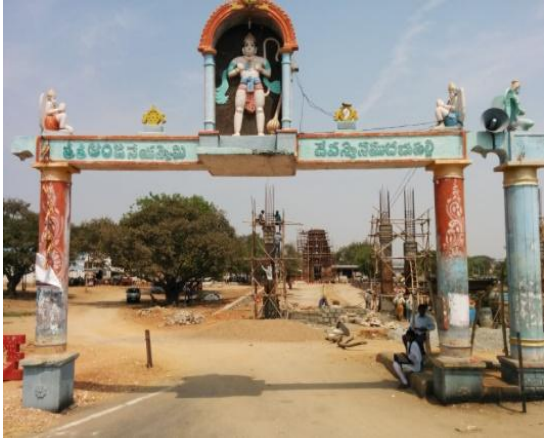
| S.No. | Area | Type of Area | Village Name | Encroachment | Since when | Why is encroachment here | Picture Documentation |
|---|---|---|---|---|---|--|--|
| 9 | Road Side with in ROW (RHS) | Road side Hanuman Temple gate | Beachebelly | Hanuman Temple gate | 150 Years | Legal process (A new arch beyond existing arch is under construction and expected to completed by June '16.) | |

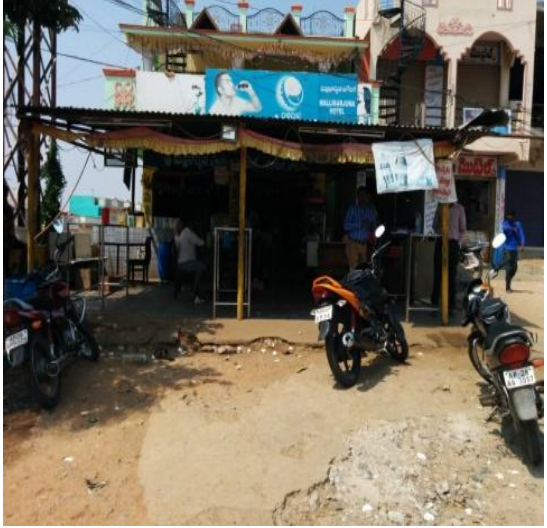
| S.No. | Area | Type of Area | Village Name | Encroachment | Since when | Why is encroachment here | Picture Documentation |
|---|---|---|---|---|---|--|--|
| 10 | Road Side with in ROW (RHS) | Road side Hotel | Kondanadapuram | Mallikarjuna Hotel | 12 Years | Opportunistic | |

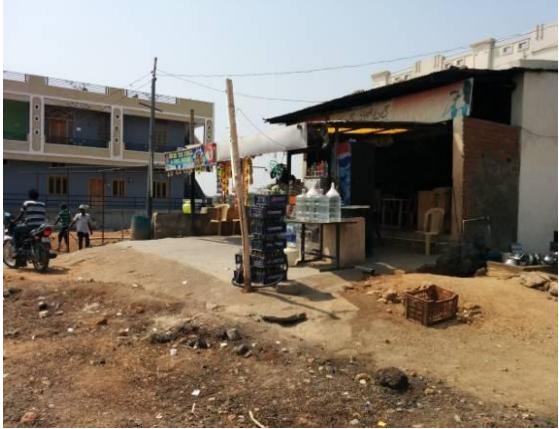
| S.No. | Area | Type of Area | Village Name | Encroachment | Since when | Why is encroachment here | Picture Documentation |
|---|---|---|---|---|---|---|--|
| 11 | Road Side with in ROW (RHS) | Road side Tea Stall | Kondanadapuram | Tea Stall | 9 Years | Opportunistic | |

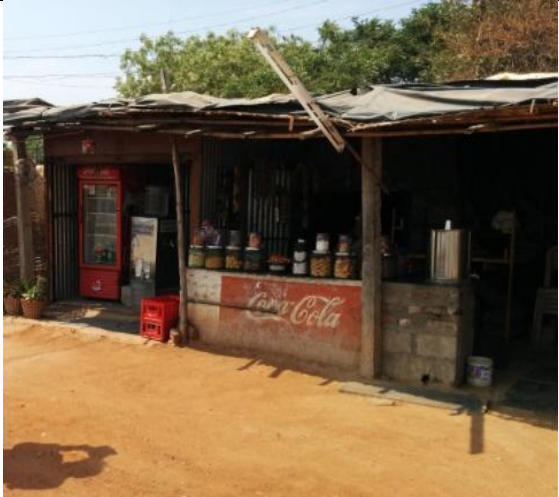
| S.No. | Area | Type of Area | Village Name | Encroachment | Since when | Why is encroachment here | Picture Documentation |
|---|---|---|---|---|---|---|--|
| 12 | Road Side with in ROW (RHS) | Road side Shop | Kondair | Temporary Tea Stall | 9 years | Opportunistic | |

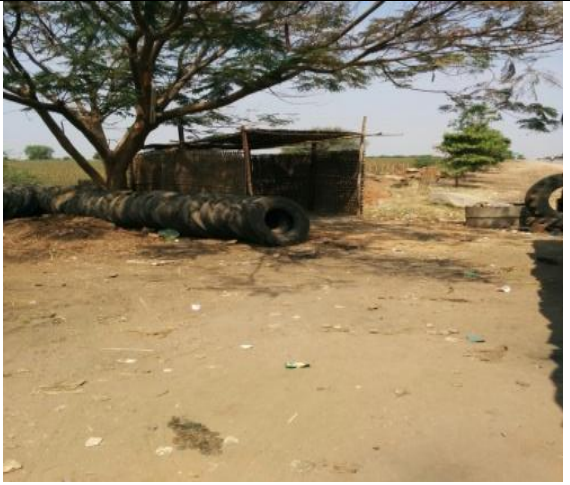
| S.No. | Area | Type of Area | Village Name | Encroachment | Since when | Why is encroachment here | Picture Documentation |
|---|---|---|---|---|---|---|--|
| 15 | Road Side with in ROW (RHS) | Road side Shop | Kondair | Temporary tyre repairing shop | 8 Years | Was existing, moved and shifted back | |

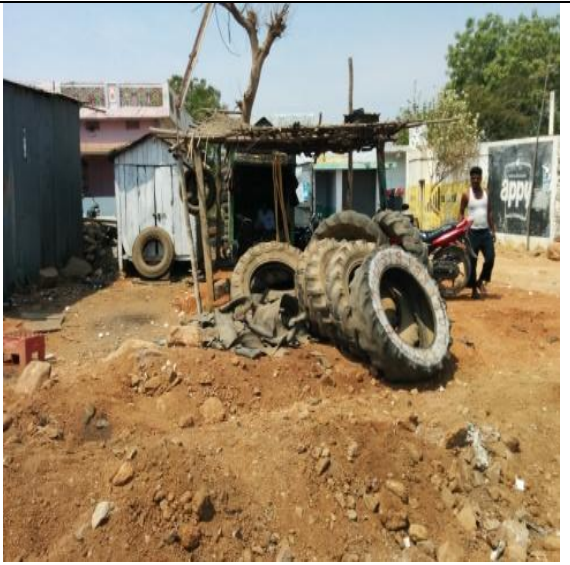
| S.No. | Area | Type of Area | Village Name | Encroachment | Since when | Why is encroachment here | Picture Documentation |
|---|---|---|---|---|---|---|--|
| 16 | Road Side with in ROW (RHS) | Road side Shop | Kondair | Temporary tyre repairing shop | 3 Years | Opportunistic | |

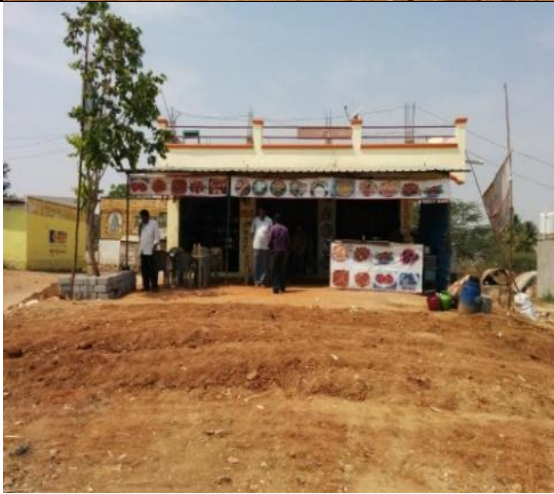
| S.No. | Area | Type of Area | Village Name | Encroachment | Since when | Why is encroachment here | Picture Documentation |
|---|---|---|---|---|---|---|--|
| 18 | Road Side with in ROW (RHS) | Road Side Restaurant | Kondair | Restaurant | 9 Years | Opportunistic | |

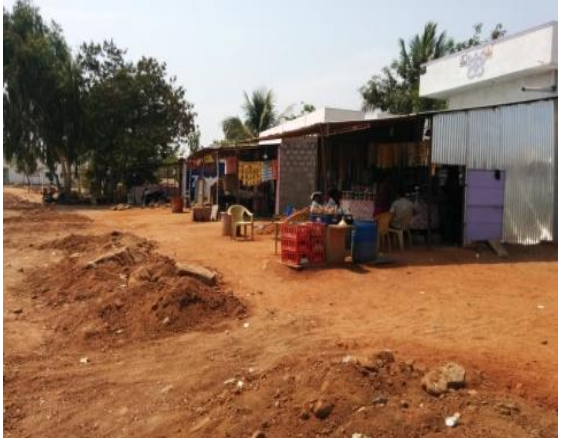
| S.No. | Area | Type of Area | Village Name | Encroachment | Since when | Why is encroachment here | Picture Documentation |
|---|---|---|---|--|---|---|--|
| 19 | Road Side with in ROW (RHS) | Road Side Restaurant | Kondair | Restaurant | 13 Years | Was existing, moved and shifted back | |

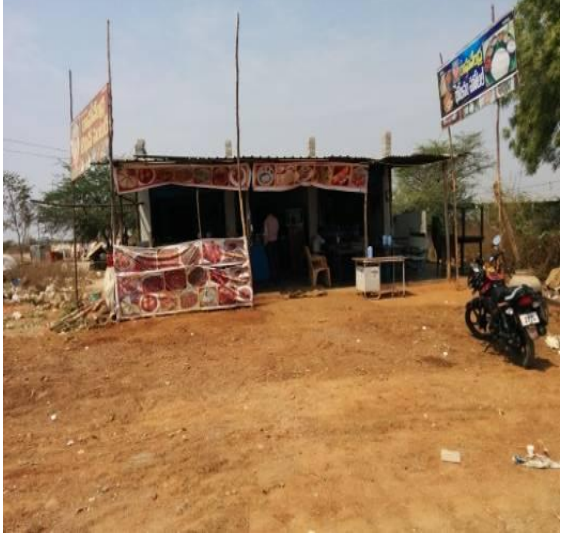
| S.No. | Area | Type of Area | Village Name | Encroachment | Since when | Why is encroachment here | Picture Documentation |
|---|---|---|---|--|---|---|--|
| 20 | Road Side with in ROW (RHS) | Road Side Restaurant | Kondair | Temporary extended tin shed covered restaurant | 5 Years | Opportunistic | |

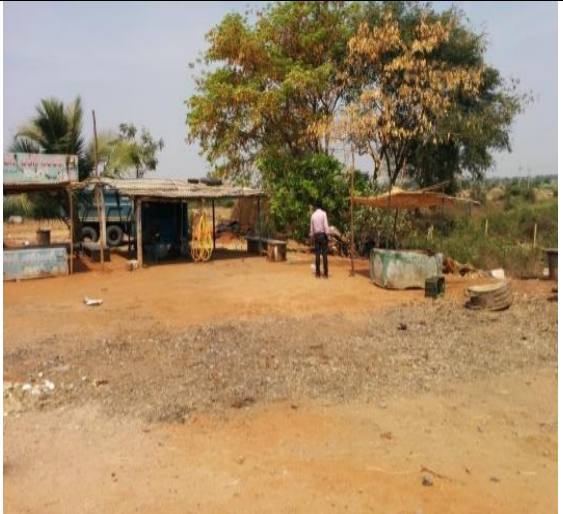
| S.No. | Area | Type of Area | Village Name | Encroachment | Since when | Why is encroachment here | Picture Documentation |
|---|---|---|---|--|---|--|--|
| 21 | Road Side with in ROW (RHS) | Road Side Chicken Shop | Kondair | Temporary extended tin shed covered chicken shop | 3 years | Opportunistic | |

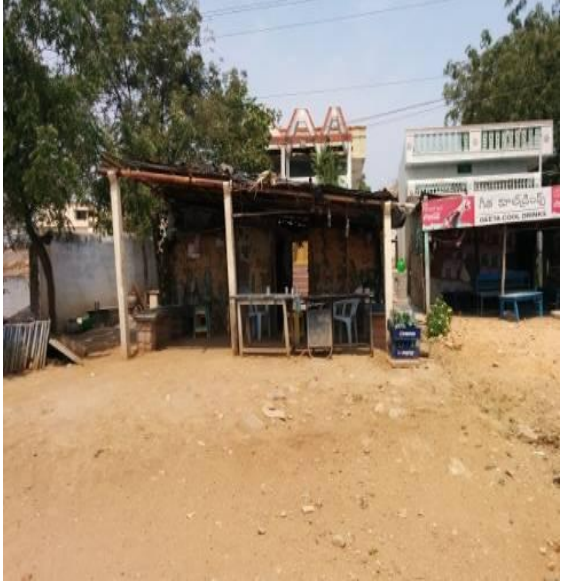
| S.No. | Area | Type of Area | Village Name | Encroachment | Since when | Why is encroachment here | Picture Documentation |
|---|---|---|---|--|---|--|--|
| 22 | Road Side with in ROW (RHS) | Road side Tea Stall | Beachebelly | Tea Stall | 10 Years | Was existing, moved and shifted opportunistic back | |

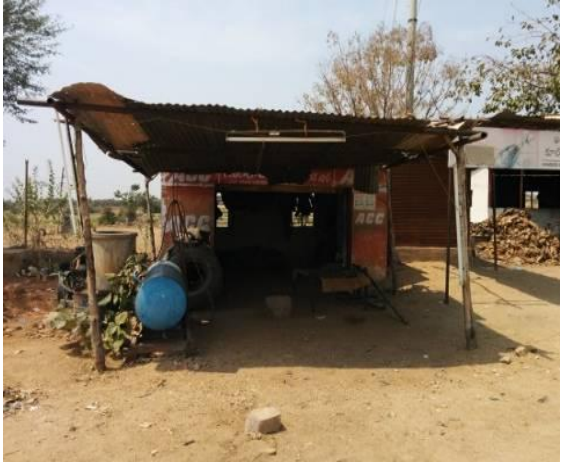
| S.No. | Area | Type of Area | Village Name | Encroachment | Since when | Why is encroachment here | Picture Documentation |
|---|---|---|---|---|---|---|--|
| 23 | Road side with in ROW (RHS) | Road side tyre repairing shop | Thomalapalli | Tyre repairing shop | 4 Years | Opportunistic | |

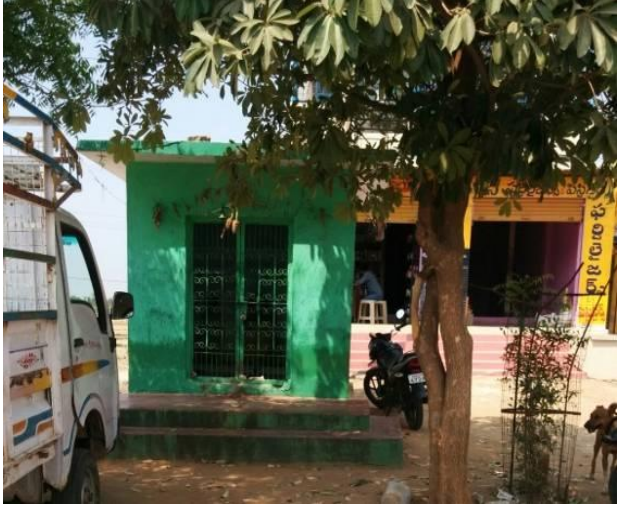
| S. No | Chainage | Side | Structure type | Photographs | Status as on 29.03.2016 |
|---|---|---|---|---|--|
| 6 | 174+400 | RHS | Temple within RoW | | <p>NHAI had allowed to relocate the structure abutting to RCW after shifting from RCW at the time of widening the project road. We can not afford to shift at this moment.</p> |

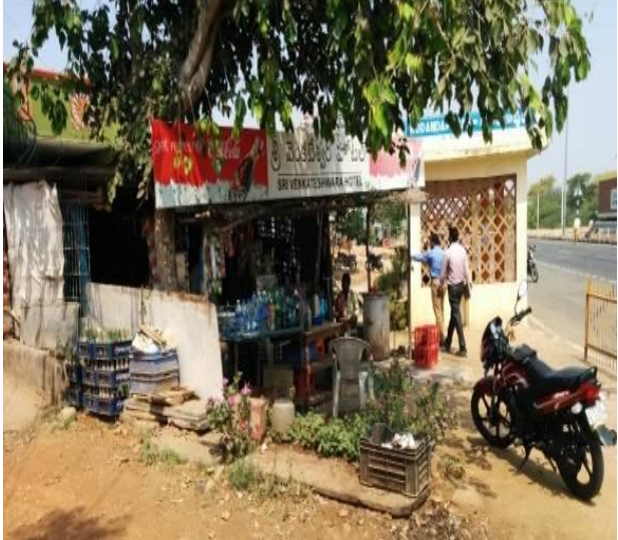
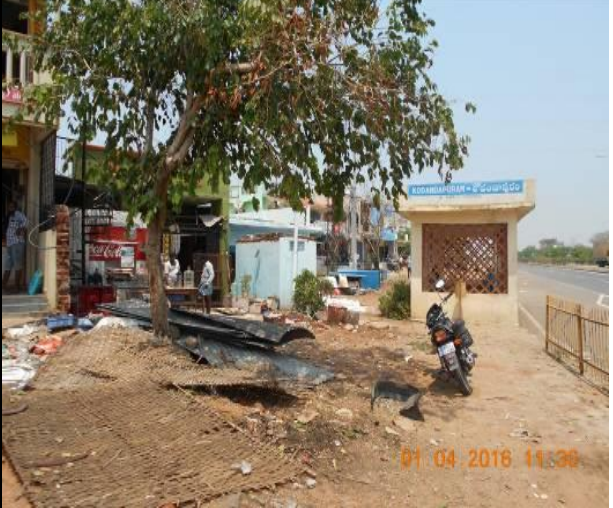
| S. No | Chainage | Side | Structure type | Photographs | Status as on 29.03.2016 |
|---|---|---|---|---|--|
| 7 | 174+320 | RHS | Temporary extended tea stall tin shed structure | | <p>Extended tin shed dismantled</p> |

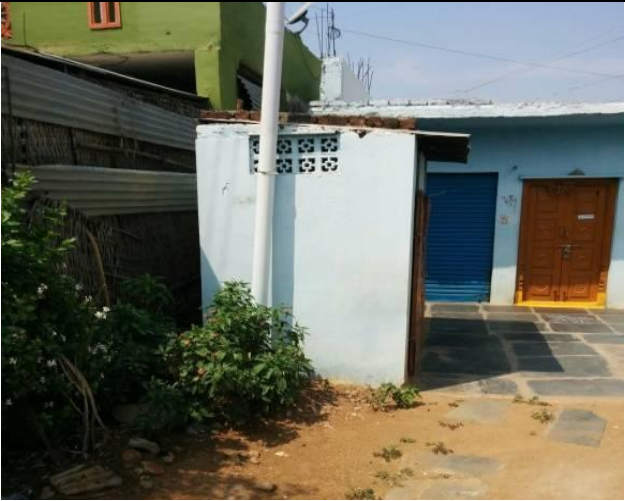
| S. No | Chainage | Side | Structure type | Photographs | Status as on 29.03.2016 |
|---|---|---|--|---|--|
| 8 | 174+300 | RHS | Extended paved bathroom structure | | Tenants had accepted to dismantle before 30.04.2016. |

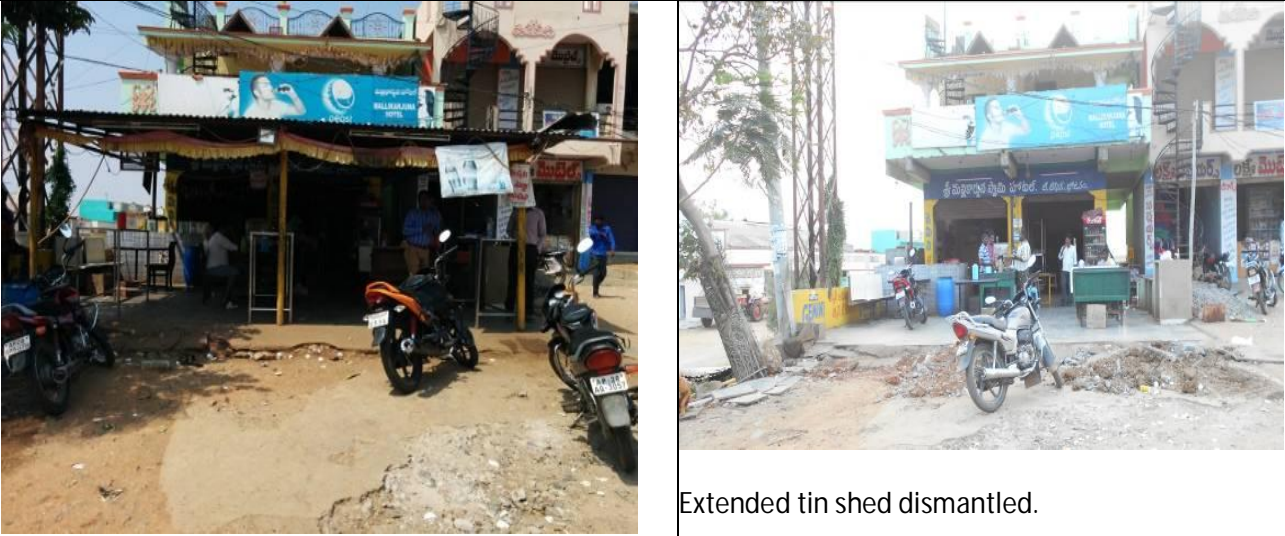
| S. No | Chainage | Side | Structure type | Photographs | Status as on 29.03.2016 |
|---|---|---|--|---|--|
| 9 | 174+270 | RHS | Temporary extended tin covered tea stall | | Extended tin shed dismantled. |

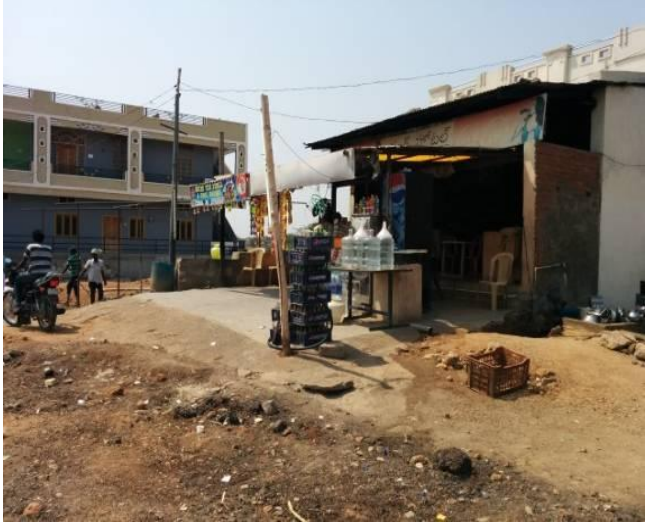
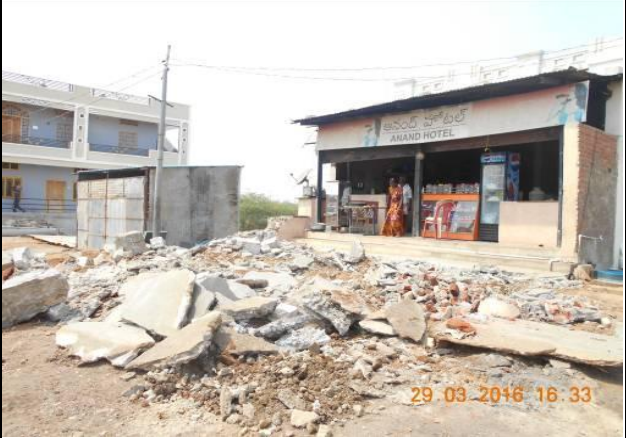
| S. No | Chainage | Side | Structure type | Photographs | Status as on 29.03.2016 |
|---|---|---|--|---|---|
| 10 | 174+200 | RHS | Temporary extended tin covered tea stall | | <p data-bbox="1473 722 1832 754">Extended tin shed dismantled.</p> |

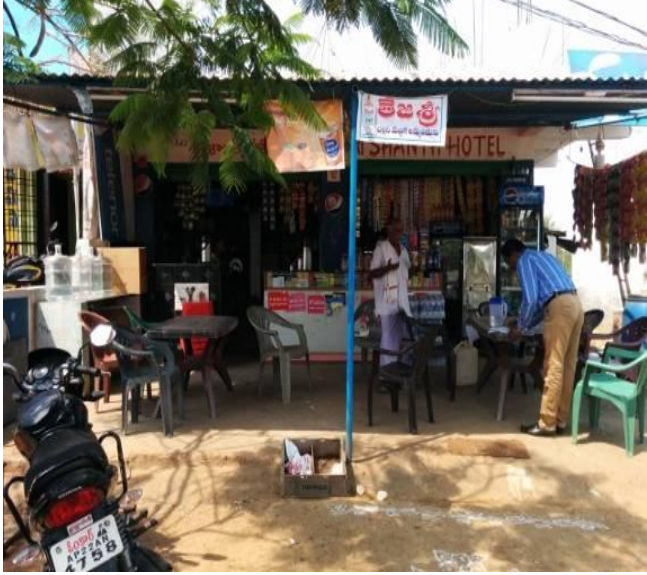
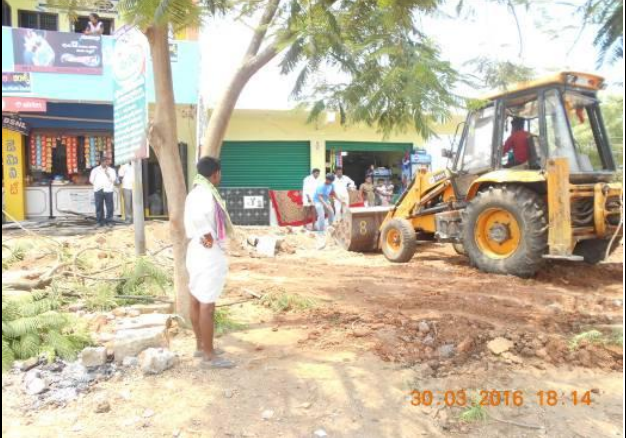
| S. No | Chainage | Side | Structure type | Photographs | Status as on 29.03.2016 |
|---|---|---|--|---|---|
| 11 | 174+180 | RHS | Temporary extended tin covered general grocery store | | <p data-bbox="1473 1281 2067 1347">Temporary extended tin covered general grocery store dismantled</p> |

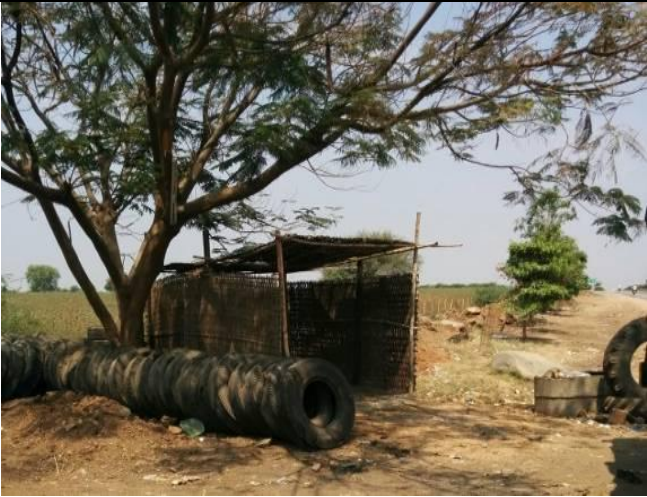
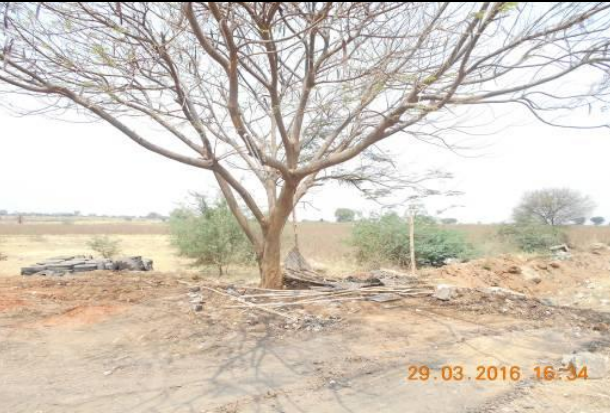
| S. No | Chainage | Side | Structure type | Photographs | Status as on 29.03.2016 |
|---|---|---|--|---|--|
| 12 | 174+150 | RHS | Temporary extended tyre repairing shop | | <p data-bbox="1471 695 2069 727">Temporary extended tyre repairing shop removed</p> |

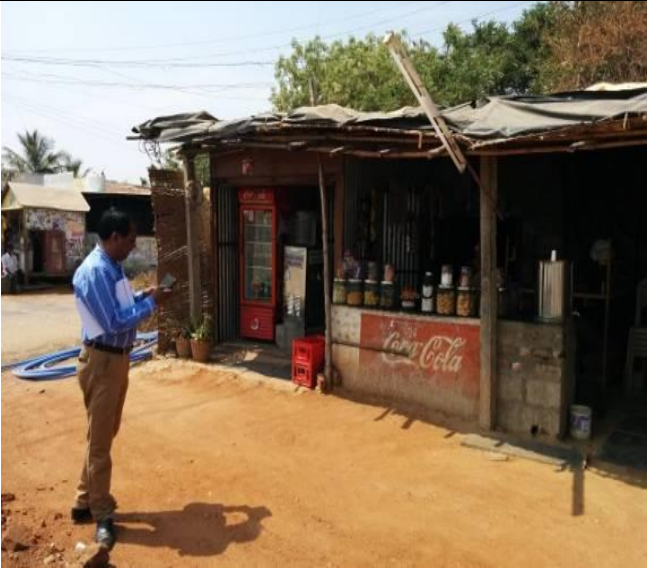
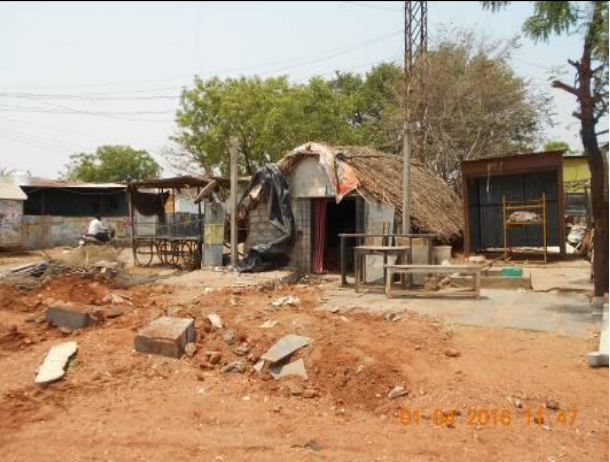
| S. No | Chainage | Side | Structure type | Photographs | Status as on 29.03.2016 |
|---|---|---|--|---|--|
| 13 | 170+200 | RHS | Temporary extended tin covered tea stall | | <p data-bbox="1471 1232 2024 1302">Temporary extended tin covered tea stall was removed</p> |

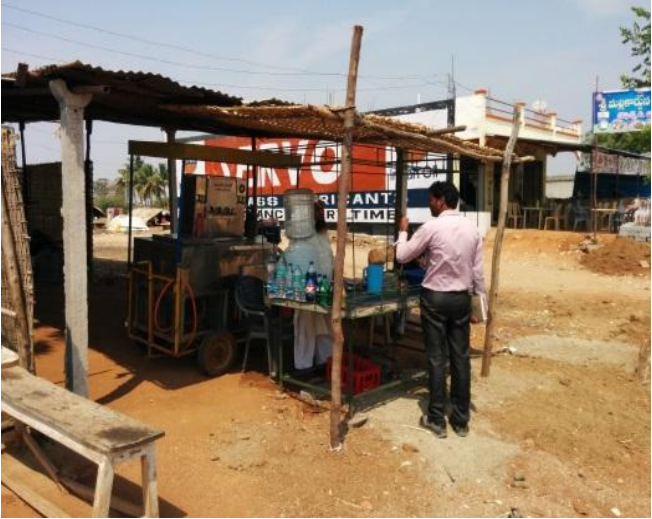
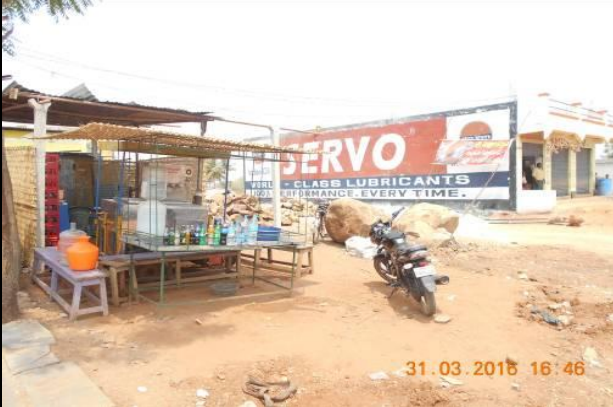
| S. No | Chainage | Side | Structure type | Photographs | Status as on 29.03.2016 |
|---|---|---|--|---|--|
| 13 | 170+150 | RHS | Temporary extended tin covered tea stall | | <p data-bbox="1473 624 2056 691">Temporary extended tin covered tea stall shifted beyond ROW.</p> |

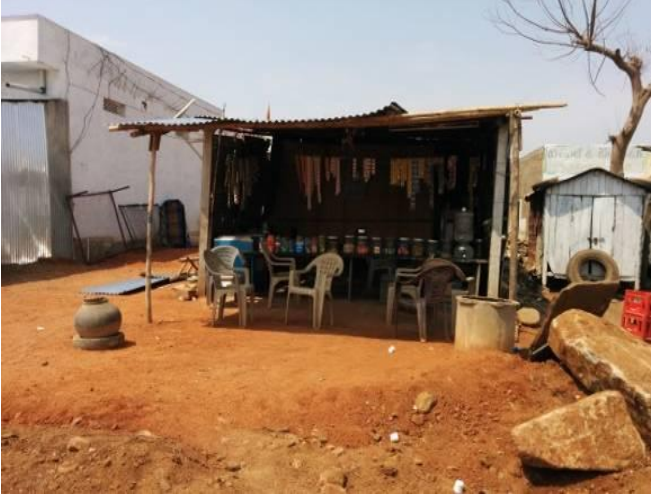
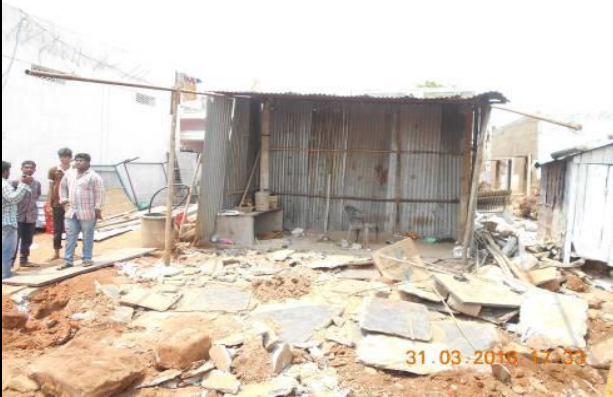
| S. No | Chainage | Side | Structure type | Photographs | Status as on 29.03.2016 |
|---|---|---|--|---|--|
| 14 | 170+140 | RHS | Temporary extended tyre repairing shop | | <p data-bbox="1473 1190 2040 1257">Temporary extended grocery and tyre repairing shop dismantled.</p> |

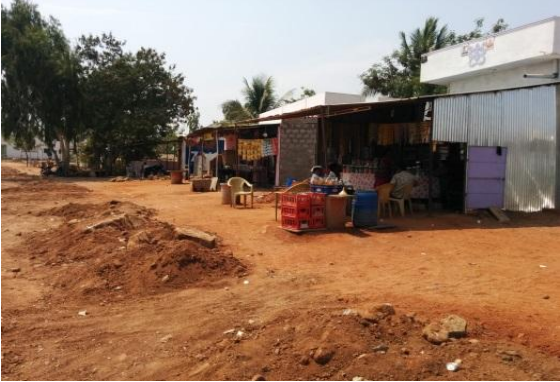
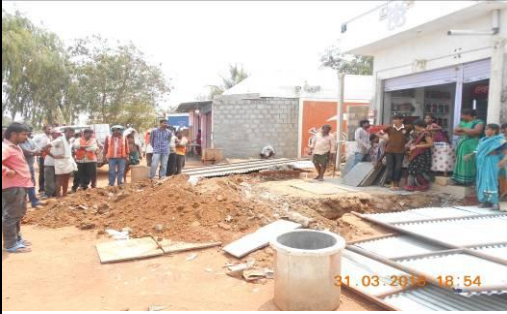
| S. No | Chainage | Side | Structure type | Photographs | Status as on 29.03.2016 |
|---|---|---|--|---|--|
| 17 | 170+100 | RHS | Temporary extended tin shed covered restaurant | | <p>Temporary extended tin shed covered restaurant dismantled</p> |

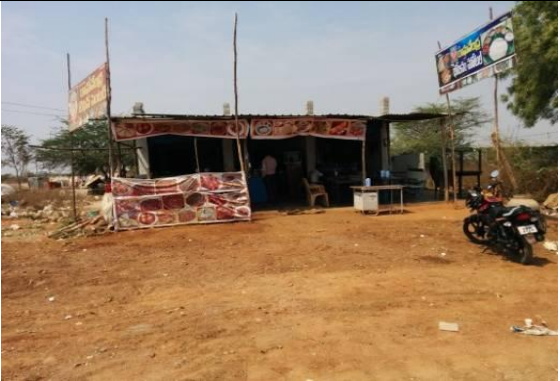
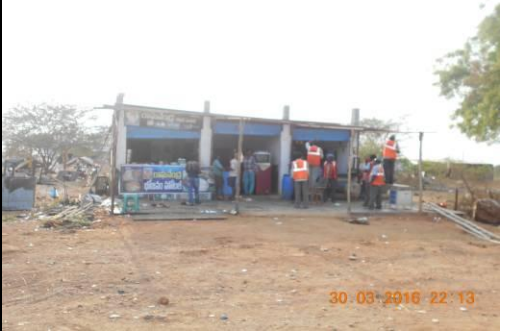
| S. No | Chainage | Side | Structure type | Photographs | Status as on 29.03.2016 |
|---|---|---|--|---|--|
| 18 | 174+050 | RHS | Temporary extended tin shed covered restaurant | | <p>Temporary extended tin shed dismantled.</p> |

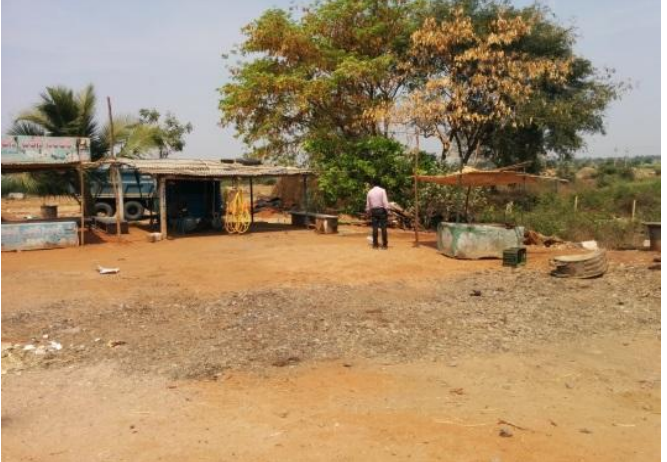
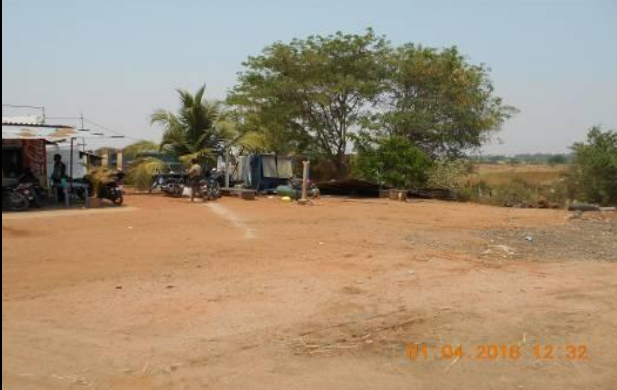
| S. No | Chainage | Side | Structure type | Photographs | Status as on 29.03.2016 |
|---|---|---|--|---|---|
| 19 | 167+450 | RHS | Temporary extended tin shed covered chicken shop | | <p>Tin shop was removed. Local MP requested to allow till 30.04.2016 (Contact no.9440297979).</p> |

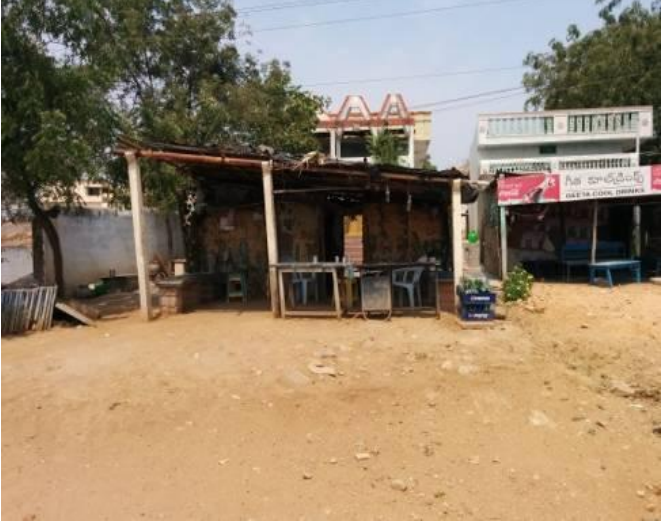
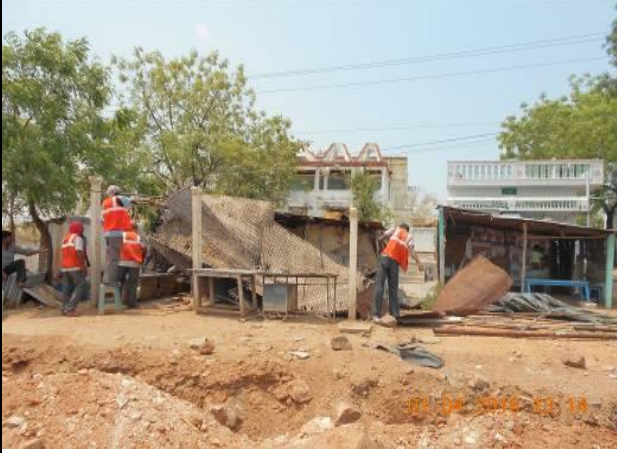
| S. No | Chainage | Side | Structure type | Photographs | Status as on 29.03.2016 |
|---|---|---|--|---|---|
| 20 | 163+250 | RHS | Temporary extended tin covered tea stall | | <p>Temporary extended tin covered tea stall was removed.</p> |

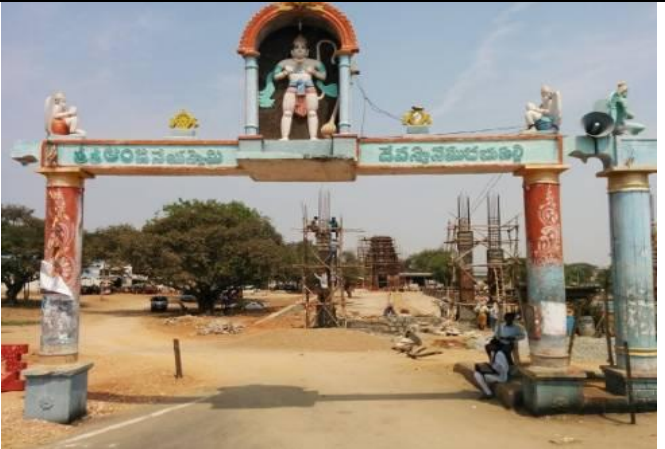
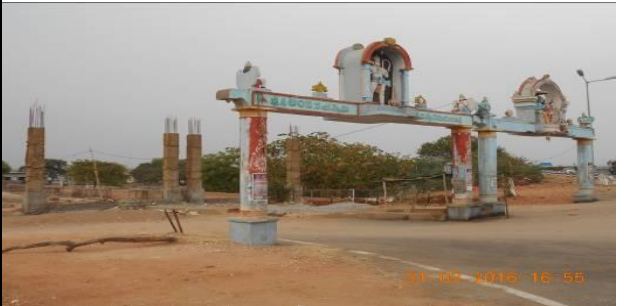
| S. No | Chainage | Side | Structure type | Photographs | Status as on 29.03.2016 |
|---|---|---|---|---|---|
| 21 | 163+050 | RHS | Paved Hanuman jiMandir gate within RoW, now gate is in under construction stage beyond RoW. | | <p>A new arch beyond existing arch is under construction and expected to complete by June '16. Existing arch will be dismantled after construction of new arch.</p> |

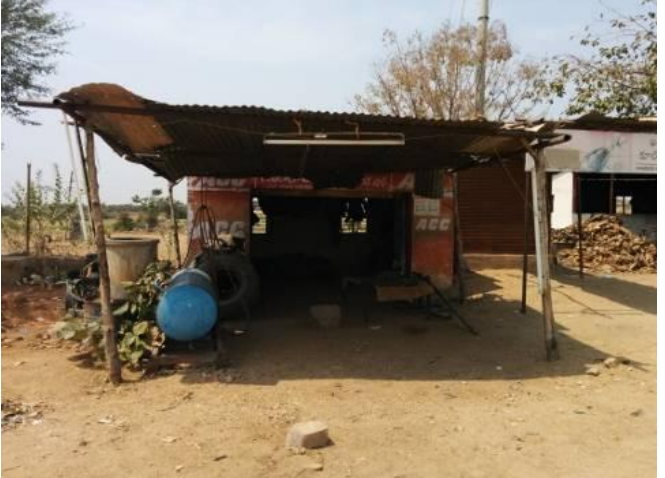
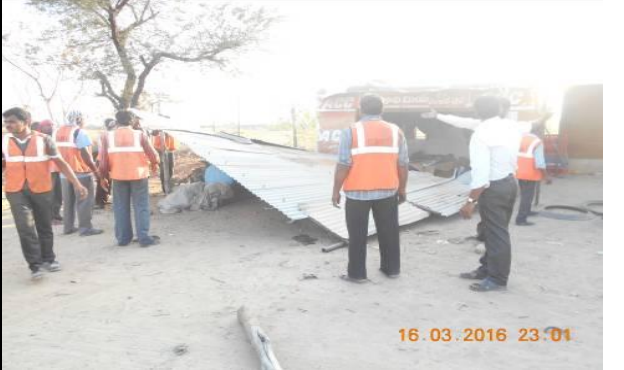
| S. No | Chainage | Side | Structure type | Photographs | Status as on 29.03.2016 |
|---|---|---|---|---|---|
| 22 | 147+750 | RHS | Temporary extended tyre repairing shop | | <p>Temporary extended tyre repairing shop dismantled.</p> |

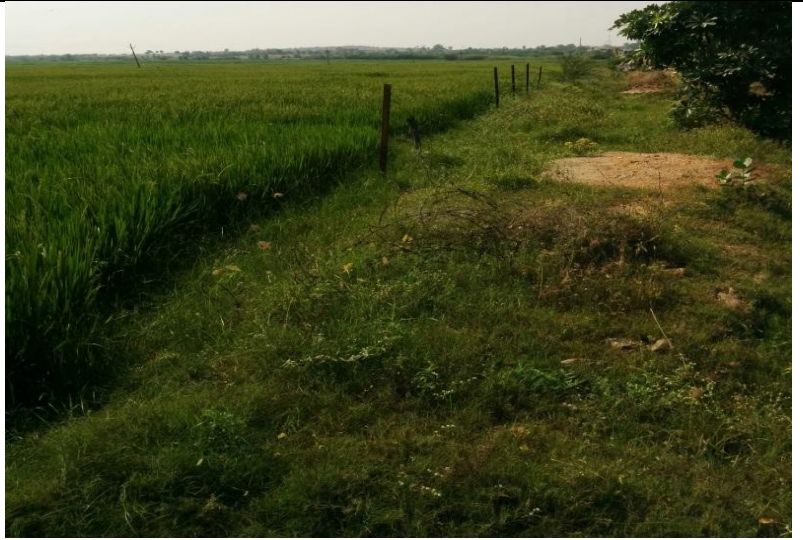
| Description: Avenue plantation fencing got damaged at Chainage 139+350 to 140+200 | |

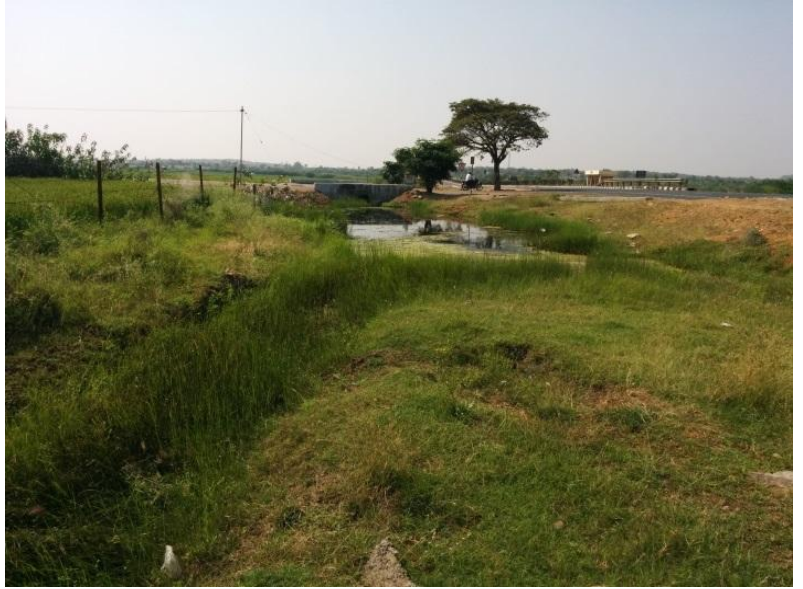
| Photo No. 5 | Date: 9 th March, 2016 |

| Description: Water logged area at Chainage 139+280 on LHS | |

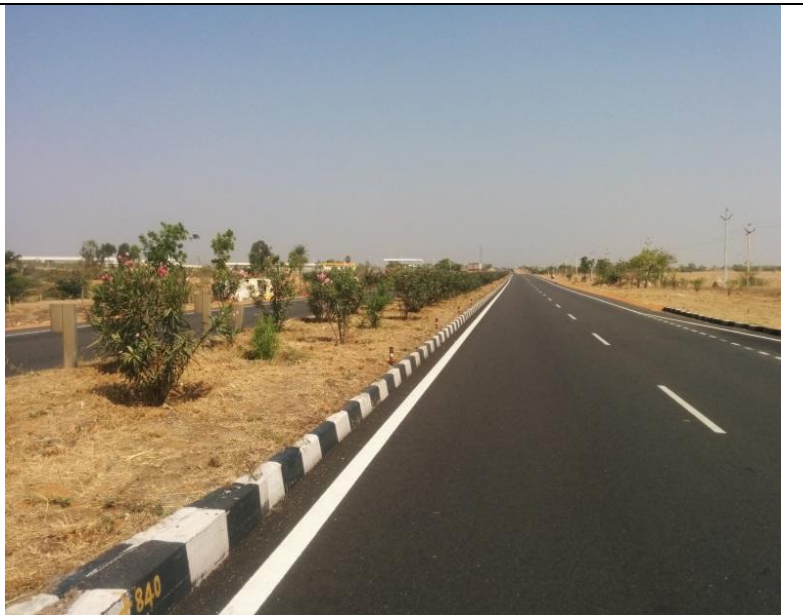
| Photo No. 6 | Date: 9 th March, 2016 |

| Description: Median Plantation | |

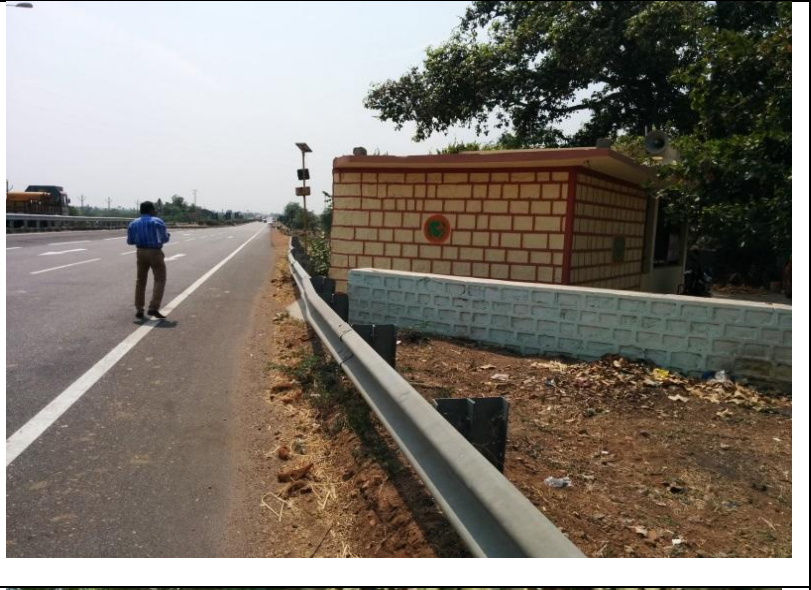
| Photo No. 7 | Date: 9 th March, 2016 | |

| Description: Temple at Kodhnandapur, very close to paved shoulder at Chainage 174+500 on RHS | | |

| S. No | Chainage | Side | Structure type | Photographs | Status as on 29.03.2016 |
|---|---|---|--|---|--|
| 4 | 174+500 | RHS | Temple at Kodhnandapur, very close to paved shoulder | | <p>NHAI had allowed to relocate the structure abutting to RCW after shifting from RCW at the time of widening the project road. We can not afford to shift at this moment.</p> |

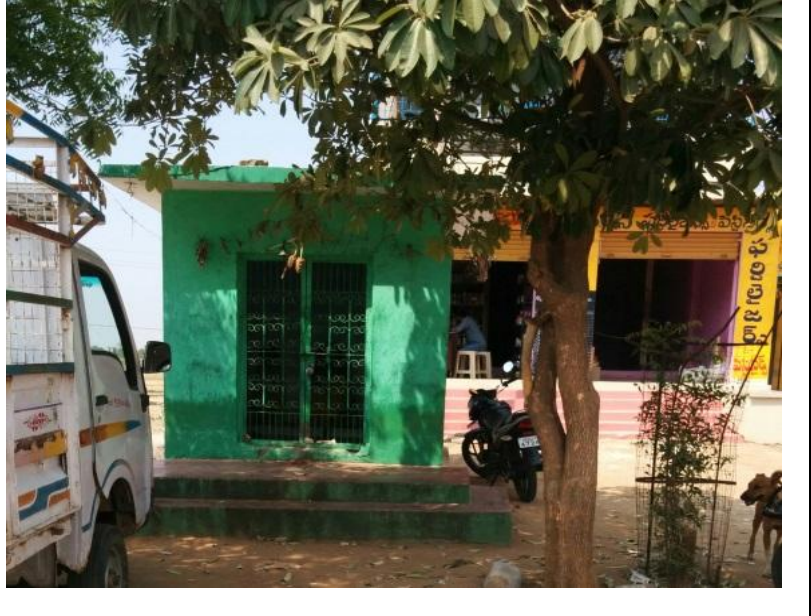
| Photo No. 8 | Date: 9 th March, 2016 | |

| Description: Temple within RoW at 174+400 on RHS | | |

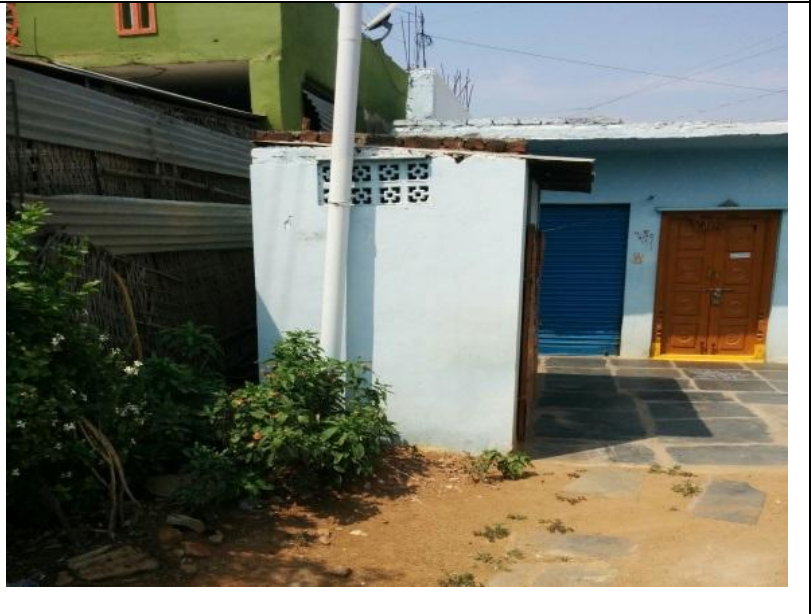
| Photo No. 9 | Date: 9 th March, 2016 | |

| Description: Extended paved bathroom structure within RoW at Chainage 174+300 on RHS | | |
