# An Environmental Impact Assessment of Ubuntu 1 Exploration Drilling Project

Report Prepared for  
**Eaglewood Energy Inc**

***SolvFit Limited***

**July 2010**

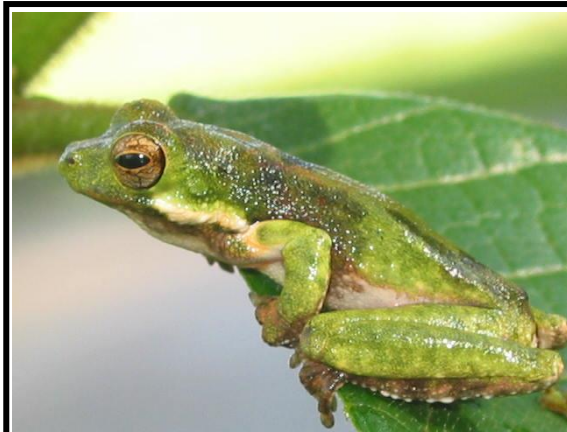
**Family: Hylidae**  
***Litoria* sp. nov.5.**

SVL 30 mm. Slender predominantly green frog with pale brown, heavily reticulated eye. Bright, rust-red on hidden surface of thighs and lower belly. An undescribed species was only known to Jagifu Ridge and Gobe Ridge (Richards, 2002). This sighting and collection now extends the species distribution range into Western Province

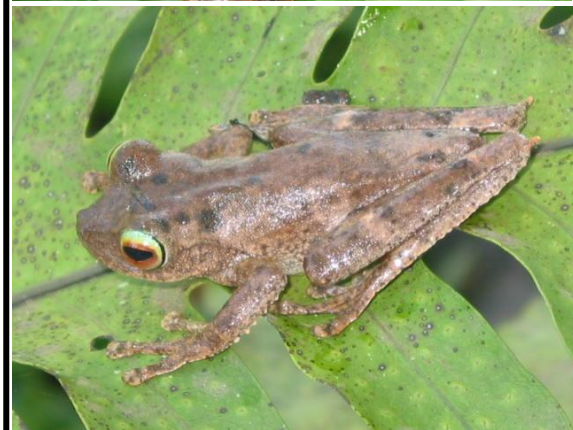
**Family: Ranidae**  
***Rana* cf. *daemeli***

SVL 77 mm. Grey or brown with bars on legs. Snout angular, legs very long. Inhabits undisturbed forest floor, reproduces in pools on tree trunks and protects eggs from dehydration with its salivary glands

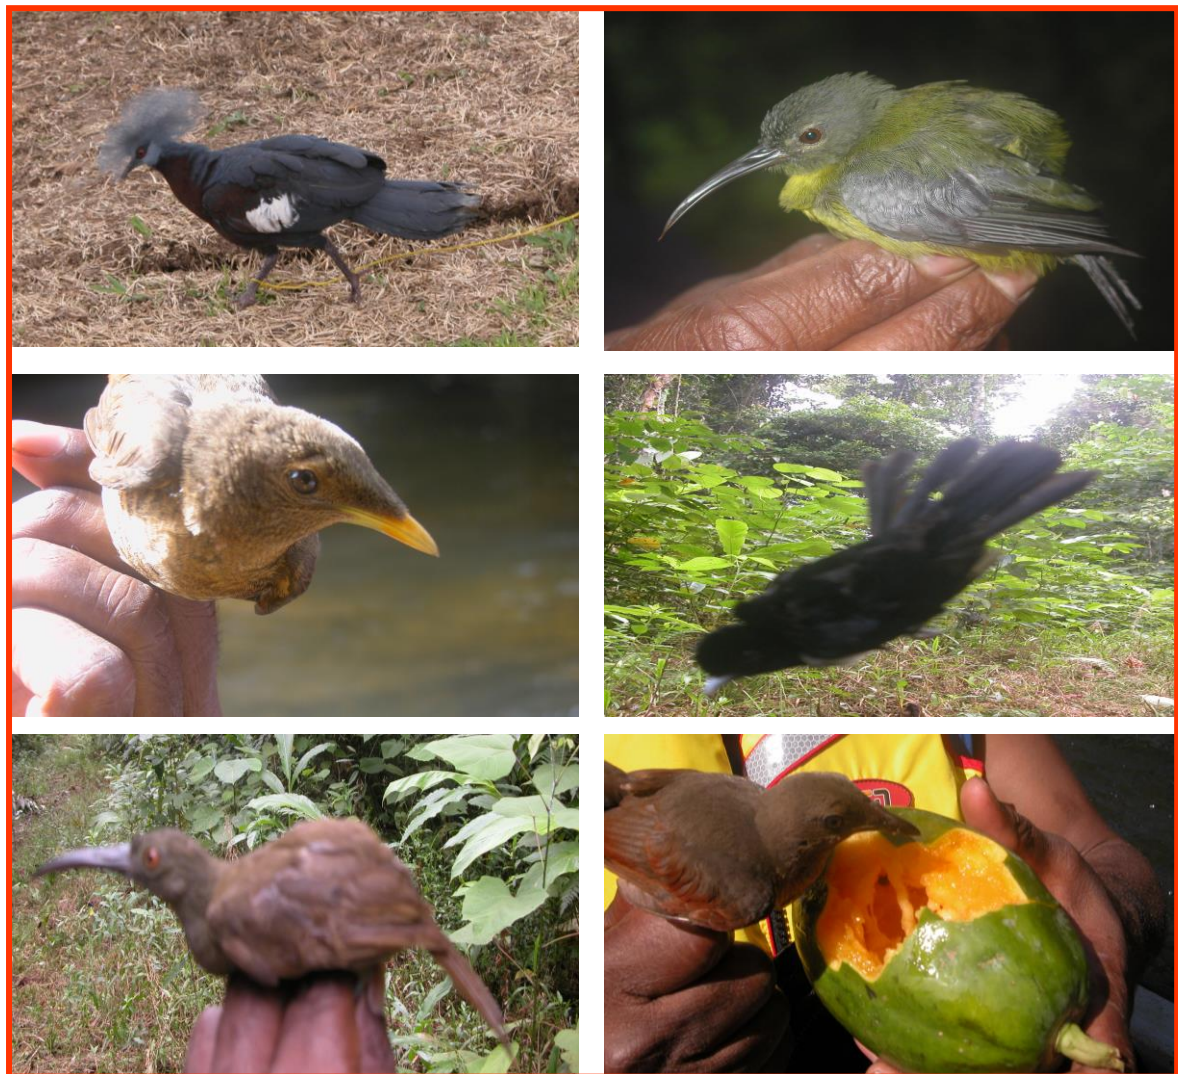
Figure 10. Some of the birds captured and recorded in the forests between Hagana and the Rig Site.

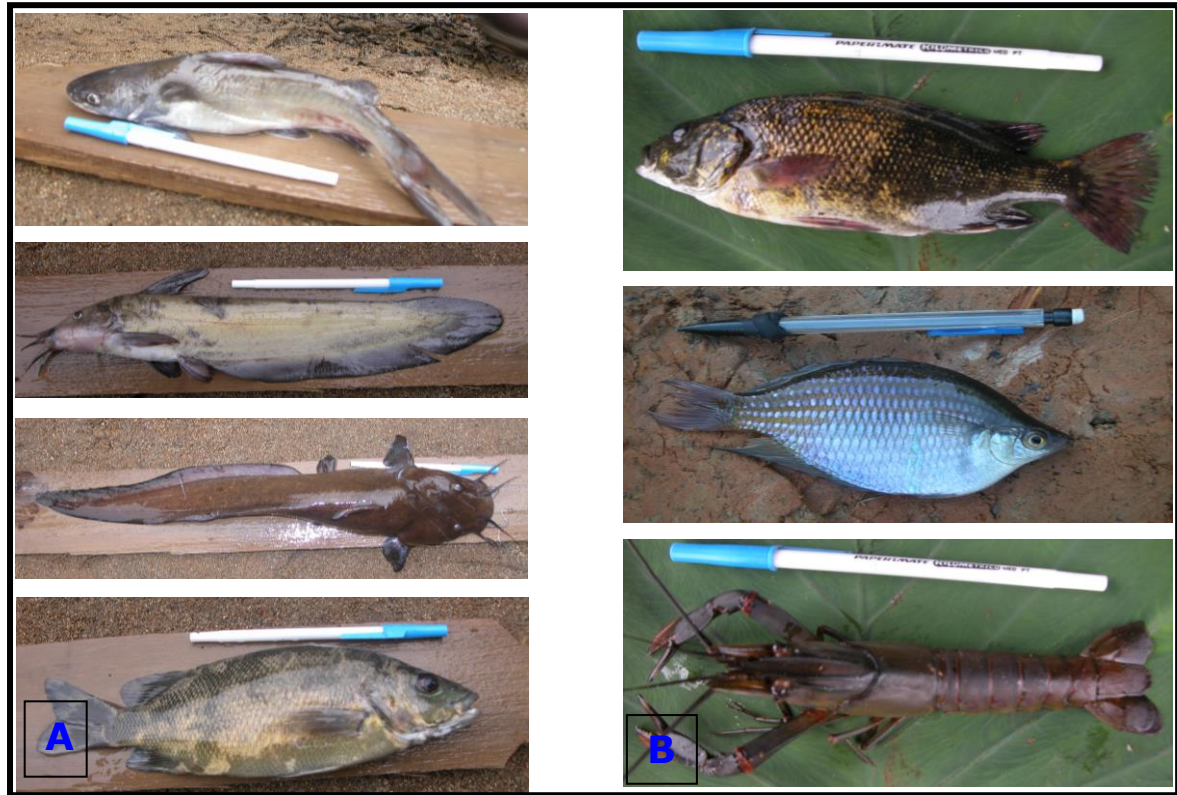
Figure 12. Fresh water fish caught in the Elevala River below Damalo village (a) and some from the Tuo River below the Well pad (b).

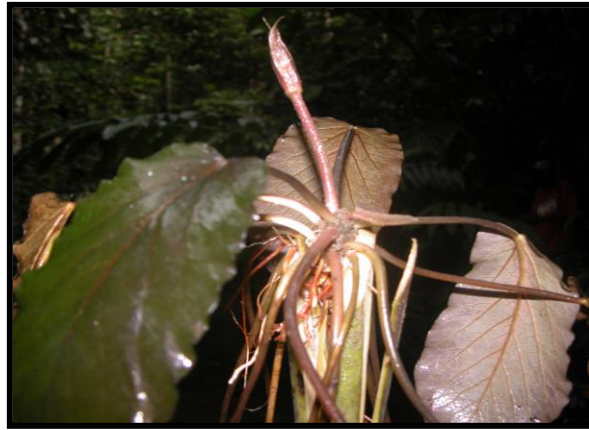
Figure 11. The only aquatic species found in the Haga creek next to the Camp site and also in an unnamed creek along the track to the Rig Site.

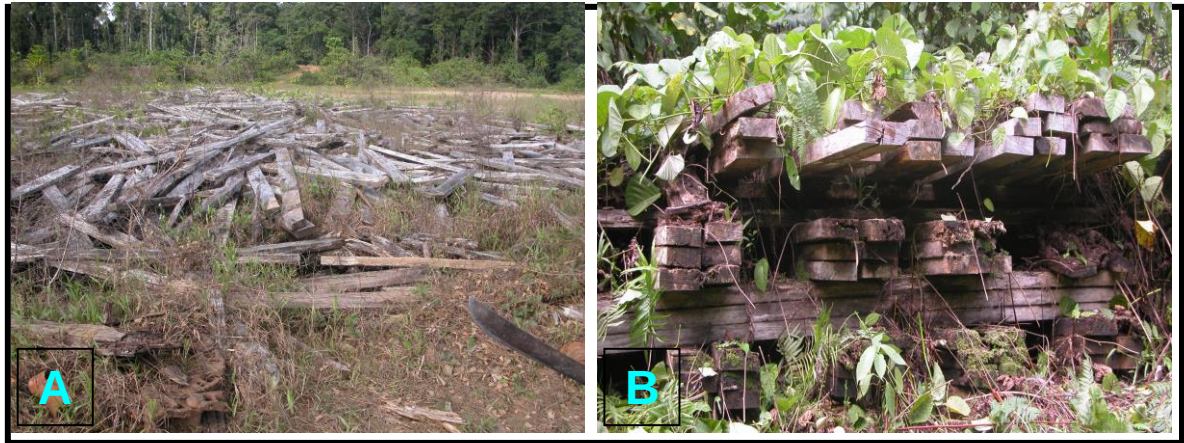
It is estimated that a total of 28,000 rig boards were cut and prepared for the well pad in 2007. The rig boards were used on the rig floor. However, after the work was suspended the boards were removed and left behind (Fig. 17 A). These boards will have to be cleared and the surface prepared for the dura mats.

Below the well pad is an abandoned stockpile of rig boards left behind by CPS after the construction of the pad (Fig 17 B). Some of these rig boards could be salvaged and used for other purposes, such as walkways and floors for the camps.

Figure 17. Rig boards removed from the rig pad and abandoned on the Rig Site.

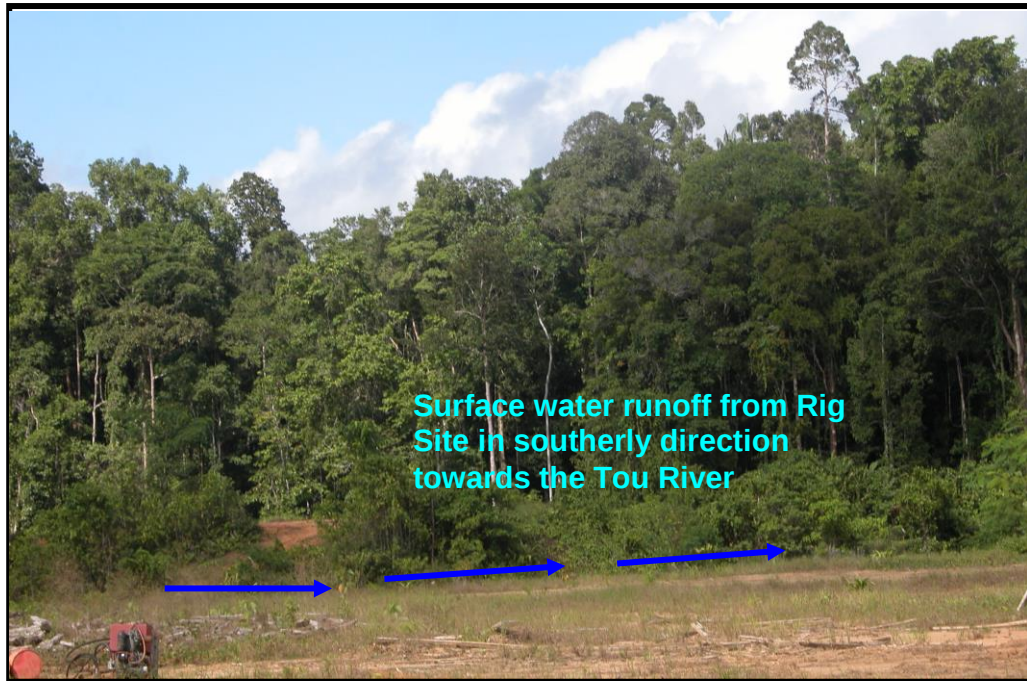
Figure 19. Direction of surface water runoff on the Rig Site towards the Tou River and towards the Meme Creek

It is recommended that all surface water runoff from the Rig Site be directed to the north where it can filter through the vegetation cover before entering the nearest stream.

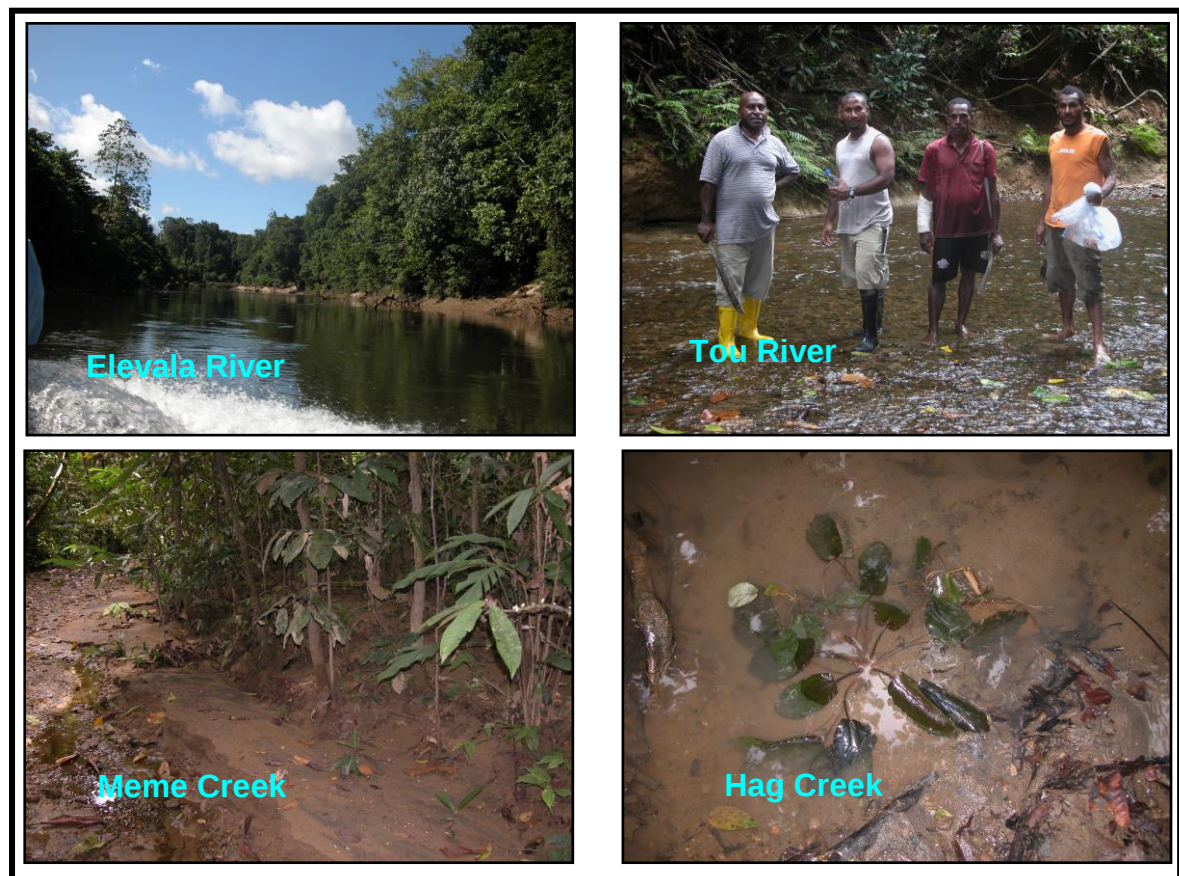
Figure 20. The Elevala River, the headwaters of Tou River and two smaller creeks within the project area.

The project site is located in the headwaters of the Tou River and three small streams flows from the site. During the time of this survey, the water in these streams was observed to be clear and free of silt and other debris.

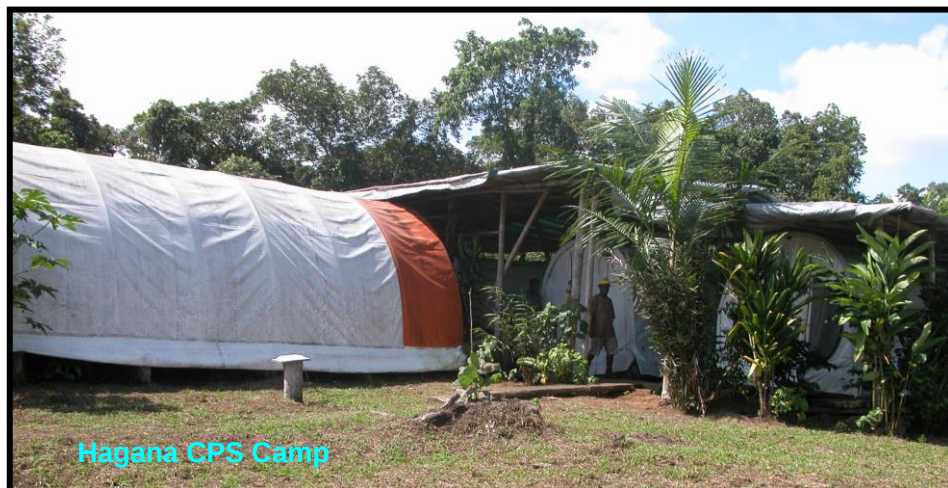
The Hagana Camp is located about 1 km away west of the Rig Site. It is not known at this stage whether this camp will continue to operate or not. However, it has all the basic facilities that are required to support the initial work of clearing and setting up the Rig Site.

Figure 22. The CPS camp at Hagana consist of accommodation units, kitchen, shower and laundry block, generator, water supply and two camps for support staff.

The camp will need to be resourced to cater for the increase in people when the work begins. Facilities to be considered for upgrading include accommodation blocks, the messing and shower facilities, field toilets and waste management pits.

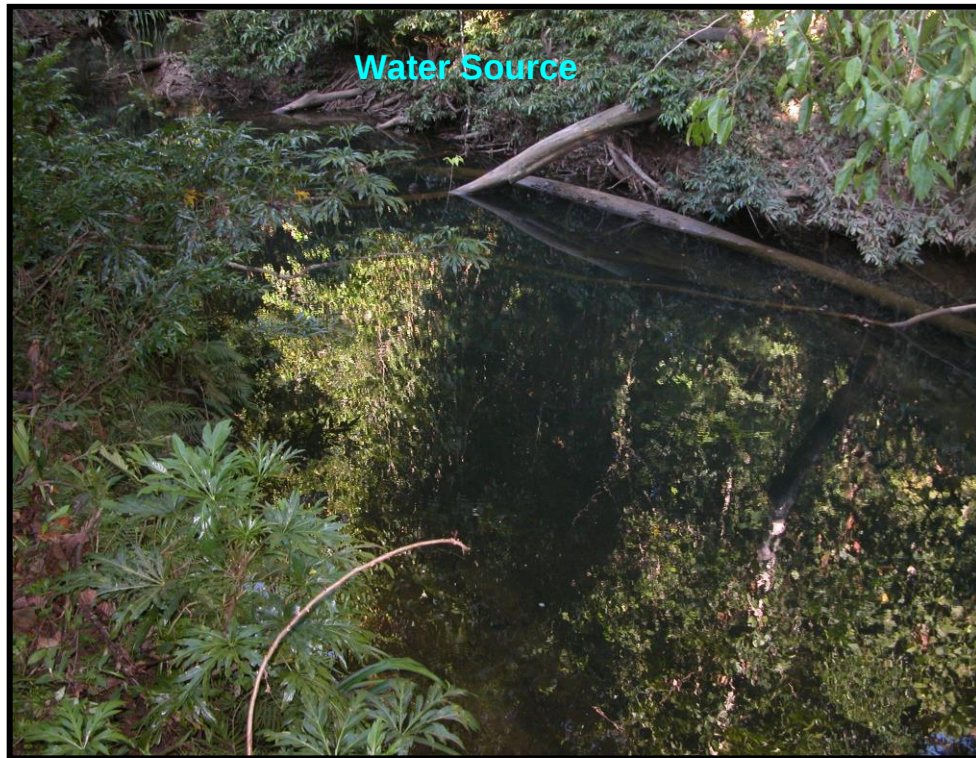
Water for drilling and the camps will be extracted from the Tou River from a location about 300-400 m from the southern end of the well pad. The site has sufficient volume of water to support both drilling activities and to maintain an adequate water level in the water ways to sustain aquatic organisms.

It is estimated that drilling activities will extract 4500 liters per hour from the system. Preliminary calculation of the water flow shows that the waterway discharges about 3,164 M3 per hour.

Figure 24. The water source where water will be extracted to supply drilling and other support activities at the Rig Site.
