**Environment, Social, Health and Safety  
Management System (ESHSMS)**

## **Biodiversity Action Plan**

**Document Number:  
02/ES/PJ/PN/009/A01**

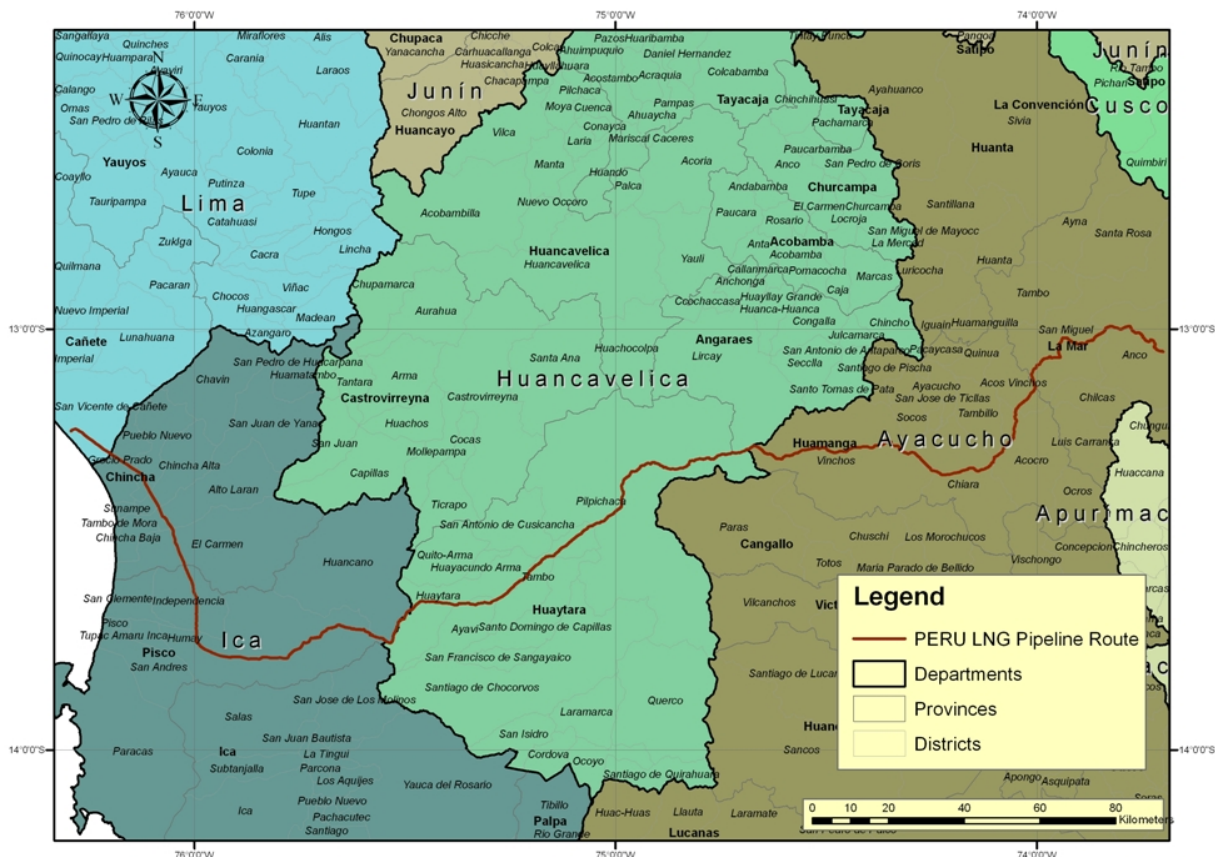
**Figure 1.1 PERU LNG pipeline route and surrounding departments, provinces, and districts (first, second, and third-order administrative divisions, respectively).**

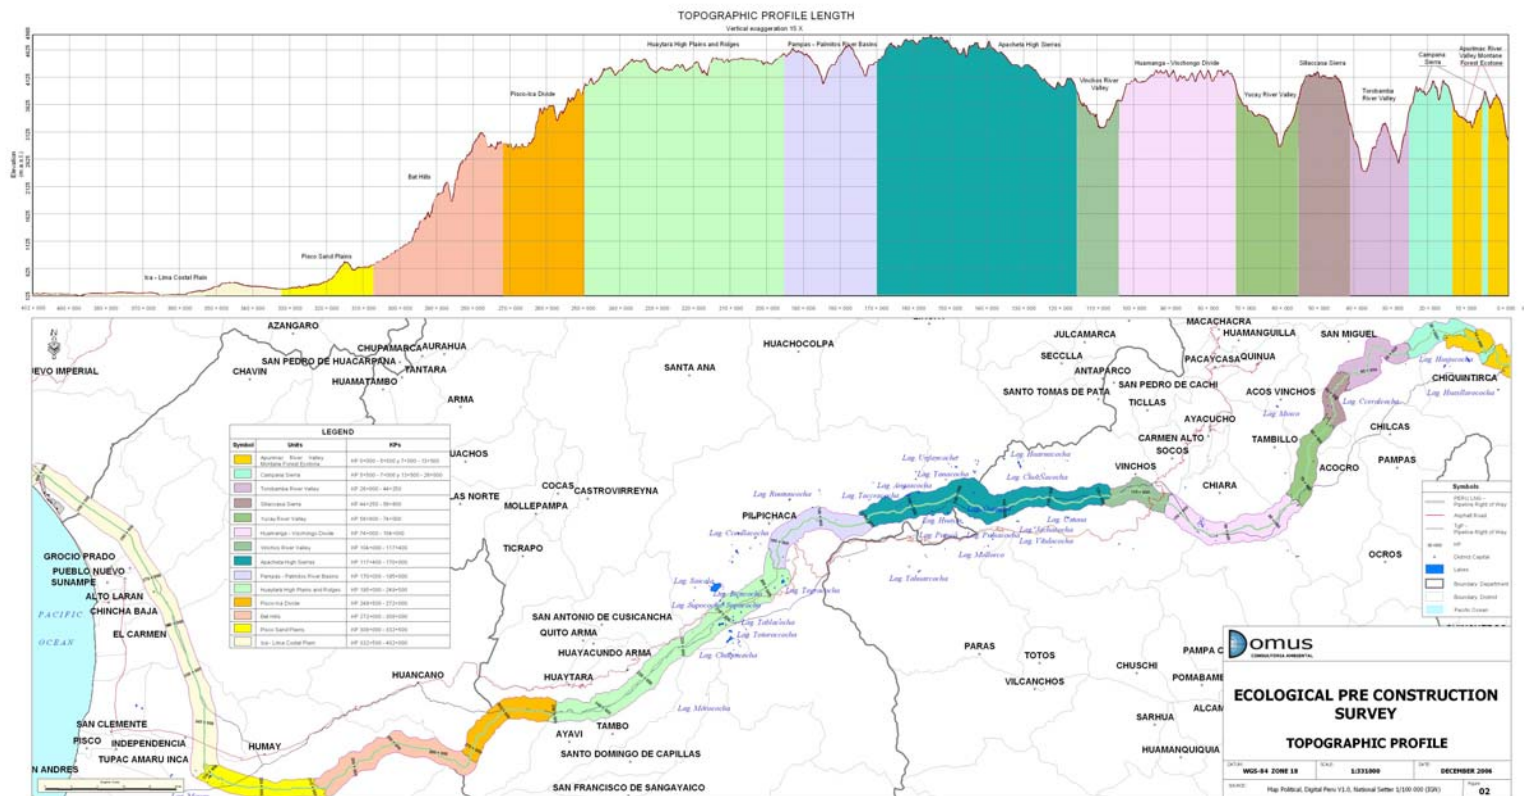
**Figure 23.1.1 Topographic Profile of the ROW**

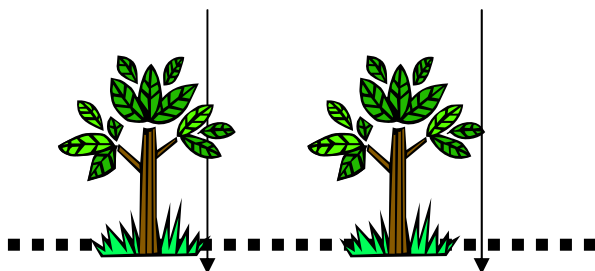
As it can be observed, in the first case the needle hits the shrub three times and the herbaceous plant once. In the second case, the needle hits the shrub only once and does not touch any herbaceous cover. So the value for the first case is 4 and 1 for the second. For this study, 50 equally-spaced location points for the needles were used in a 50-m linear transect.

The point-quadrat is a method that was designed at the beginning to obtain the values of the frequency variable (presence-absence) in herb and bush communities. Later it was used to obtain cover data (projected area on the soil covered by plants). However, this method shows to be very useful generating "repeated cover" values that are calculated from the number of times a plant touches a "needle" ("zero" width and "infinite" length in theory). So the number of times the plant hits the needle will depend not only on the simple cover but also on the size and volume of the plant foliage becoming an indirect and non-destructive measure of the biomass. So that the repeated cover values has a high correlation with the ones of the biomass.

The plant species and the number of hits with the needle were registered in each point. The sum of values in the 50 points for each species was considered as the abundance measure ("repeated cover"). This measure was used to calculate the diversity indicators and the percentage of abundance (having as the total sum the number of hits in the 50 points of all the plant species). The following measures were calculated:

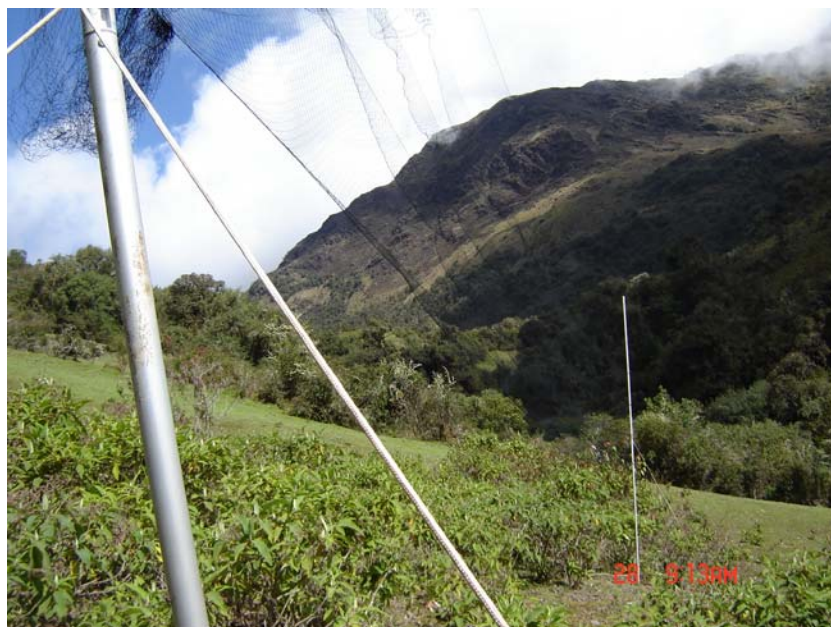
**Figure 2.** Mist net set in Montane Forest, 10 m far from the river that goes to SP3.
